Centrifugal Compressor Failure Analysis

KnightHawk Engineering, Inc.

- Compressor failure at refining facility in Gulf Coast of USA
 - 6000 HP two stage process gas compressor in catalytic cracking process
 - Catastrophic failure occurred prior to shutdown for turnaround

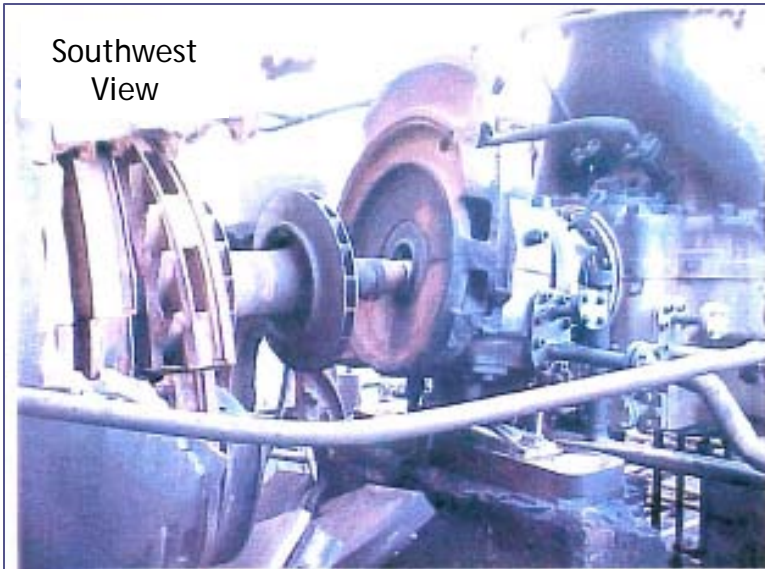
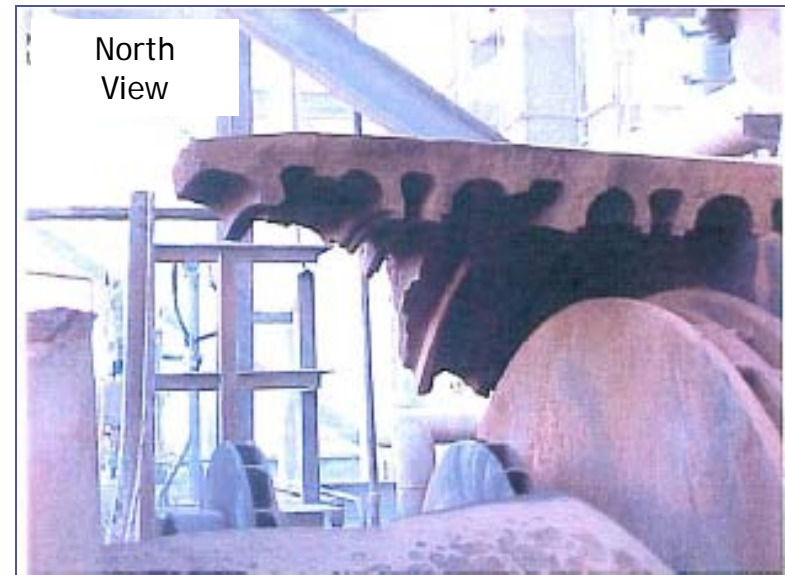
Failure Site Assessment

- Impellers still on rotor
- Sudden case rupture evidence

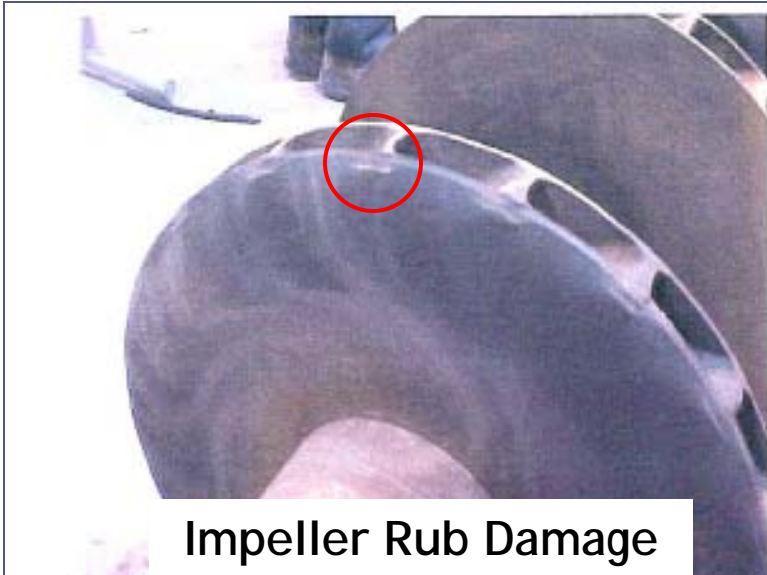
Impeller Rub Damage

- Evidence of rubbing

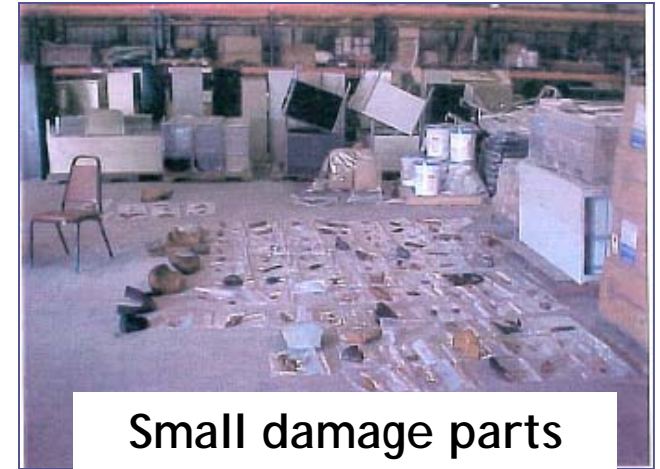
Damaged Compressor

Small damage parts

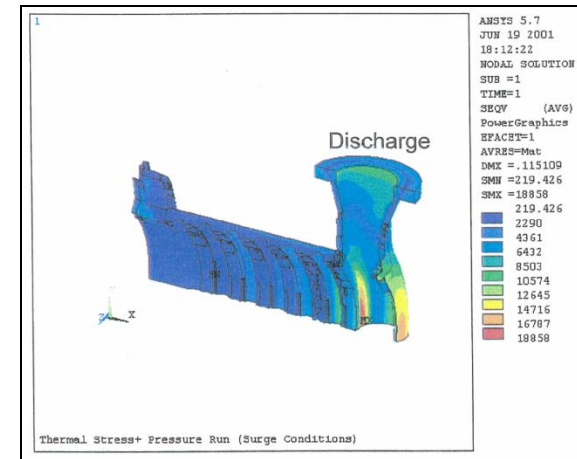
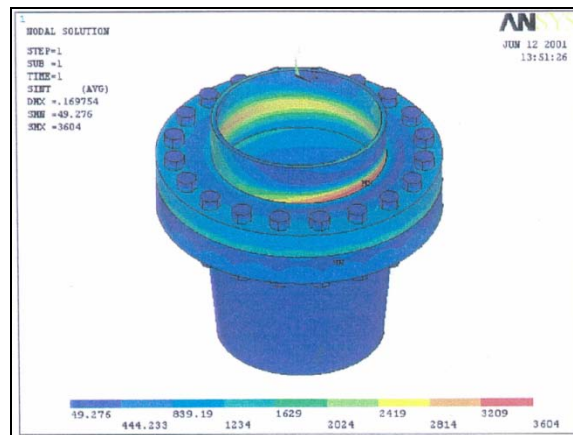
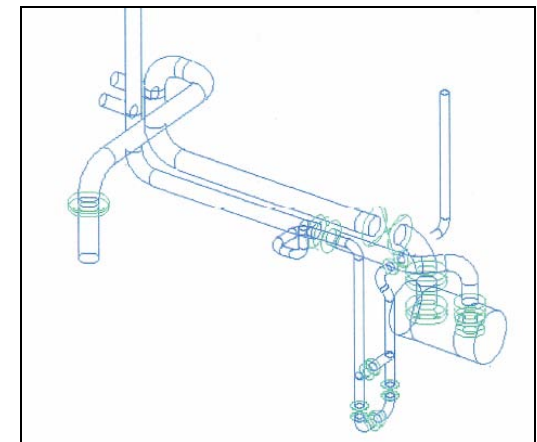
- Case thermal stresses below case strength
- Suction and discharge pipe stresses within acceptable design stress levels
- Discharge nozzle stresses acceptable

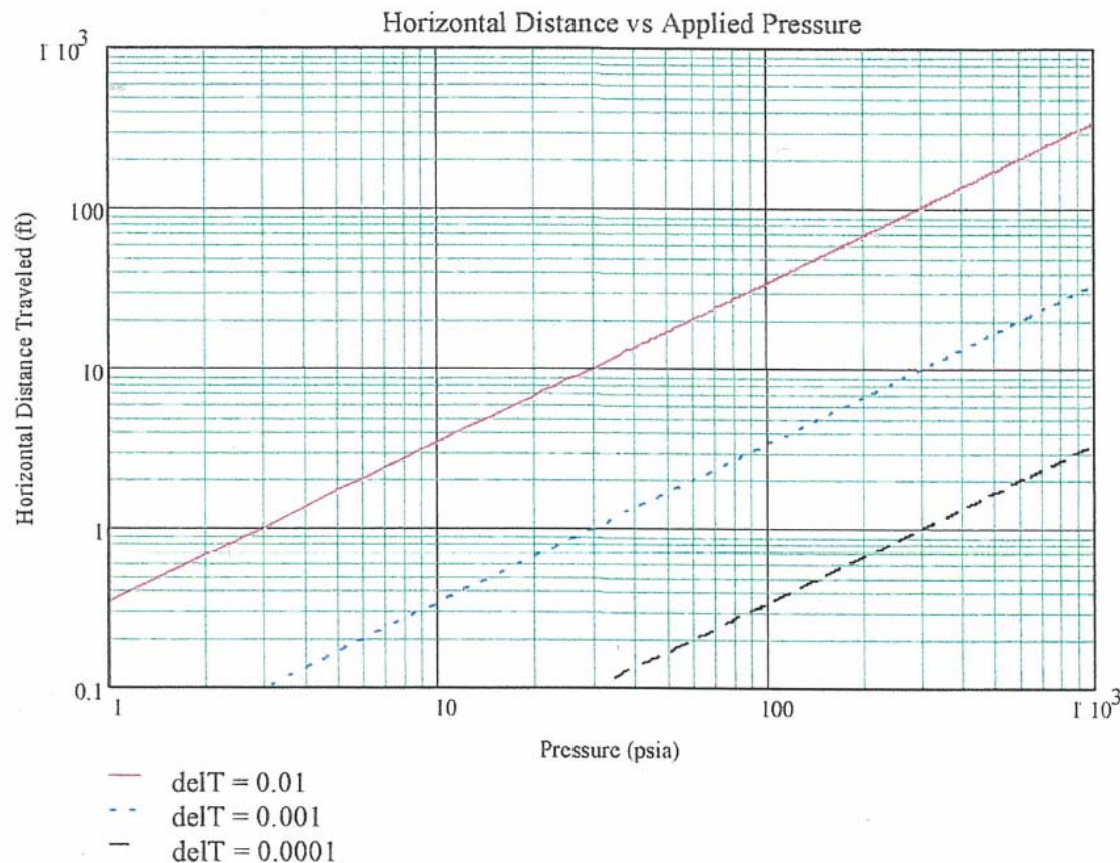
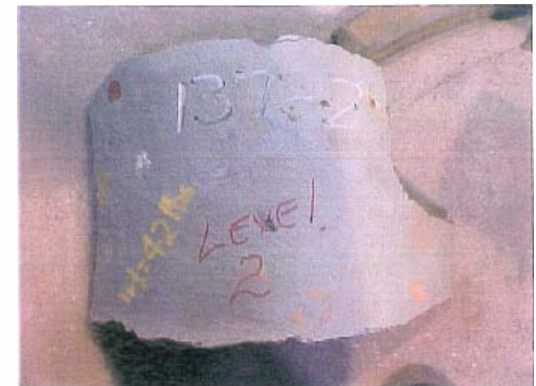
- 50 lbs projectile piece due to explosion not discharge pressure

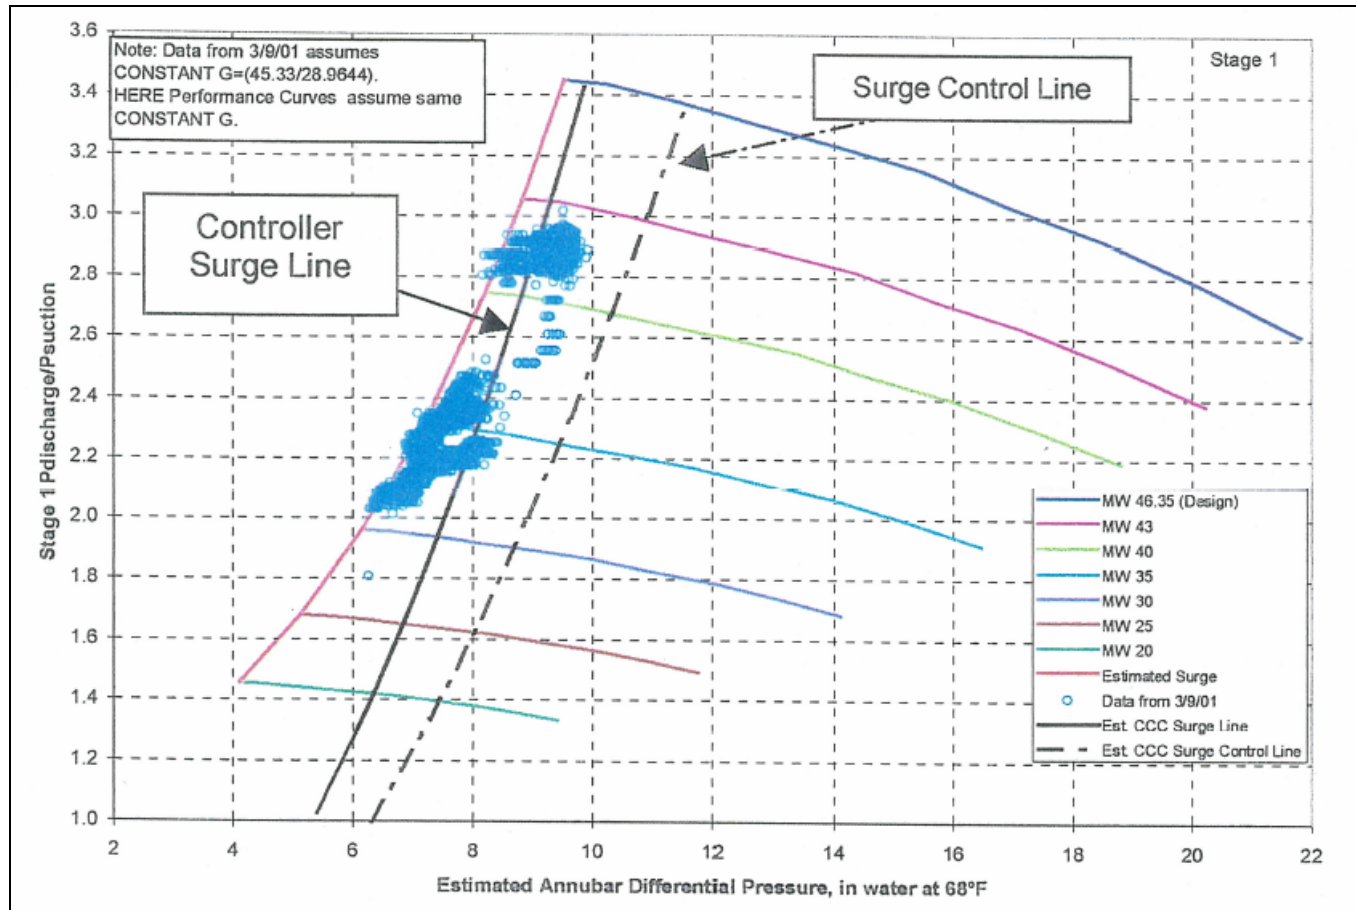
Compressor Performance Review - Stage I

- Surging evidence
 - Data from 3:00 AM until failure around 7 PM

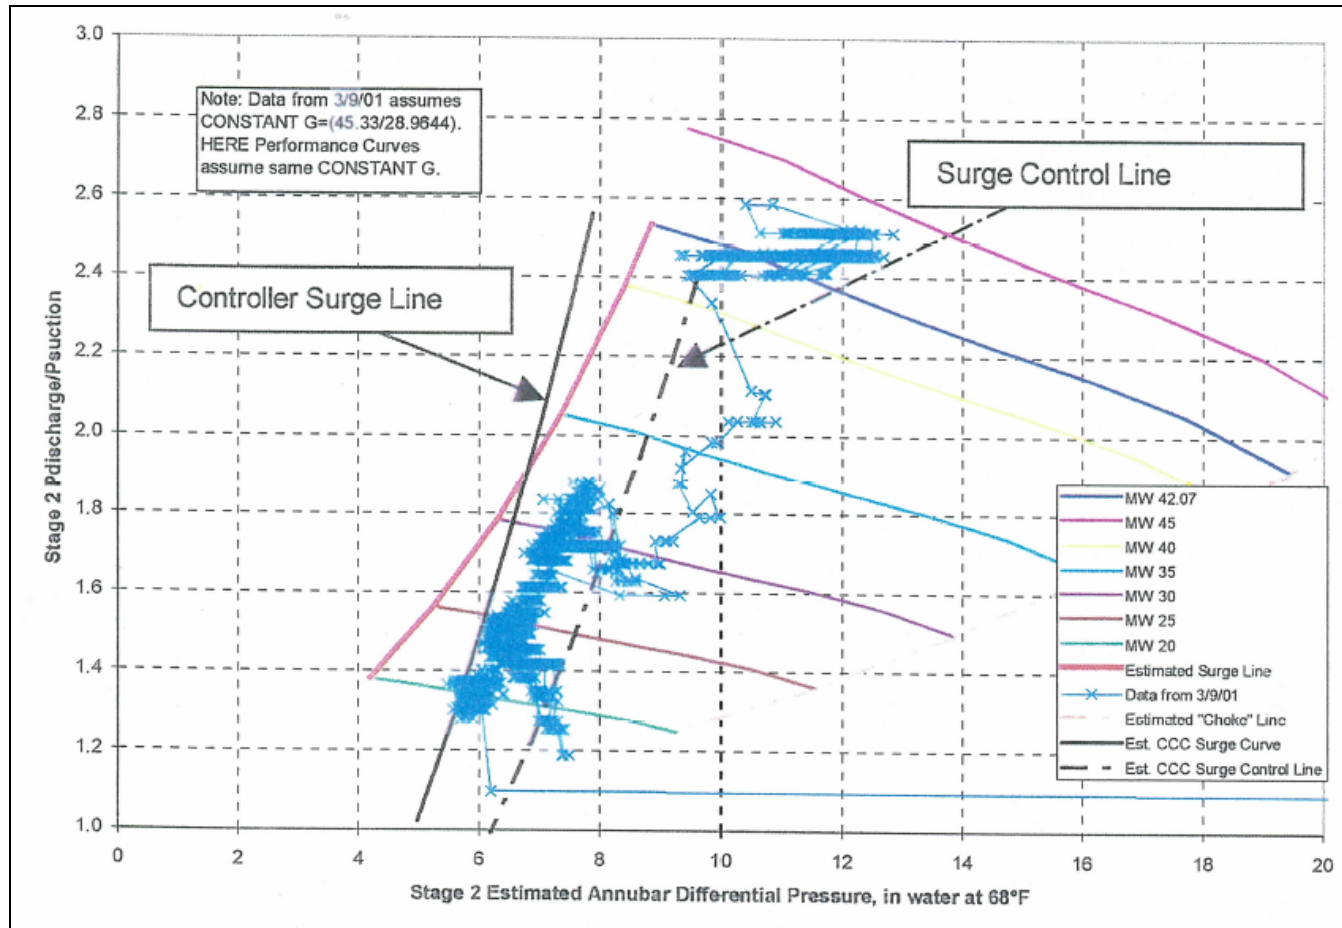
Compressor Performance Review - Stage II

- Evidence of surging evidence
 - Data from 3:00 AM until failure around 7 PM
