The 1st Middle East Turbomachinery Symposium (METS)

RCFA Case Study: Infant Mortality: Lean Solvent Centrifugal Pump Motor

Qadeer Ahmed

Qatargas Operating Company Limited, Qatar

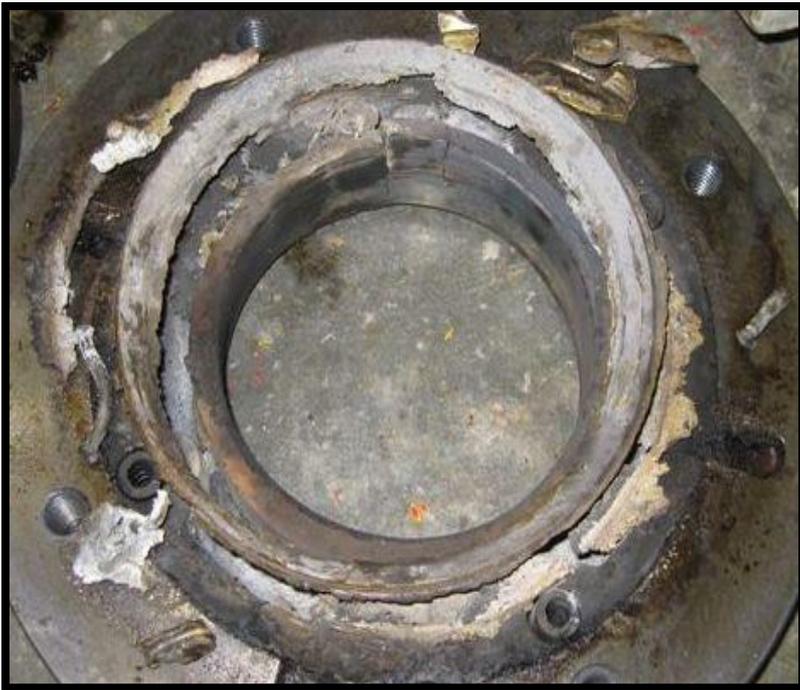
Motor Non Drive End

- Lack of lubrication is the leading root cause of this failure. No grease was found during inspection and bearing showed the clear signs of overheating. Vibration data supports and confirms the failure initiating point was bearing (BPFO -Ball Pass Frequency Outer Race).

1. Activate the all PM plans in CMMS. Ensure to set the initial PM startup date manually. Revisit the equipment strategies to include vendor recommendations.
2. Create area based lubrication work orders and release for maintenance execution.
3. Develop greasing procedure for Motors (based on type of bearing).
4. Inspect the pump and accessories prior to installation of new motor.

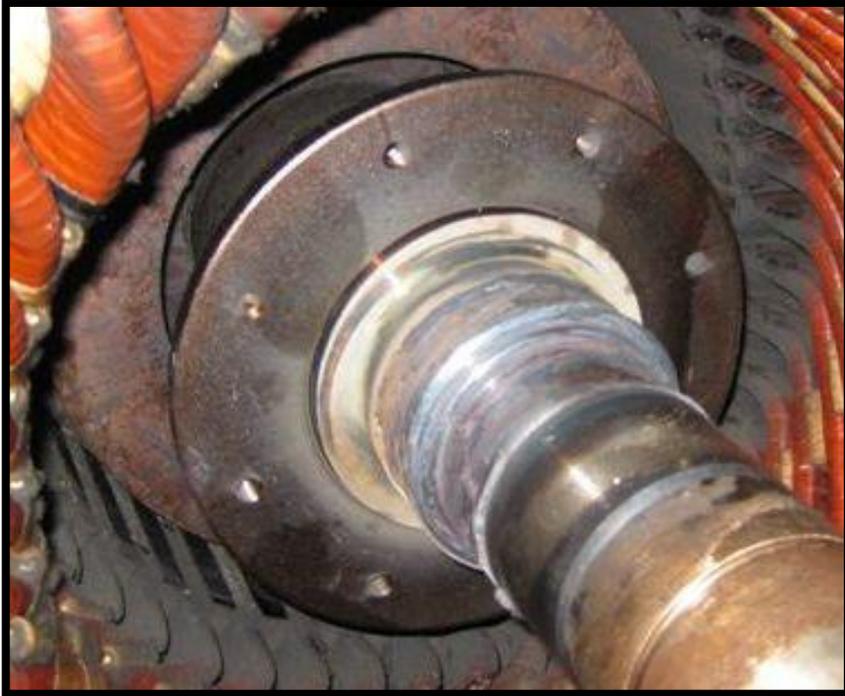
Motor Burnt Shaft

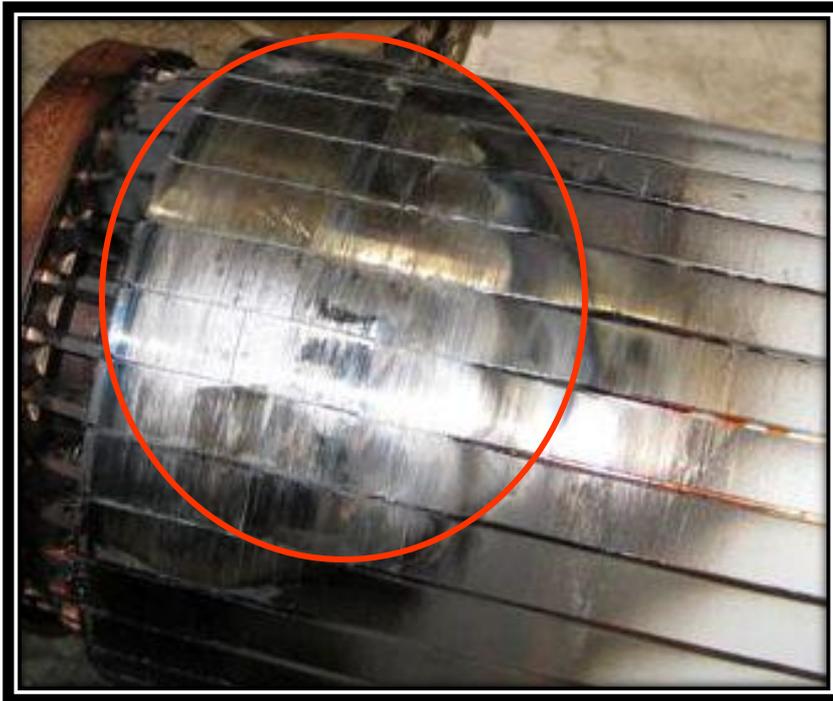
Cage - Drive End

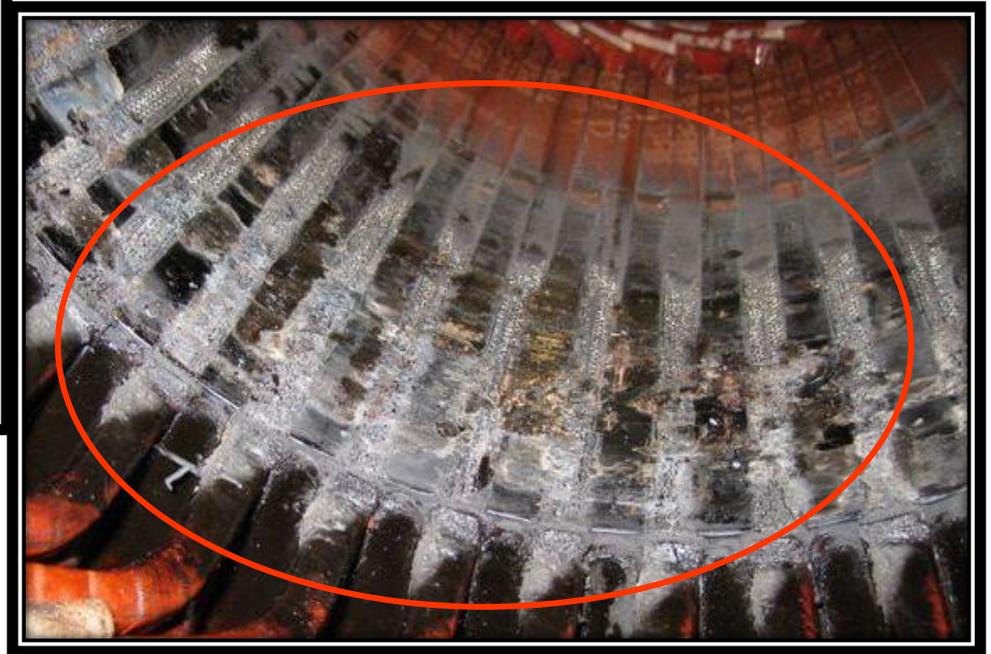
Stator - Drive End

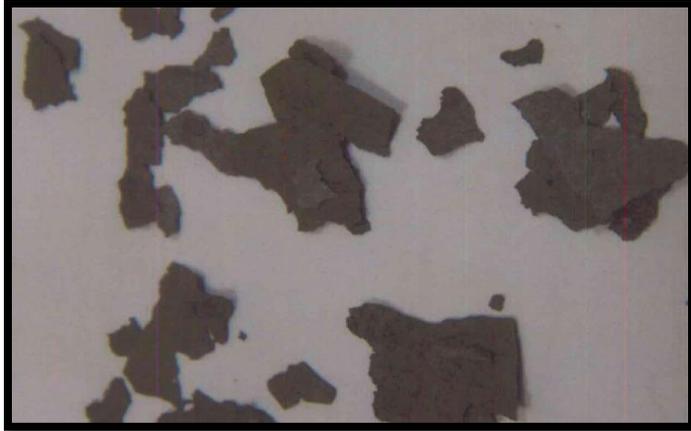
Peeled Off Coating

- Internal Coating Peeled Off
- Lube Oil Contamination

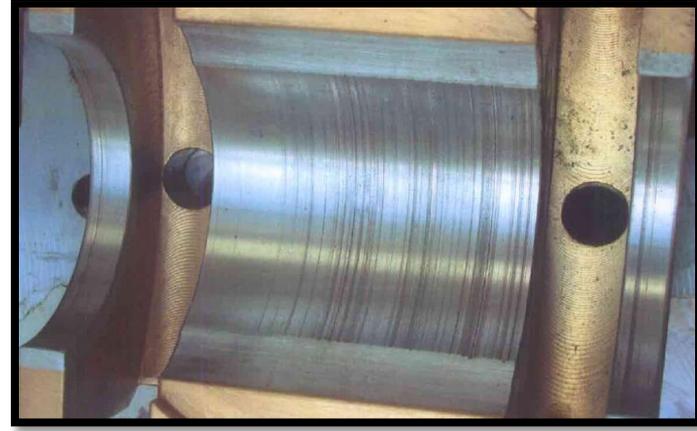
Pump Bearing

- Bearing Damage (Replaced)
- Excessive Clearance
