FLOATING SEAL RING ACTING AS A THIRD BEARING

Case History

Presented by:
Sherif Mekawey, Principal Engineer
Machinery Management Services
GE – Bently Nevada
Abu Dhabi

February 2011

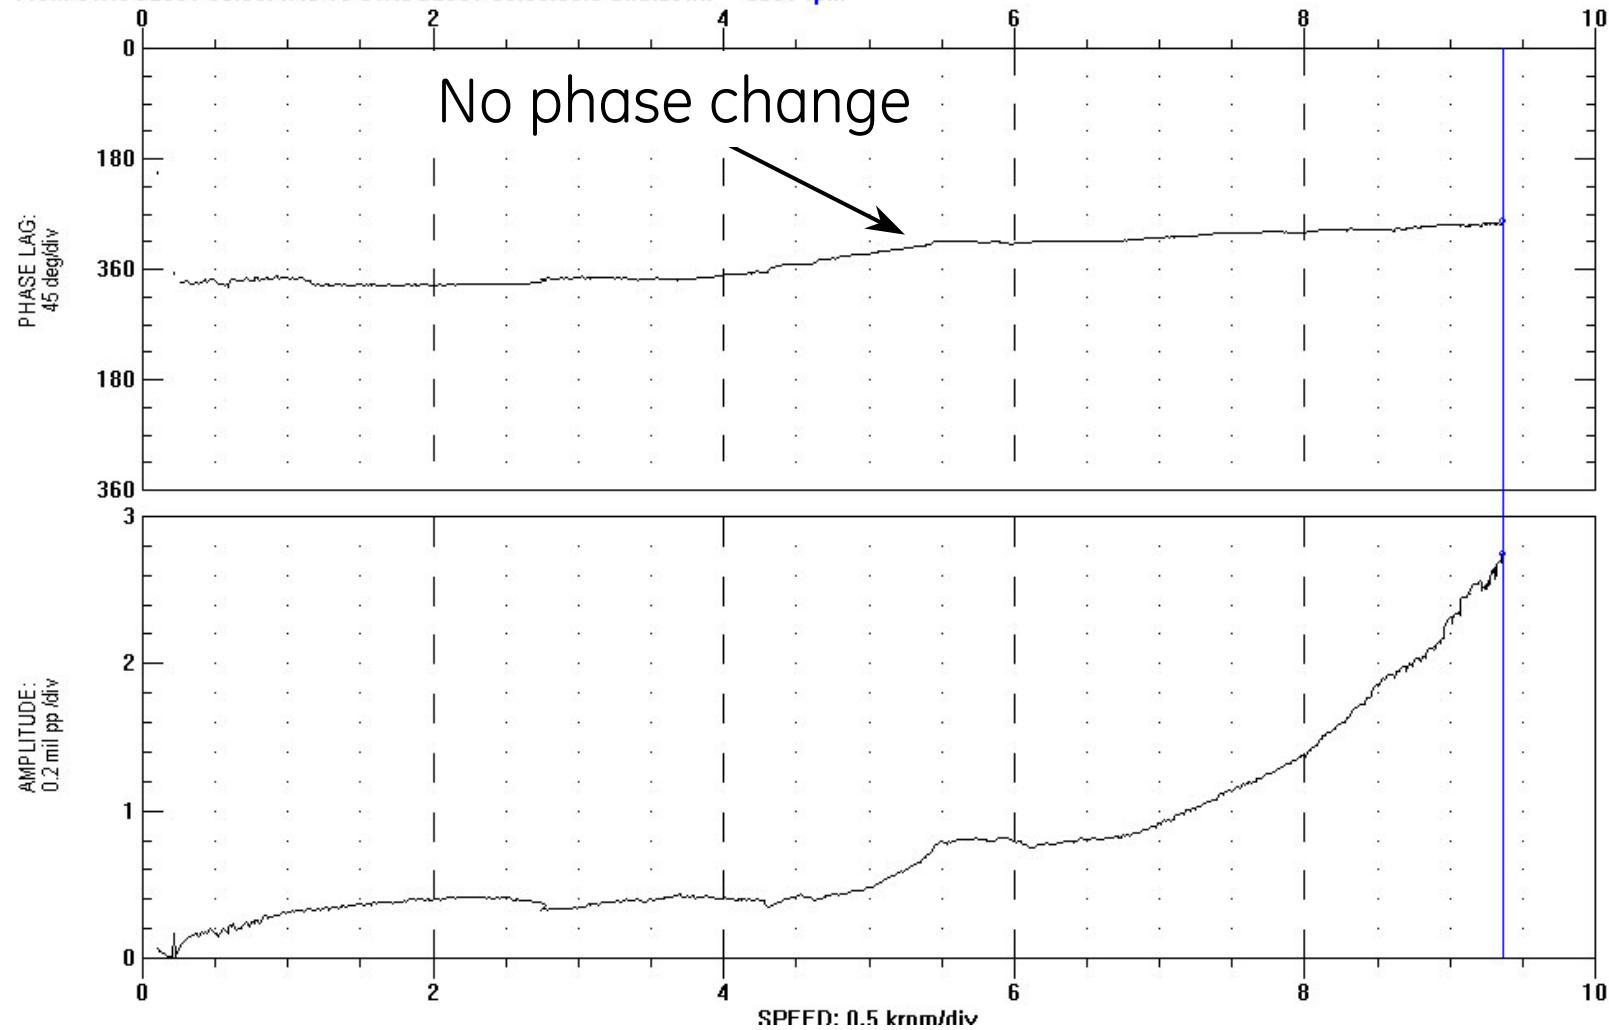
Shutdown Bode Plot

POINT: Comp I/B V-201 $\angle 45^\circ$ Left 1X COMP SR: $0.437 \angle 131^\circ$ $2.72 \angle 288^\circ$

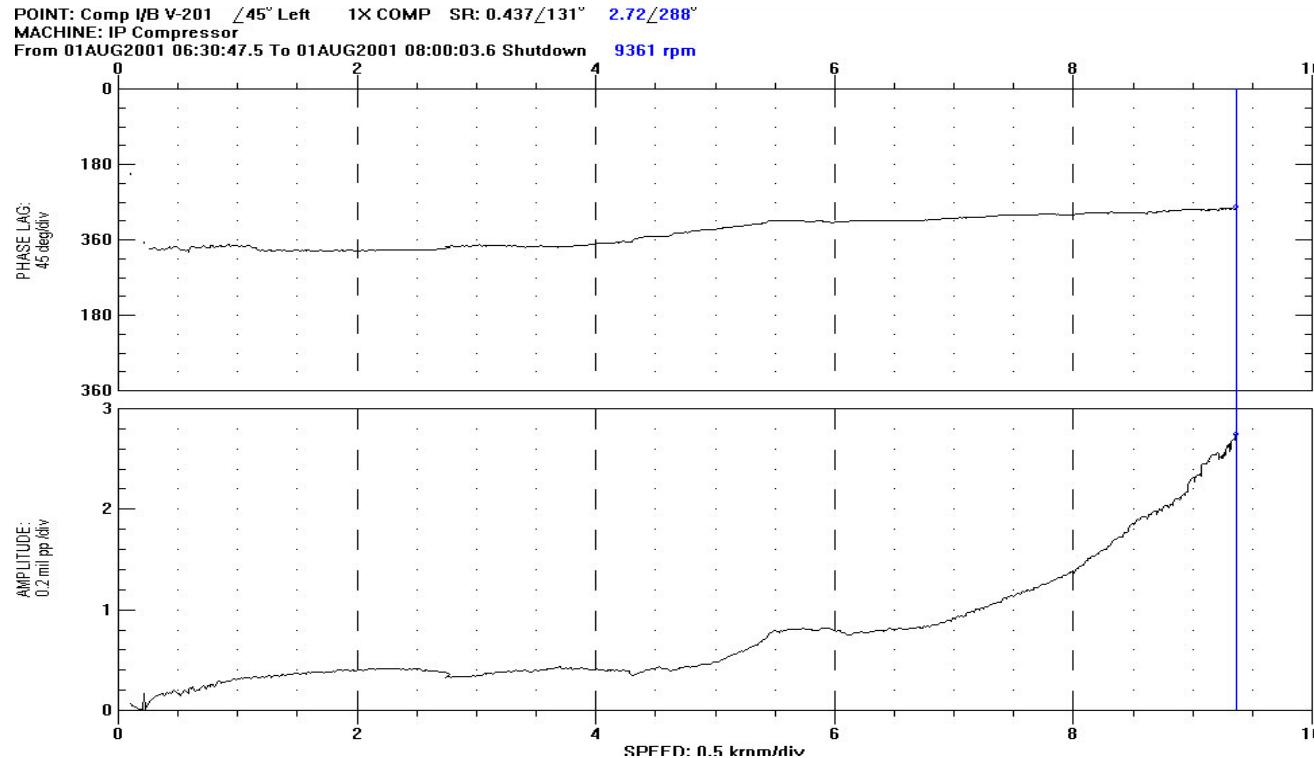
Symptoms:

- Vibration amplitude did not peak at the designed balance resonance speed of 5700 rpm
- The amplitude kept changing as the square of the speed changed from 5000 rpm to 9200 rpm.

All these symptoms prove that the balance resonance speed has increased to beyond operating speed.

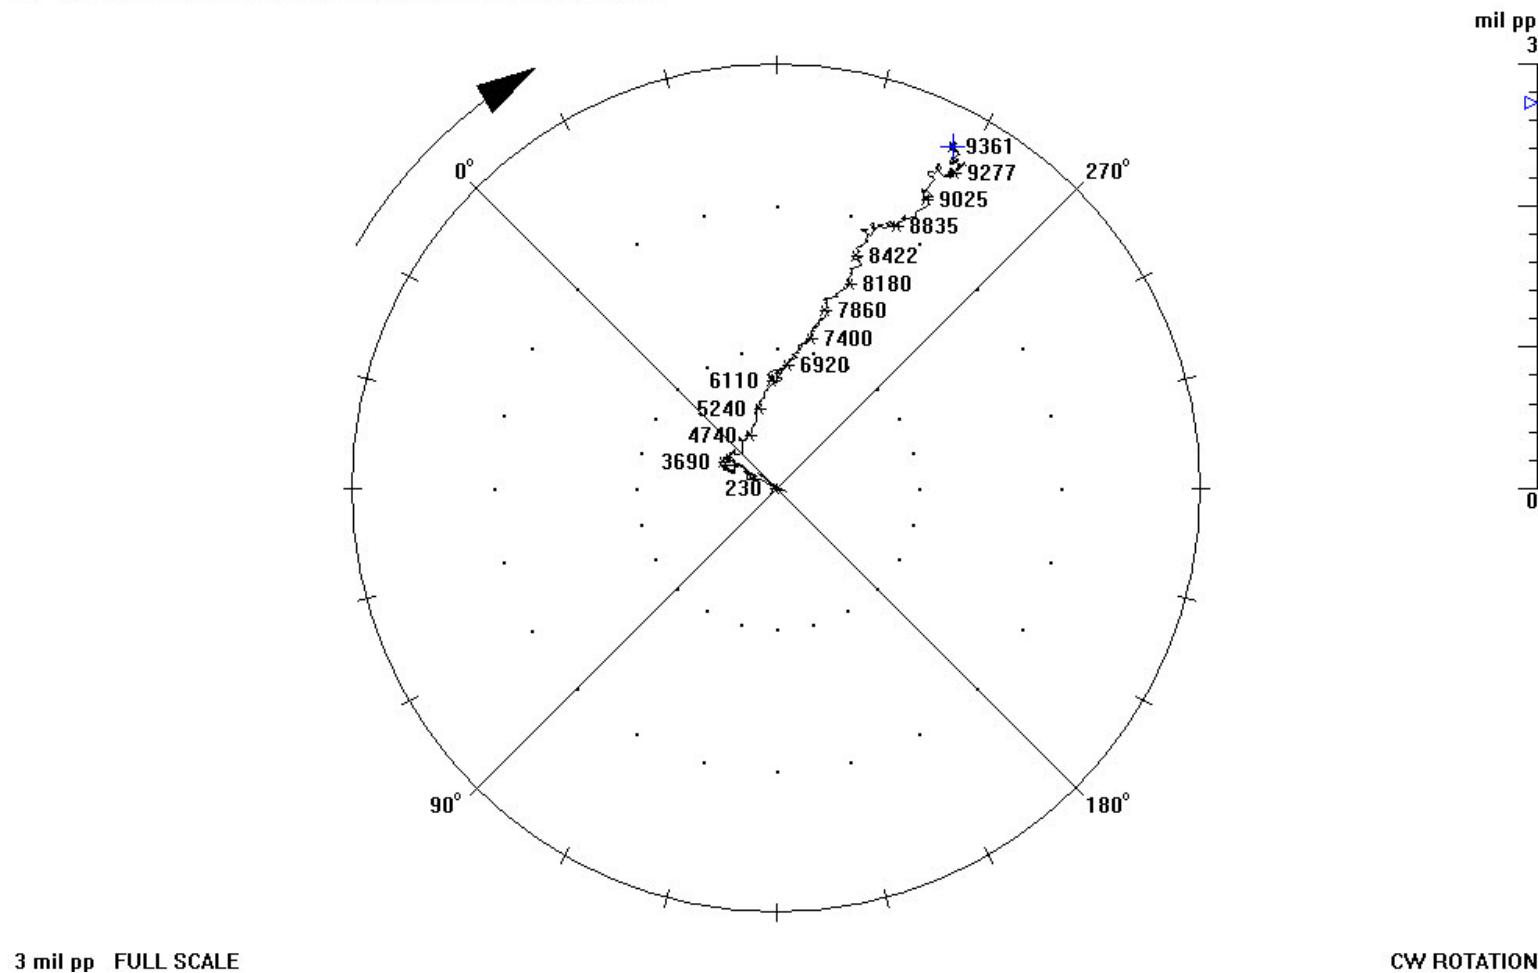
Symptoms:

- The phase angle also did not change while passing the designed balance resonance speed

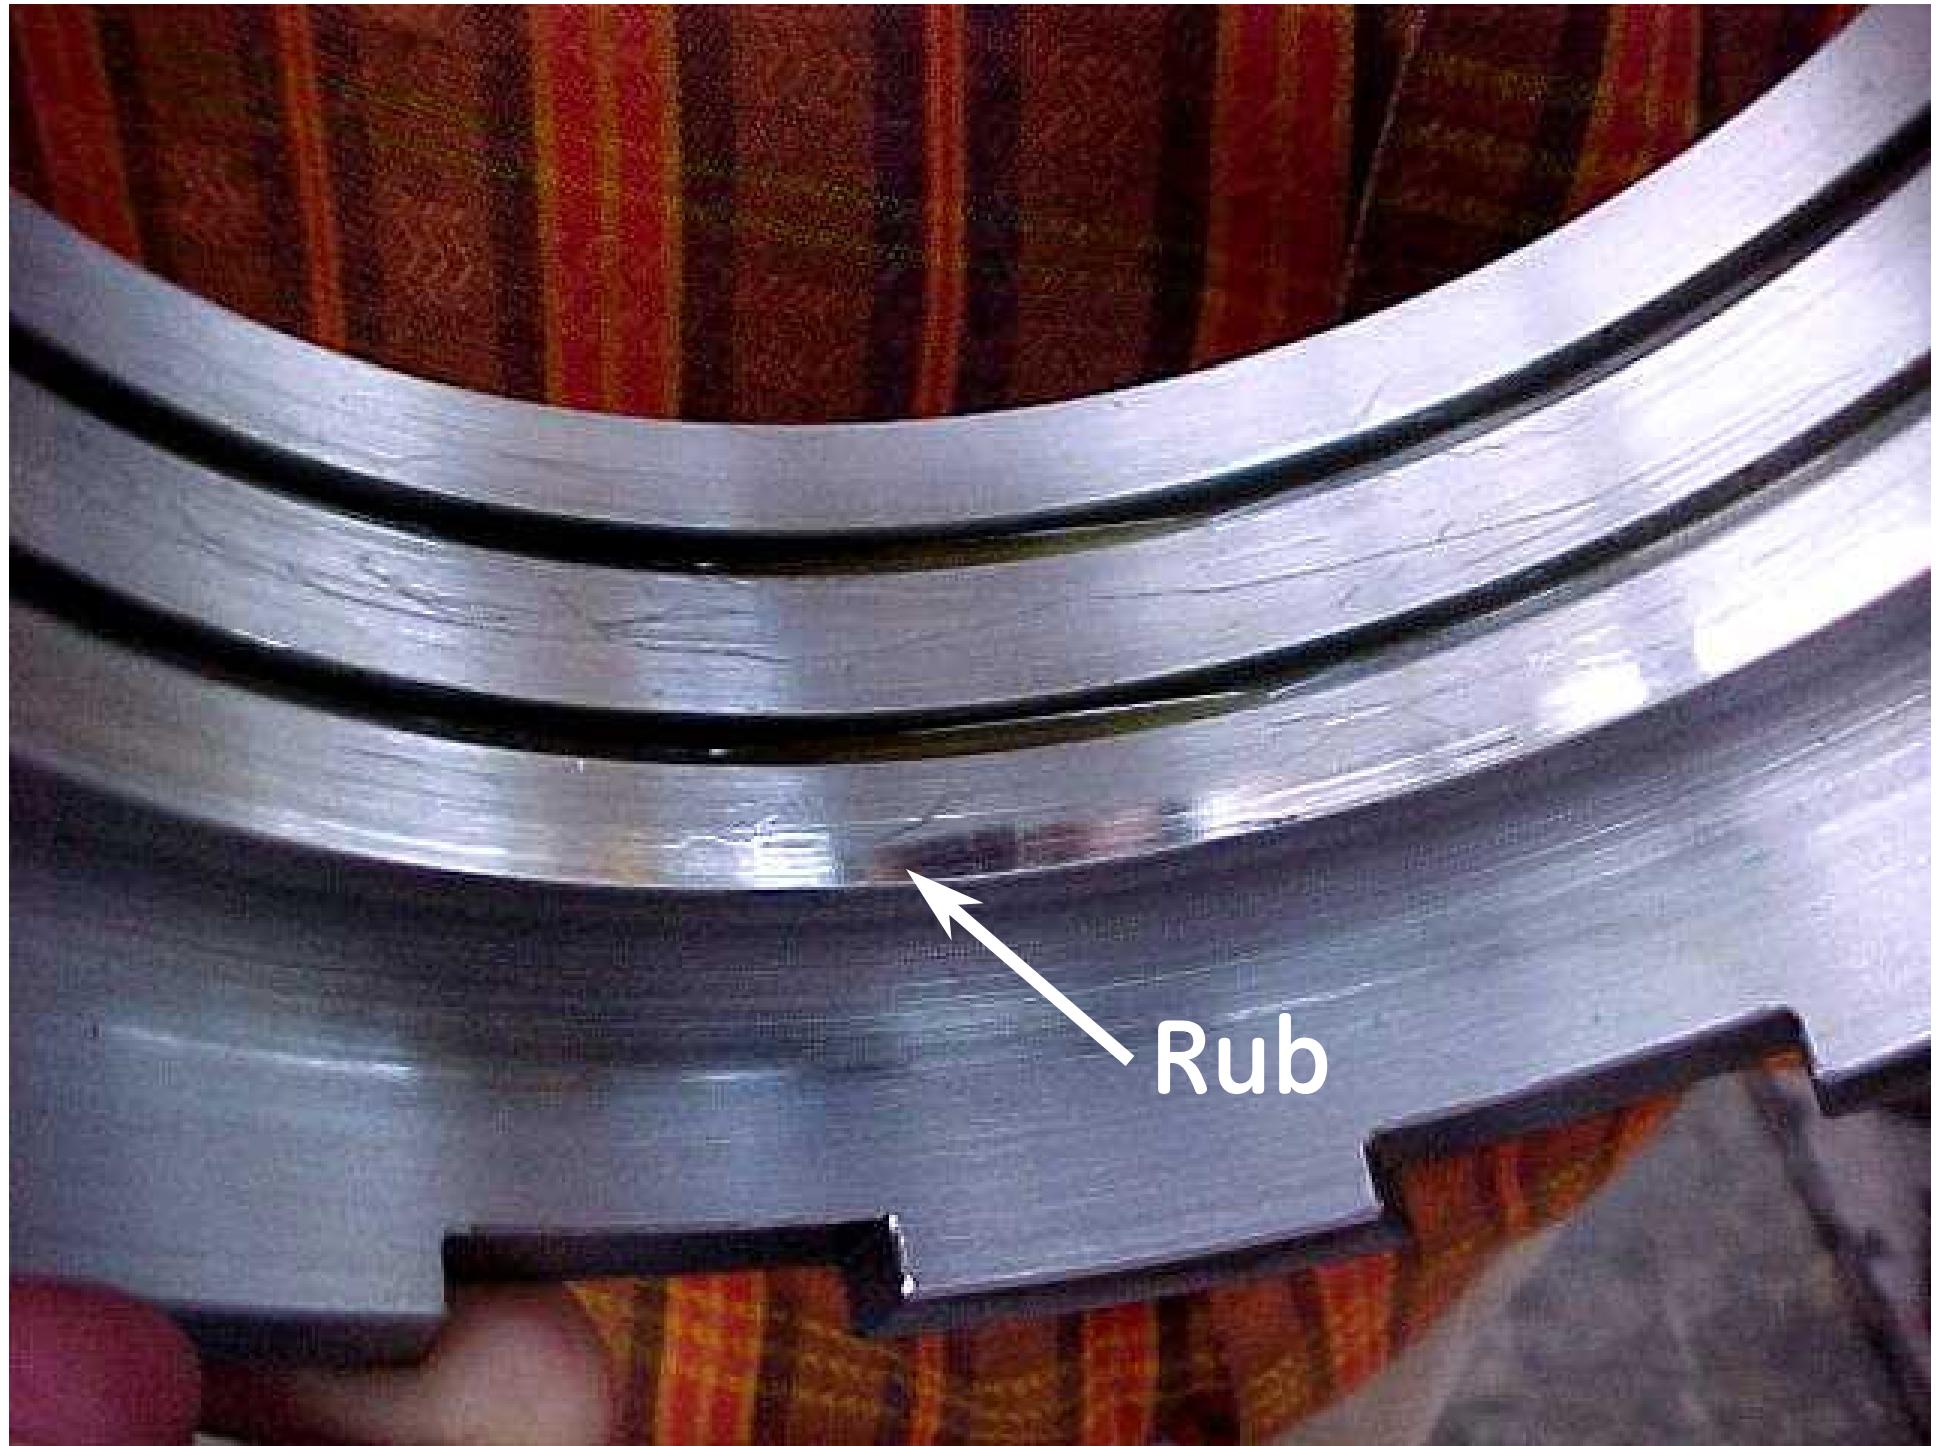
Rub

*Locked-up seal ring acting as
an additional bearing*

Corrective action:

- Increased the seal rings clearance, typically from 0.001 to 0.003 inch (OEM Recommendation)
- Adjusted the anti-rotation pins to allow maximum floating

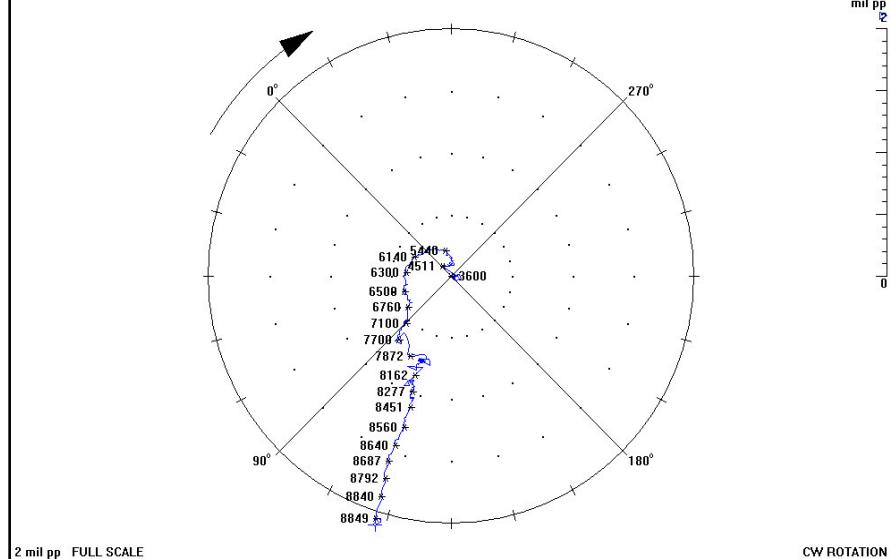
Prior to balancing

POINT: IP Comp I/B V-201 45° Left TX COMP SR: 1.13/169° 2.10/118° @8849 rpm
MACHINE: IP Compressor
From 06AUG2001 07:06:07.4 To 06AUG2001 11:27:04.2 Startup

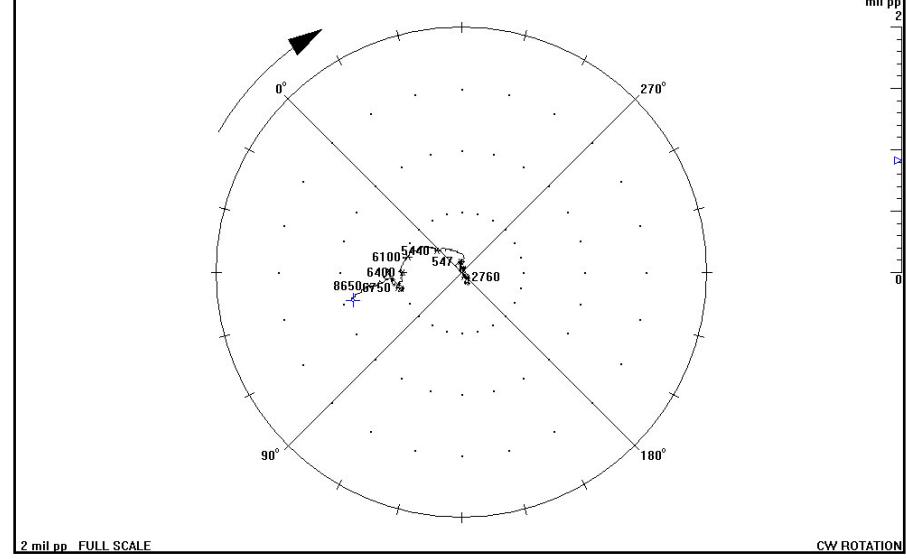
After balancing

POINT: IP Comp I/B V-201 45° Left TX COMP SR: 0.704/174° 0.910/59° @8820 rpm
MACHINE: IP Compressor
From 07AUG2001 04:40:46.3 To 07AUG2001 08:29:25.8 Startup
