VSD Motor Intermittent Vibrations Excursions

PEARL GTL – INTRODUCTION

Compressor/ Driver Details

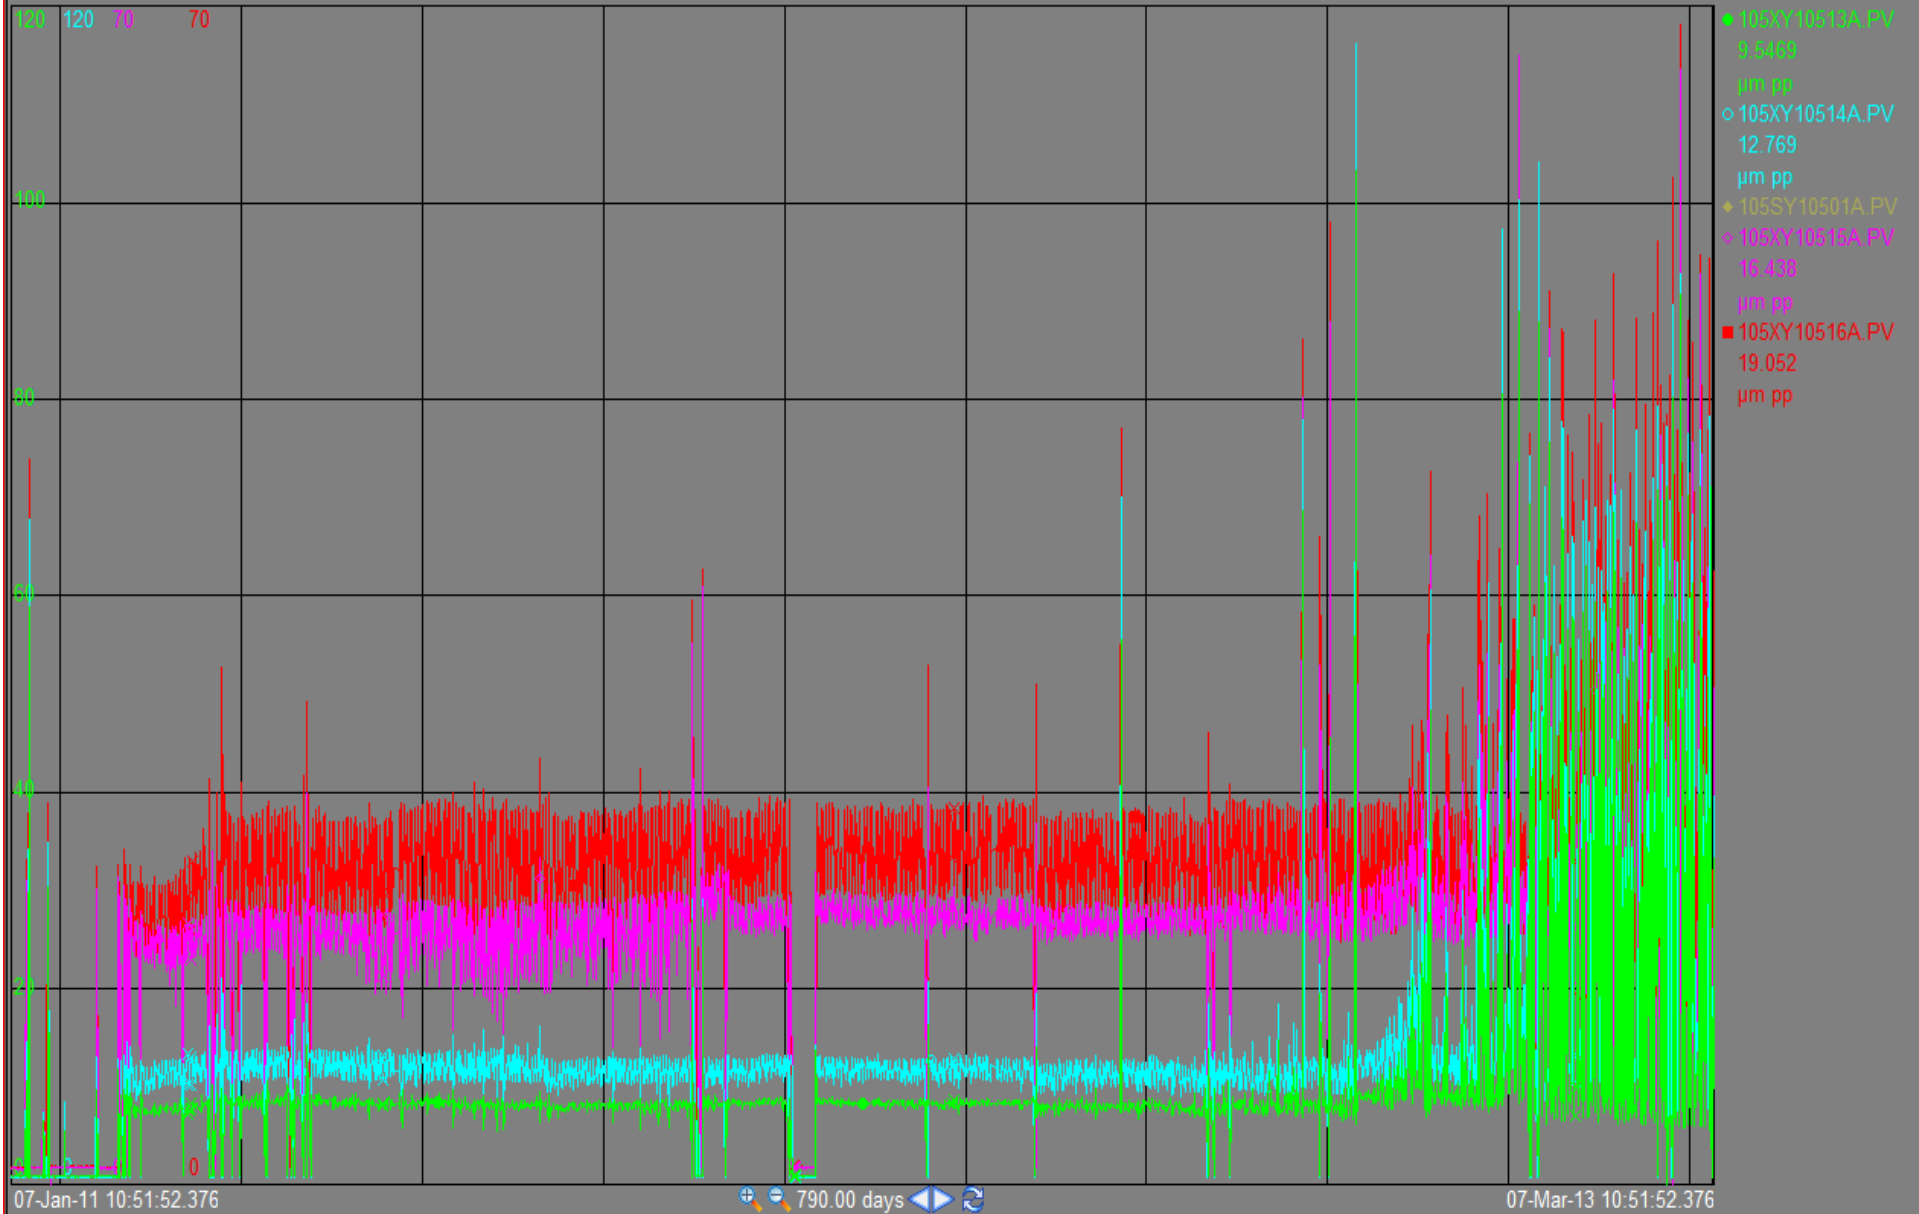
Excursion Trend

- Compressor Drive Motor DE/NDE Bearing vibrations started increasing, from June'12 onwards, without any change in the operating conditions of the machine.
- Compressor & Gear Box were not affected and kept running at normal vibration levels.
- The incident of high motor bearing vibrations started repeating every few weeks initially and slowly the frequency of the incident and vibration amplitude started increasing near to trip limits.
- Trends showed vibrations slowly rising up to and beyond alarm limits, and slowly subsiding and falling back to acceptable, normal limits

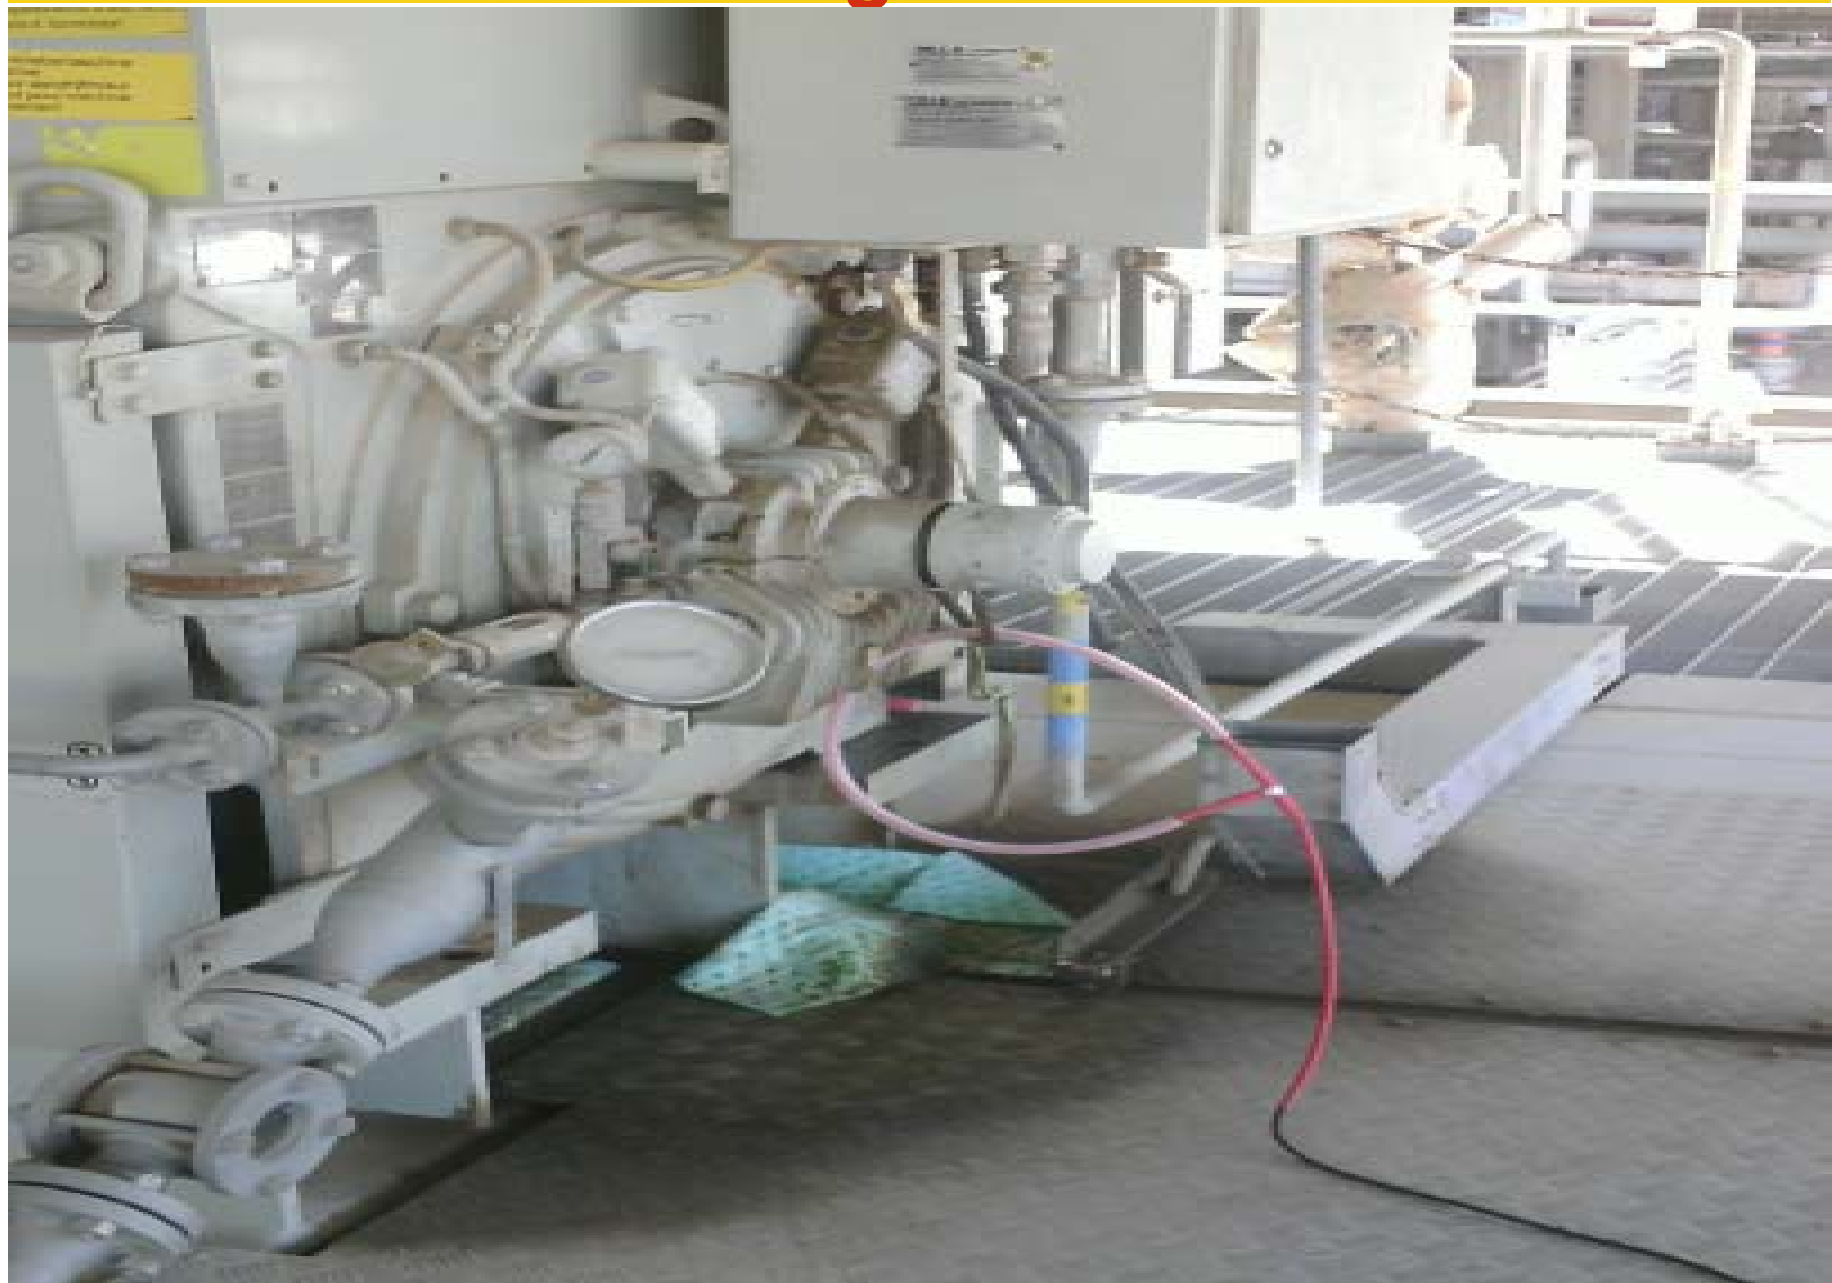
Motor Grounding Unit

- **Grounding fitted with 2 pairs of carbon elements.**
- **One of the element pairs found snapped off.**
- **Carbon elements oriented at bottom.**
- **Elements working length within limits.**

- **Elements replaced.**
- **Grounding unit orientation changed.**
- **Holding spring tightened to increase the element seating tension.**
- **Grounding cable connections cleaned and retightened.**
- **Grounding unit inspection scheduled in PM list.**

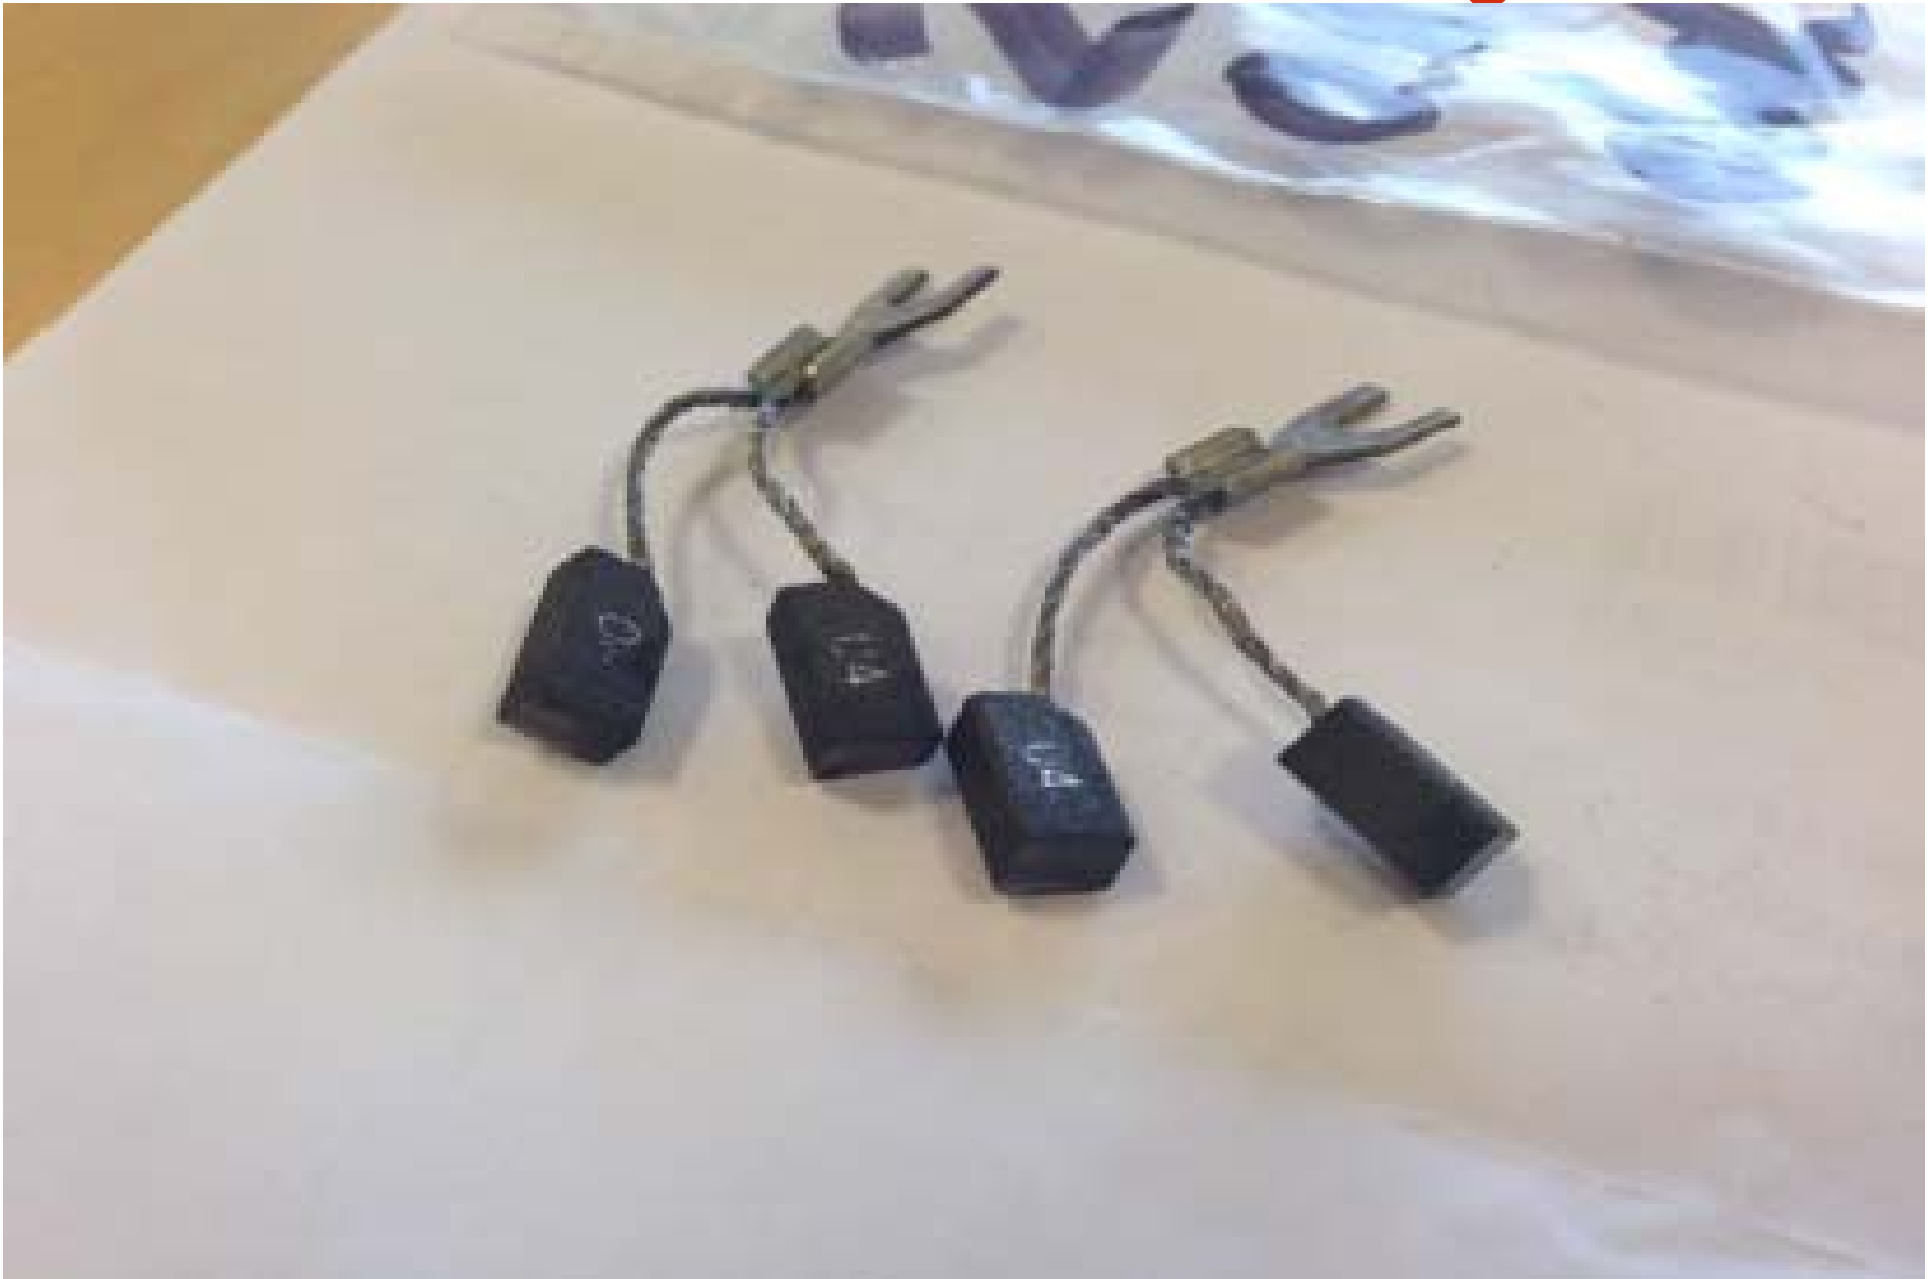
Carbon Elements For Grounding

- High voltage motors with VSDS, induce parasitic currents/voltages on the Rotor.
- Motor Rotor gets magnetized, overtime, if not grounded properly.
- GB/Comp. high impedance, insulated motor bearings, and absence of proper grounding connection prevents induced parasitic currents/ voltages to go to earth.
- Electromagnetic forces having same rotational frequency as of rotor, led to an unbalanced rotating magnetic field.
- The rotating magnetic field interacting with static magnetic field, resulted in unbalance in the rotor and led to high vibrations.
- The amplitude of vibrations depended on the magnitude of unbalanced electro magnetic forces.

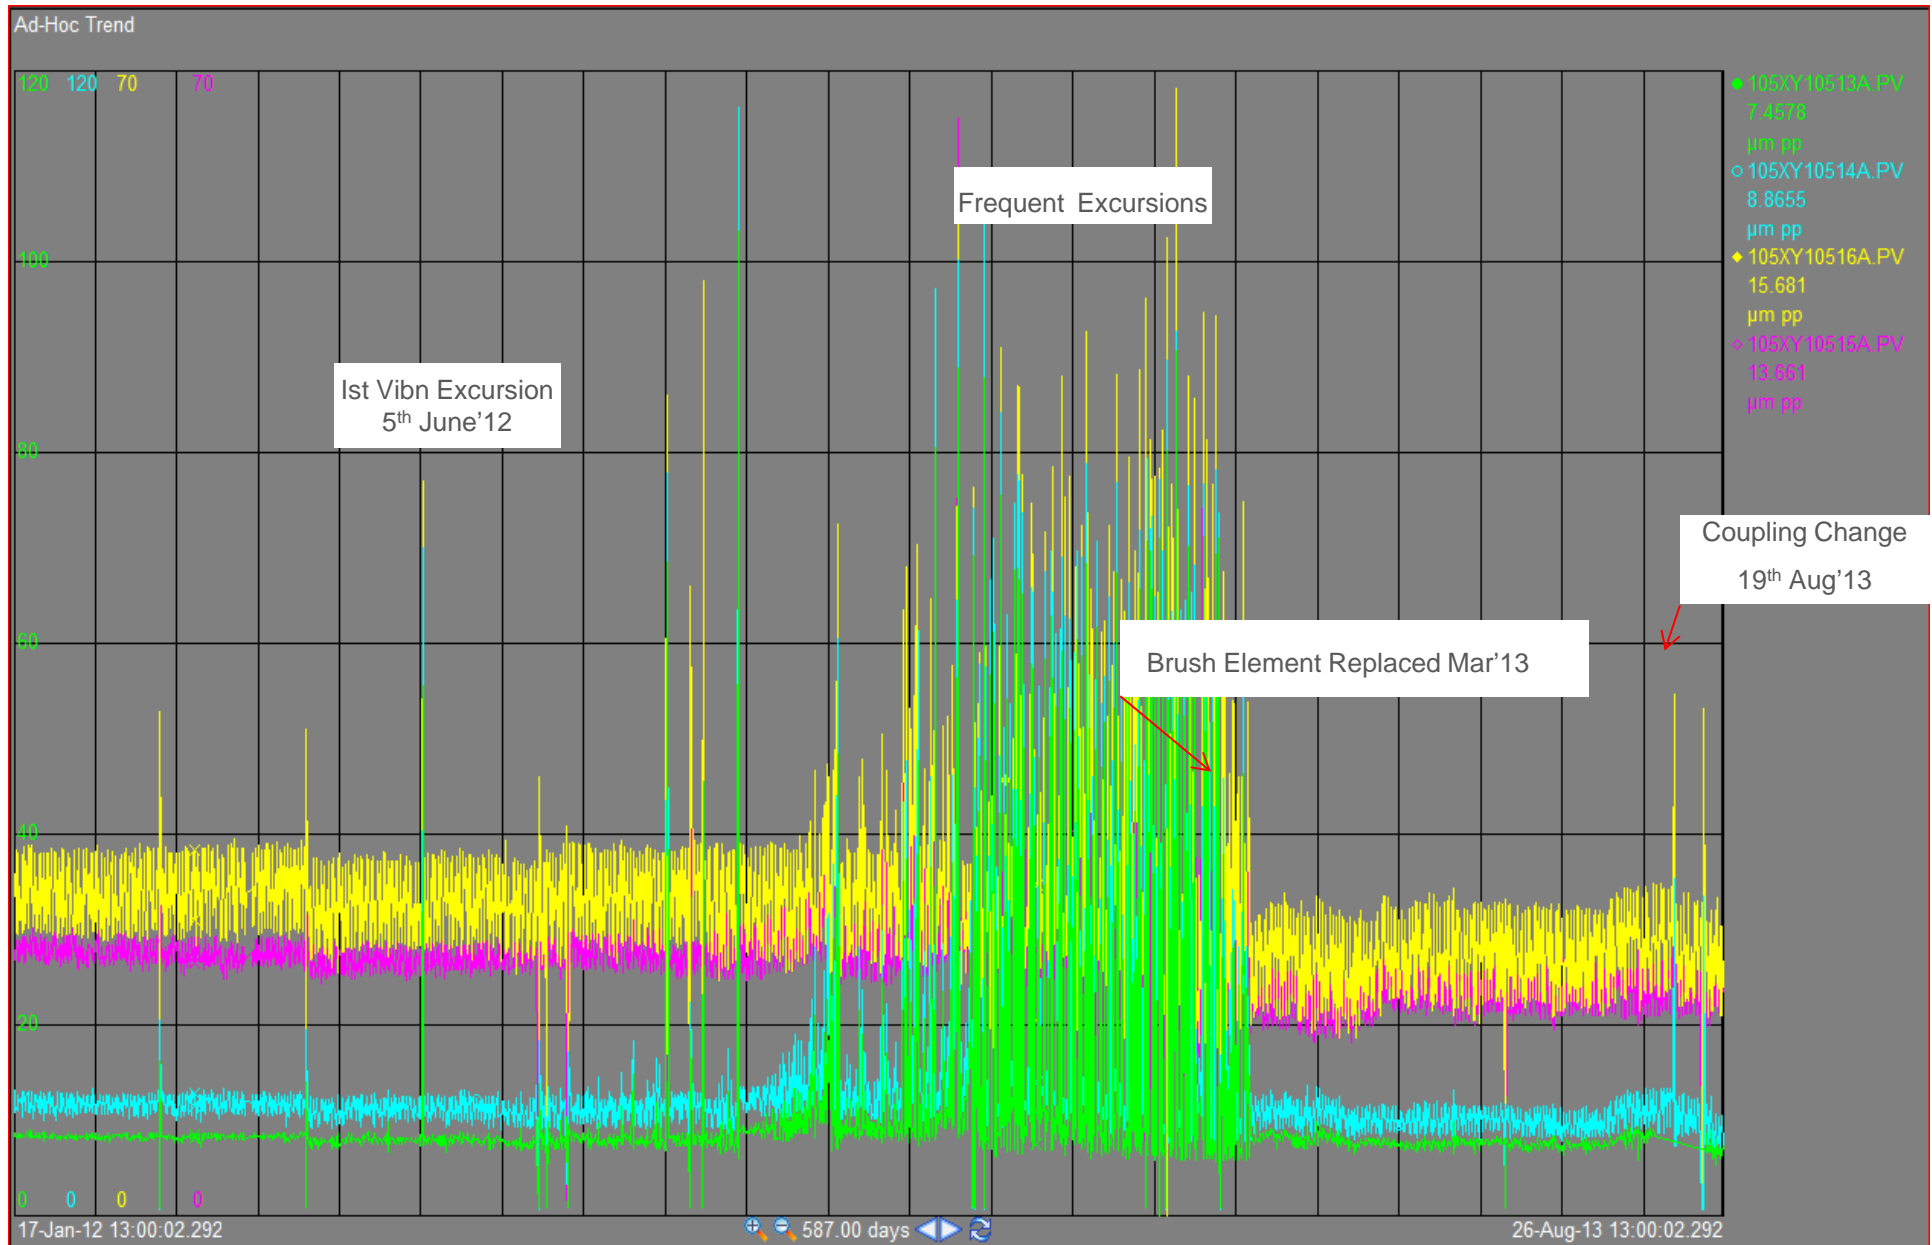
Vibration Trend Jan'12 Onwards

- Vibrating Motor rotor got de-magnetized, due to grounding connection establishing during vibrations/ excursions/jerks .
- De-magnetization of Rotor, reduces vibrations back to normal.
- Magnetization & de-magnetization cycle kept repeating till the grounding connection was rectified.
- Vibration came to normal after 10 days of carbon element replacement. This is run-in-effect of the new elements , to build up a new patina at the slip ring surface.
