Incinerator Air Blower Repetitive Failures

Authors : **RasGas Company Limited**

Incinerator Air Blower (Sulfur Recovery)

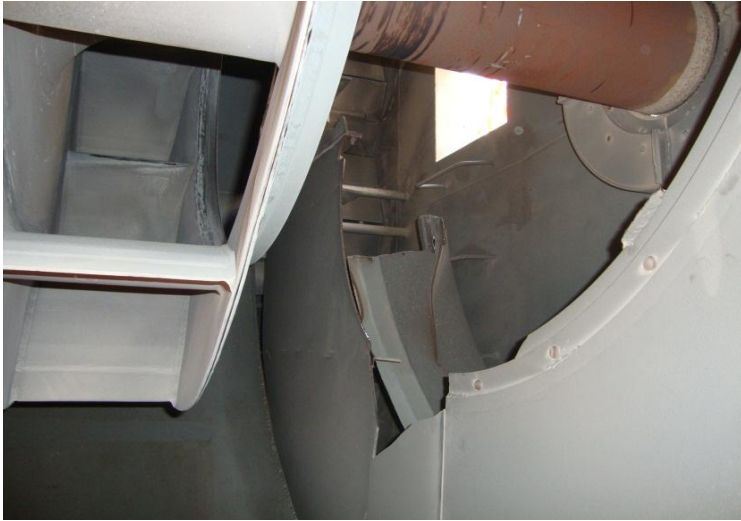
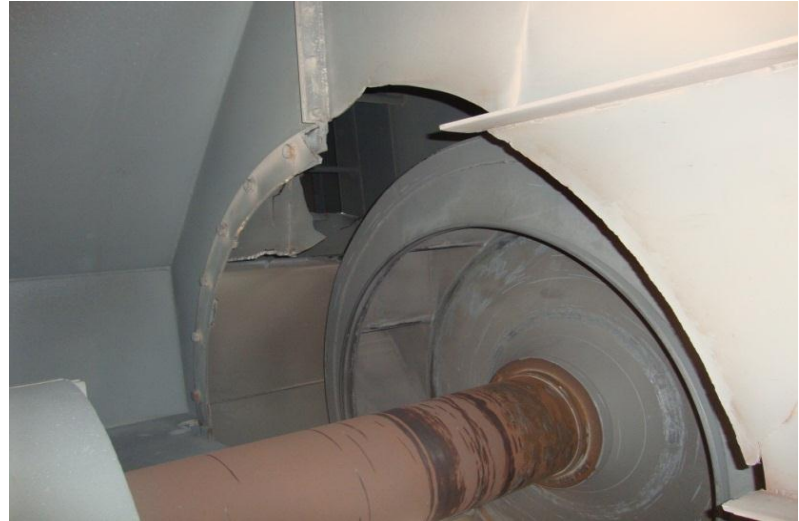
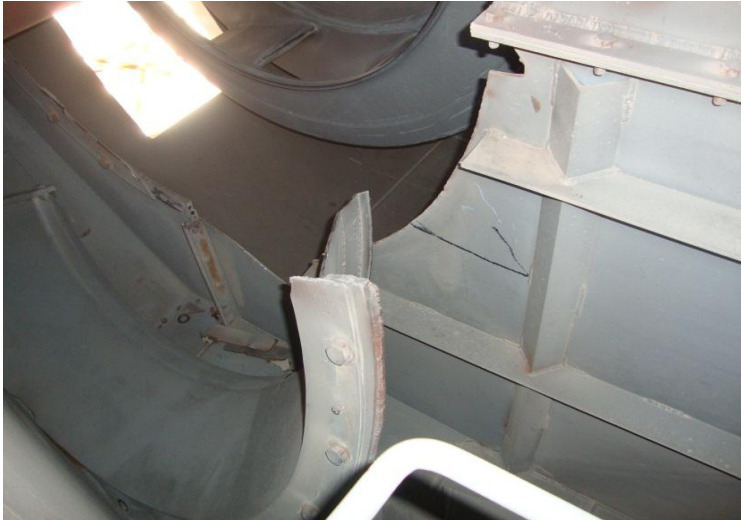
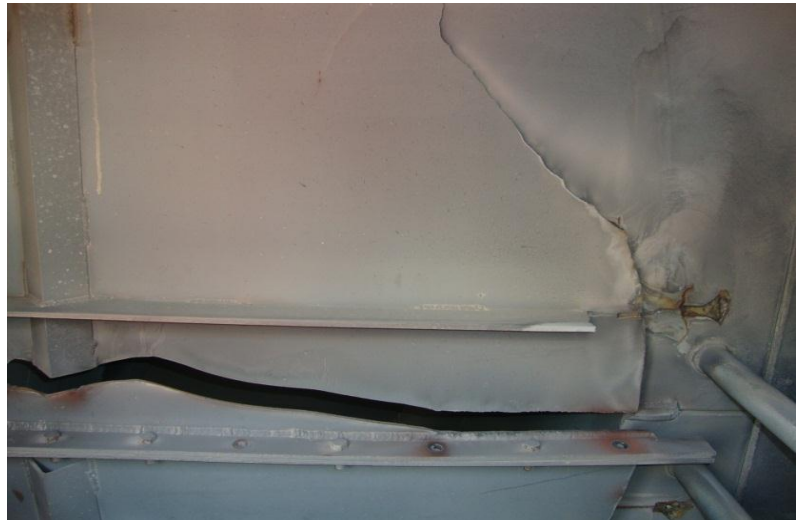
Casing internal damages / cracks

- Blower operation in unstable region (surge conditions), leading to resonance and cyclic fatigue.
- Insufficient surge protection control system.
- IGV system used for furnace flow demand not for blower surge protection.

- New blower max capacity is 3066 m³/min (old was 4830 m³/min).
- No major site modification:
 1. Same foot print, coupling and suction and discharge duct with transition pieces.
 2. Existing motor.
 3. No change in air inlet filtration unit.

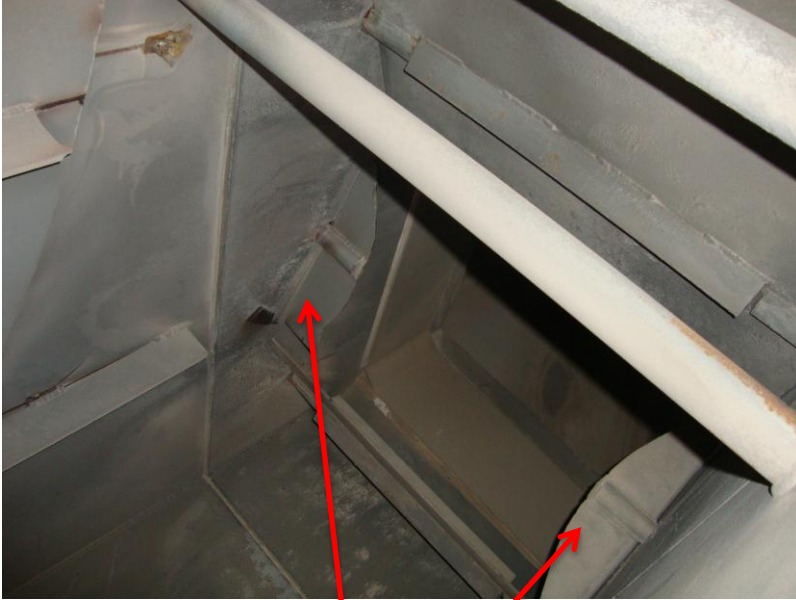
IGV blade broken

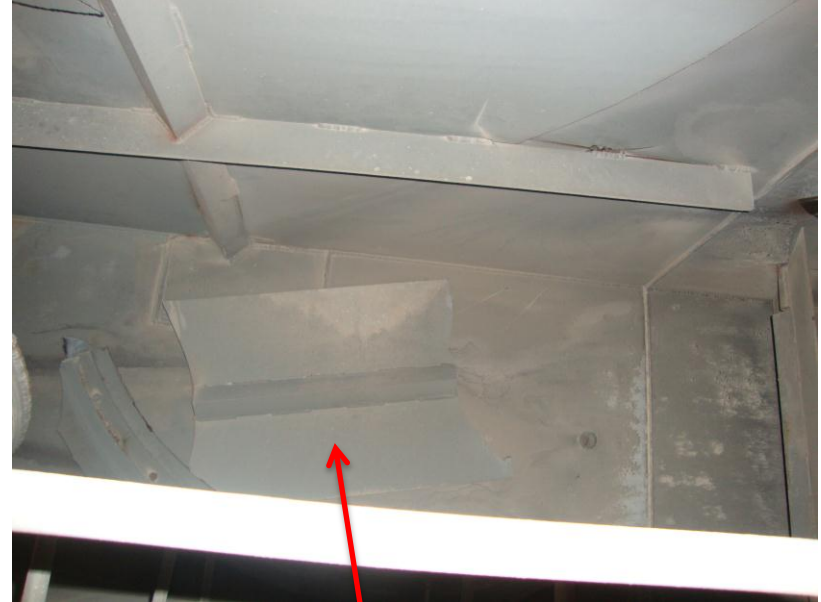
Broken blade inside casing

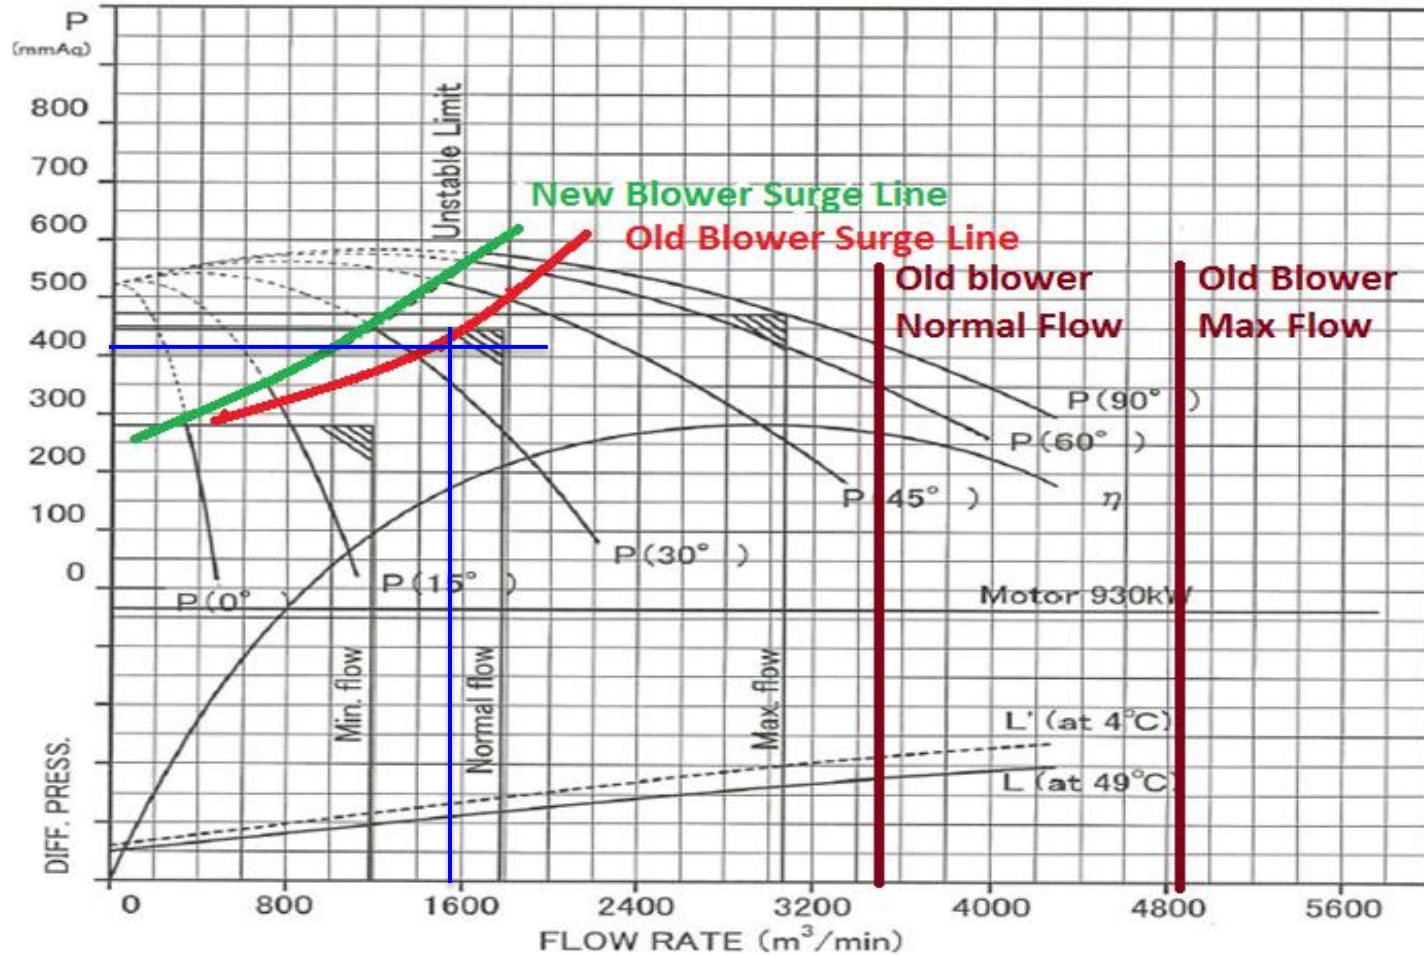
New Blower Operating Point

- Flow = 85 to 95 KNm³/hr (1416 to 1583 Nm³/min) and
- Dish Pressure = 40 mbarG (407.89 mmAq)
