Compressor rotor failure due to fouling at Qatargas condensate refinery

Muhammad Zahid (Sr. Engineer – Rotating)
Devrajan Venkatesh (Rotating Equipt. Analyst)
N. K. Raju (Lead Process Engineer)
Christopher G Holt (Proj & Facilities Engg Div Manager)

A Case Study

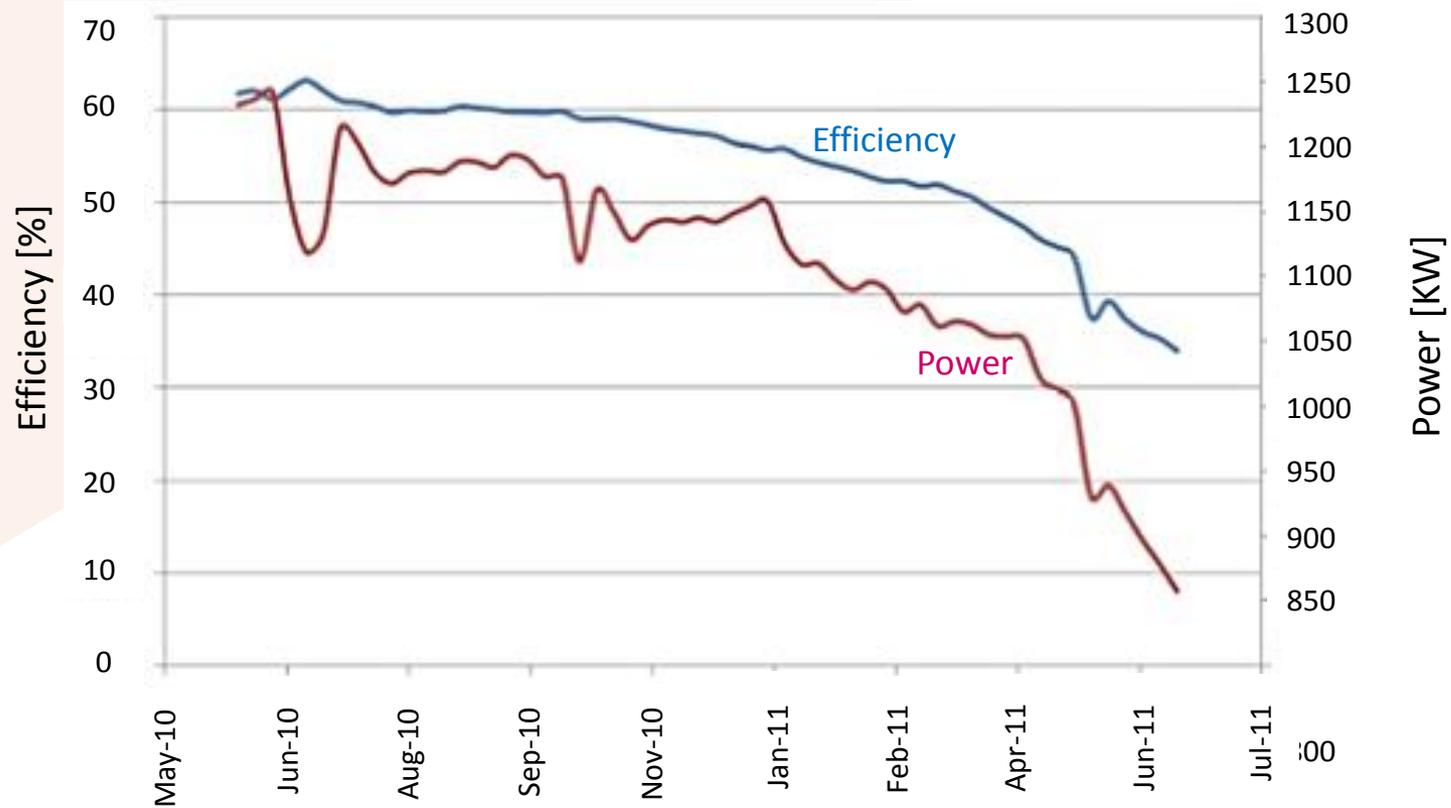
Performance Trends

- **About six months after commissioning in September 2009, LP compressor performance degradation was observed**
 - **Degradation was slow initially accelerated with time**
 - **Compressor efficiency dropped from 65% (new) to 35% (failure)**
-

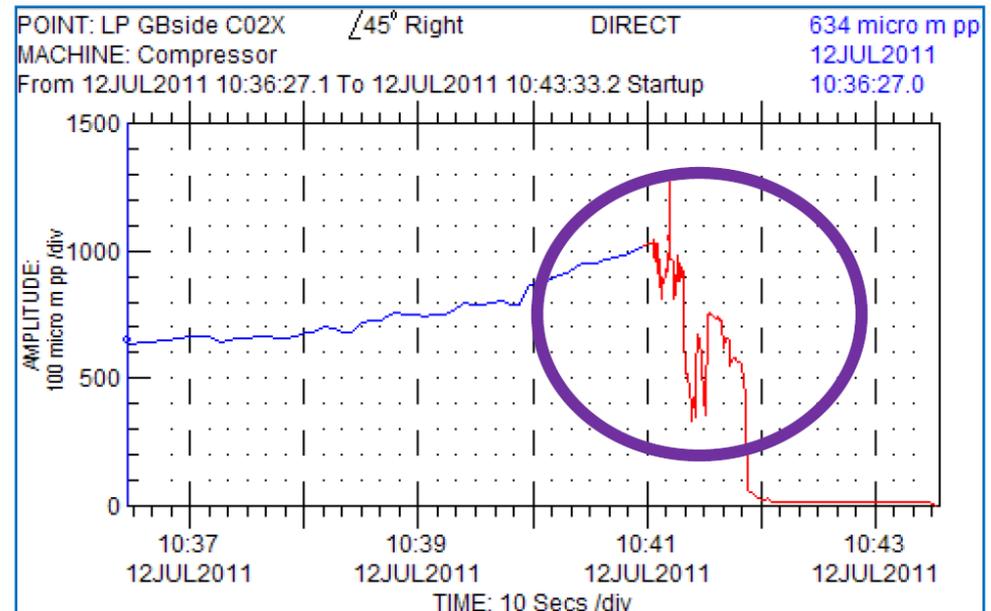
LP Compressor Failure

- July 2011, after about 20 months in service, a sudden increase of LP compressor vibration from 10 mic to 75 mic at DE
- BN ADRE was installed on machine vibration rack to analyze the data
- However, meanwhile vibration quickly increased to danger levels (beyond 1000 mic) at DE
- Machine was manually shutdown because vibration trip did not function

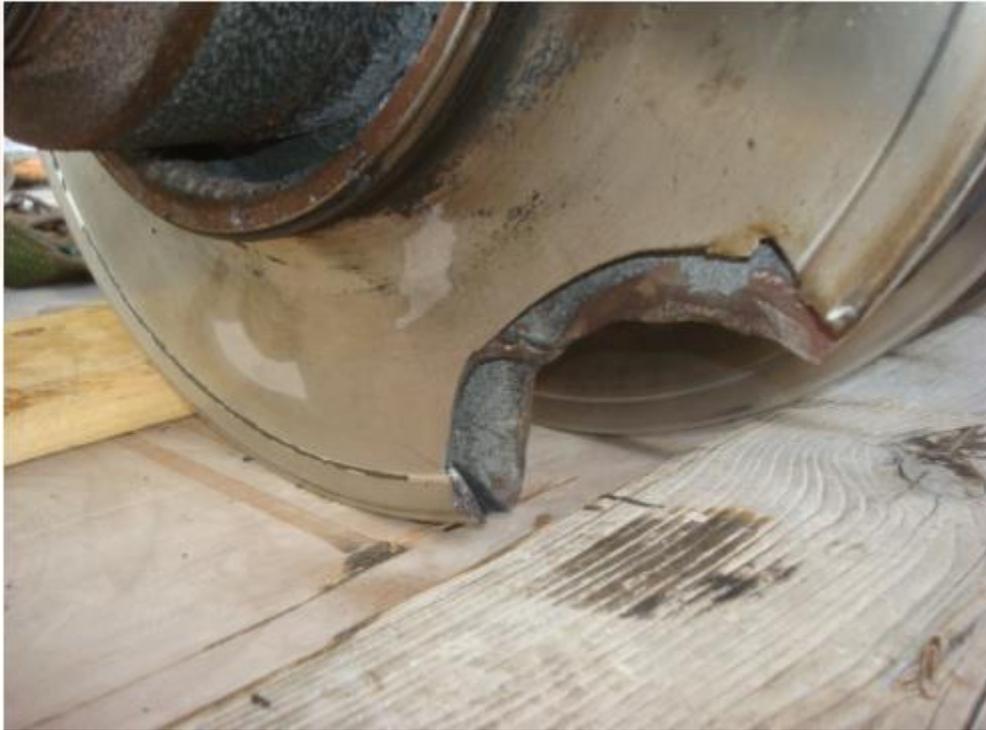
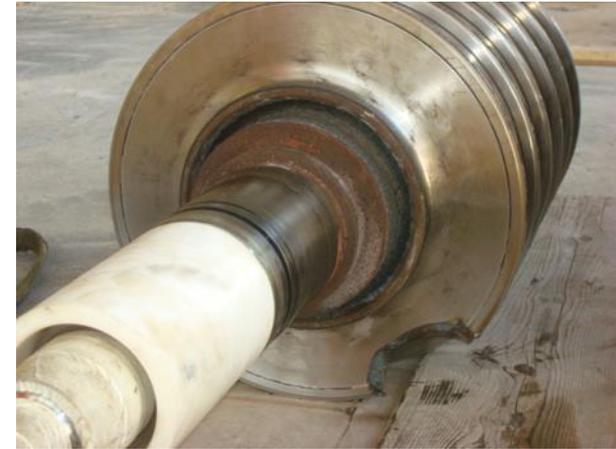
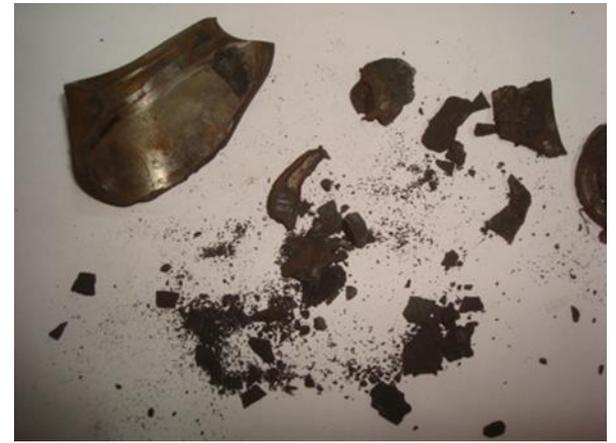
Broken 1st stage impeller

- **First stage impeller found broken**
- **Heavy deposits / fouling of impellers and diffusers**
- **Damaged Journal bearings, DE was severe**

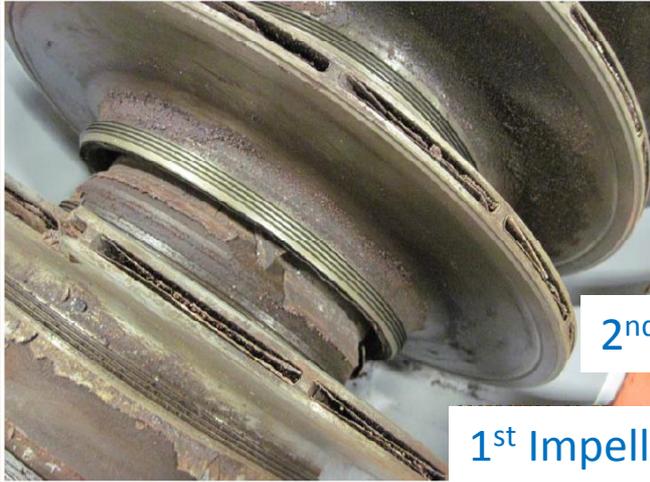
1st Impeller

Fouling was most severe on 1st impeller and was progressively less to the 4th impeller.

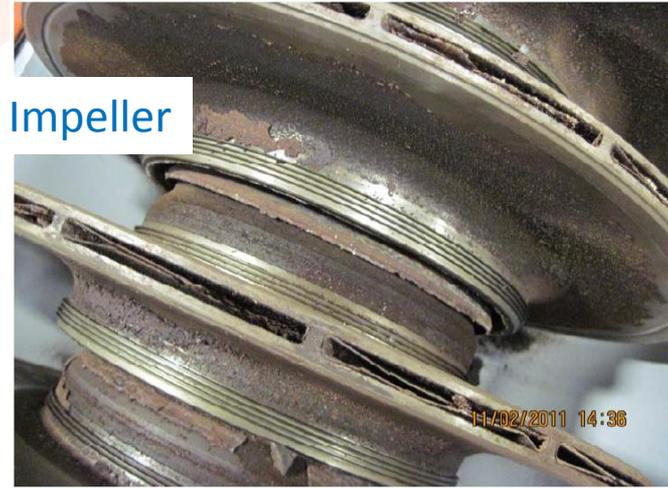
5th Impeller

Almost no fouling of 4th & 5th impellers

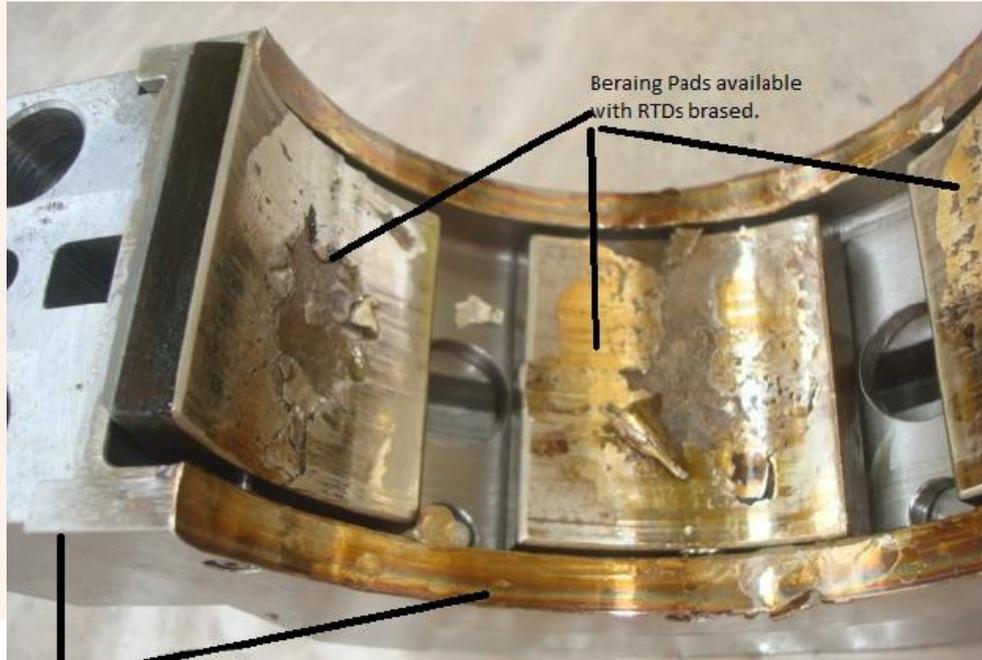
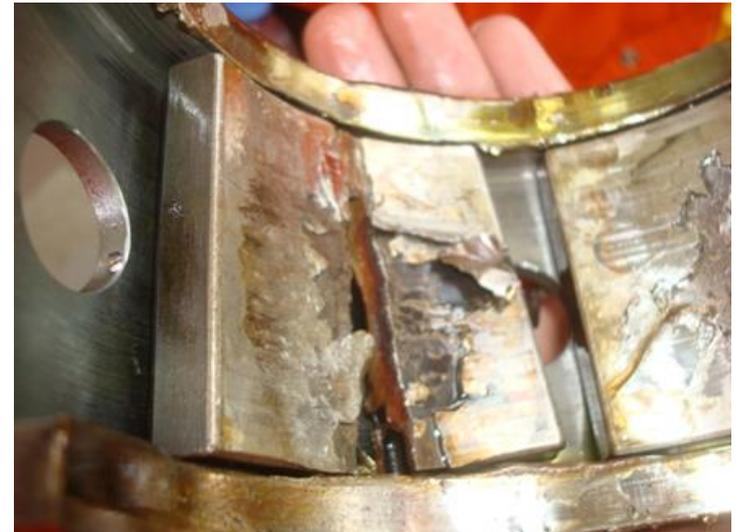
Damaged Journal Bearings

Journal bearings were subjected to very high cyclic load due to unbalance rotor after impeller breakage. Max bearing temperature recorded was 130°C.

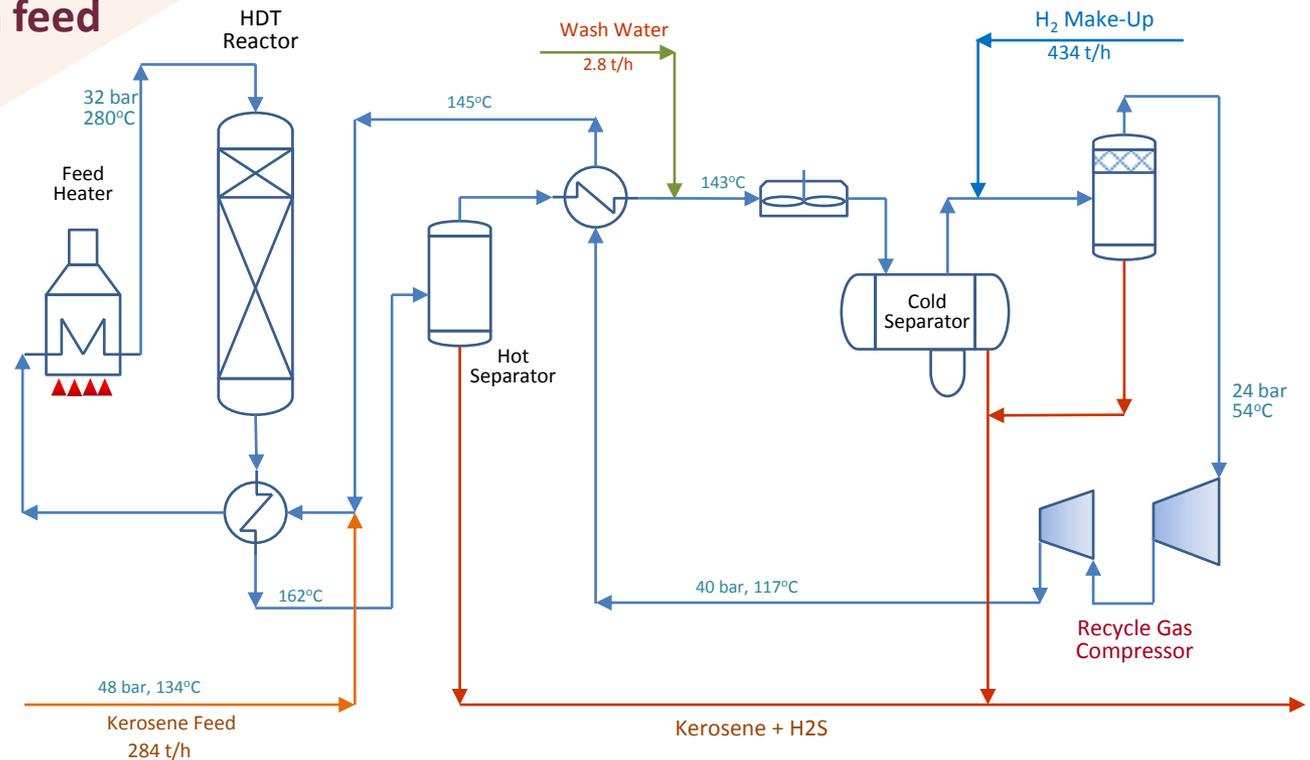
Deposits Analysis

- The deposits were mainly Ammonium Chloride per laboratory analysis
- Ammonium Chloride is produced in traces in the reactor due to the presence of N_2 , H_2 and chlorides in feed

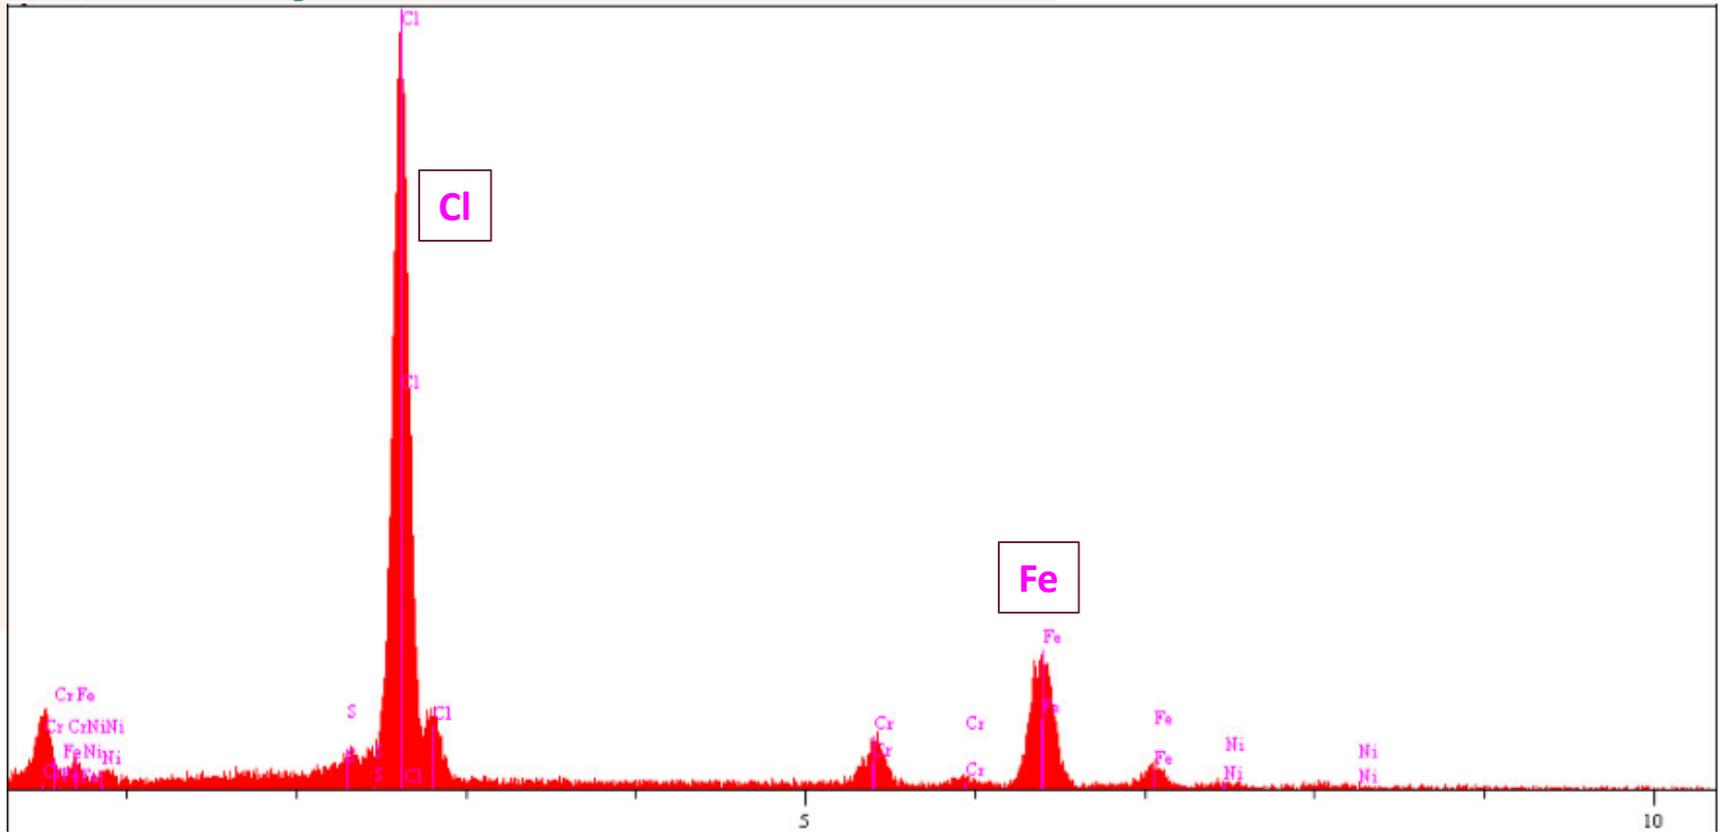
EDS Analysis of foulant on 1st Stage Impeller showing high Chlorides & Iron

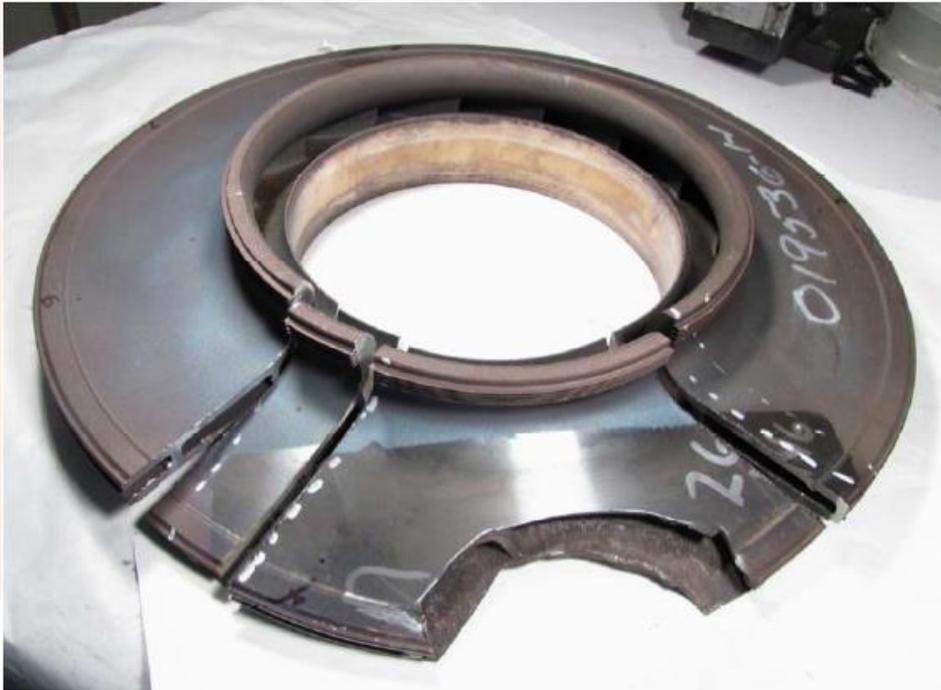
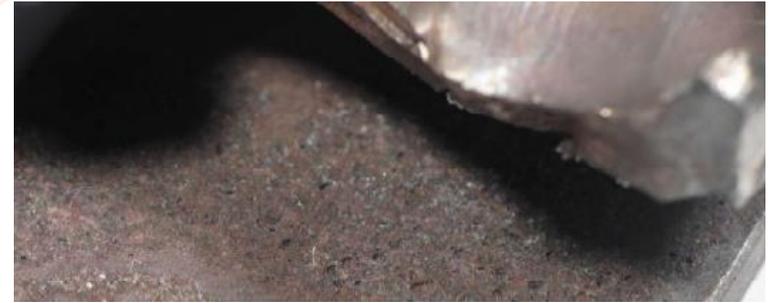
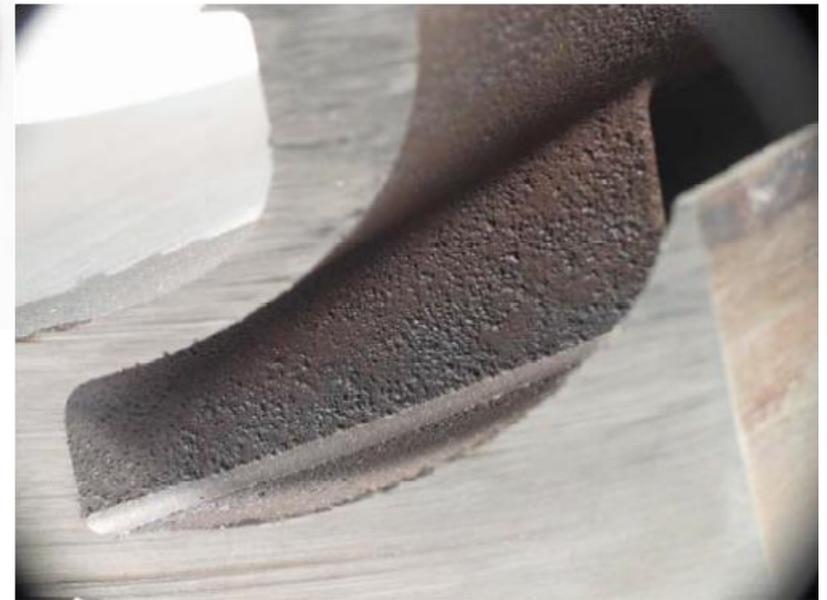
Metallurgical Analysis

“The fracture surface is smooth, relatively featureless, and contains some evidence of beachmarks and thumbnails which are all characteristics of a fatigue failure”.

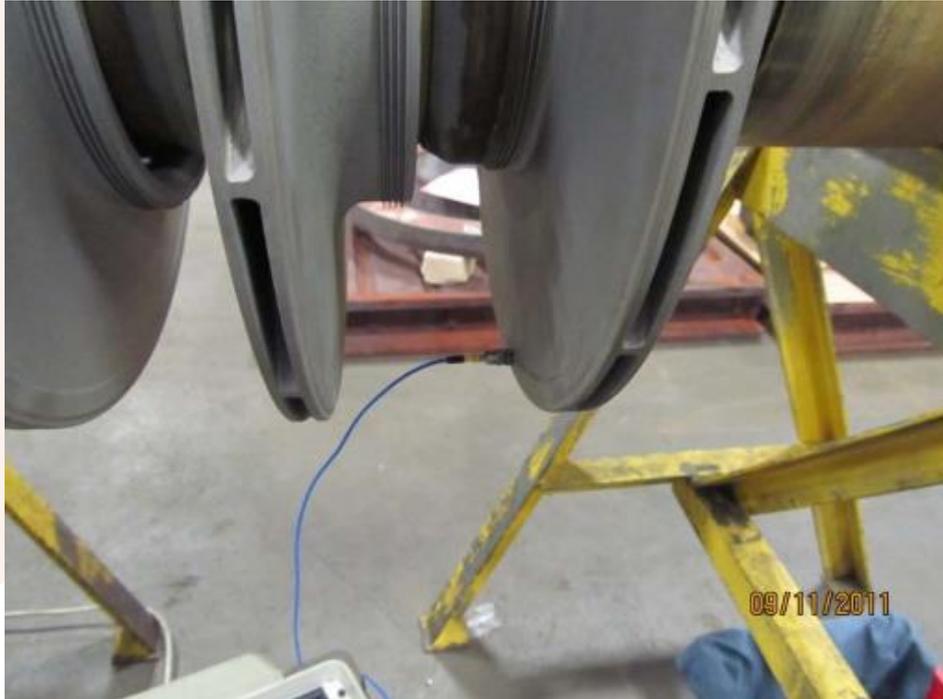
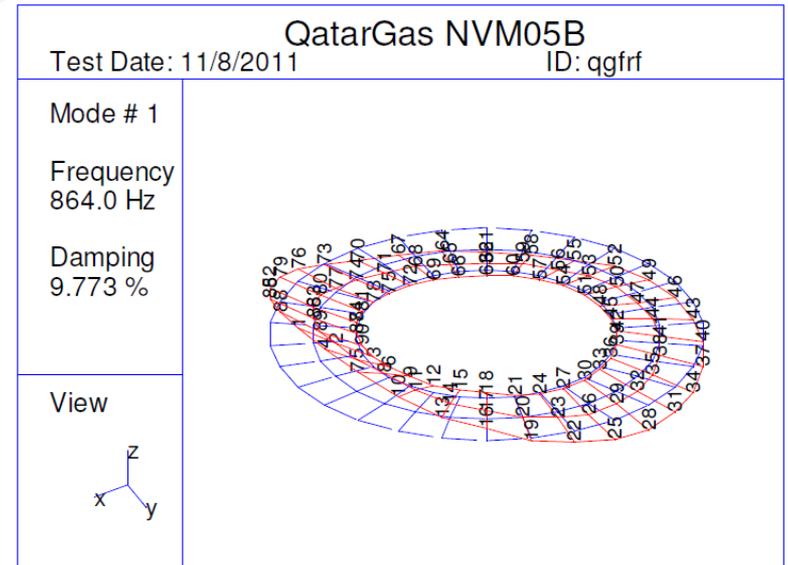
Figure 3 – 1st mode (1-Diameter Mode).

Modal analysis were carried out with the OEM to know if the impellers natural frequencies are close to the operating range and could be responsible for broken impeller. Sufficient margin was found.

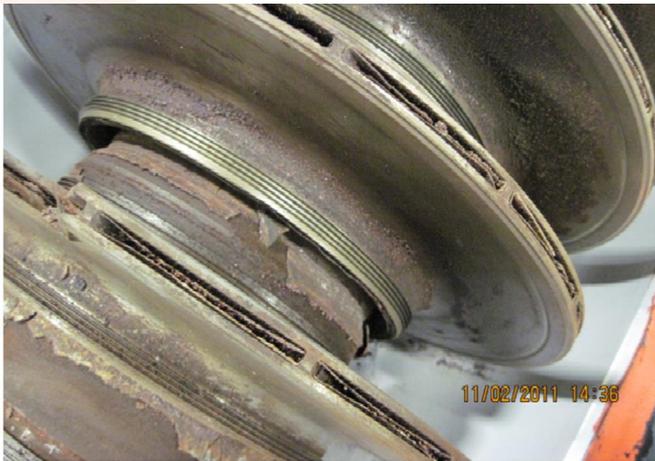
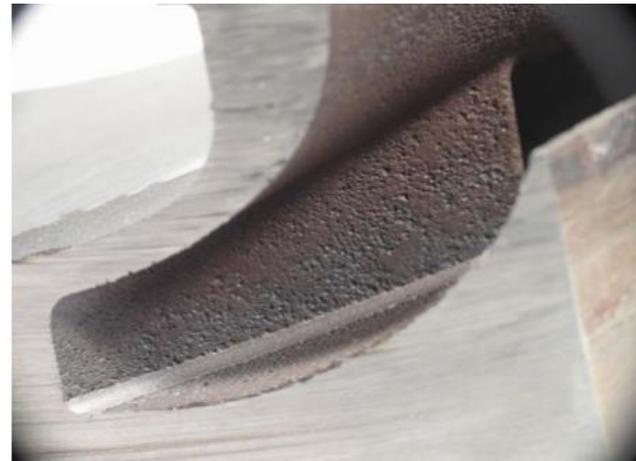
Root Cause of Failure

- Under deposits pitting corrosion of 17-4 PH SS impeller by chlorides
- The impeller failure was attributed to stress corrosion cracking and possibly combined with high cycle fatigue resulting from flow irregularities caused by excessive fouling of the gas flow passages and pitting.
