Oil-flooded Screw Compressor Failures, Causes, Rectifications

Quraisy Shatri (RE Specialist - RasGas)

Qatar is second world largest producer of Helium after the US, and biggest exporter of this lightest gas. In Helium Plants operated by RasGas several flooded-type screw compressors are running. There have been some issues with the units which can be categorized in to three groups: installation, maintenance and operations.

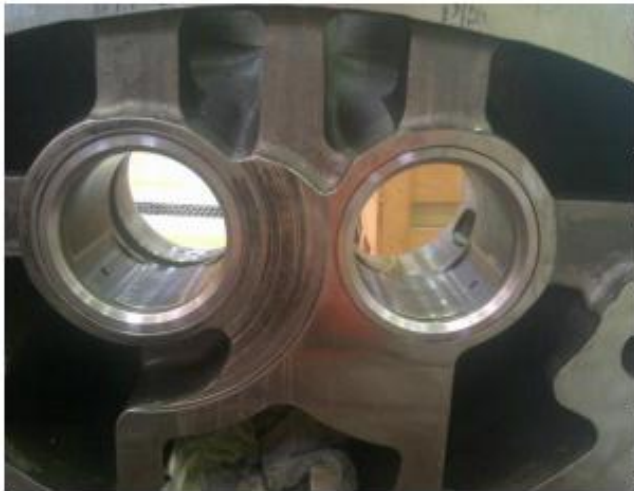
- Male rotor was found with severe damage to the NDE side surface area.
- Suction cover severely damaged
- Scoring on male and female rotors
- Scratches at screw-blades of female rotor
- Scratch marks on male / main rotor casing
- Thrust bearings both active and inactive and the thrust runners were severely damaged, worse on active sides
- scratch marks and dents on radial bearings drive and driven, reusable

Damage casing (in conjunction to male rotor (see above pic)...

- Damaged area @ the casing NDE side was machined ^{**)}
- Damaged areas on both male and female rotors were grinded-off, polished
- Both the male and female rotors were balanced (G2.5)
- Unit was rebuilt with new bearings and seals – dimensions, clearances / tolerances strictly following the OEM / standard

^{**)} ~ 1.5 mm; welding repairs were not recommended; performance is expected to be very slightly lower

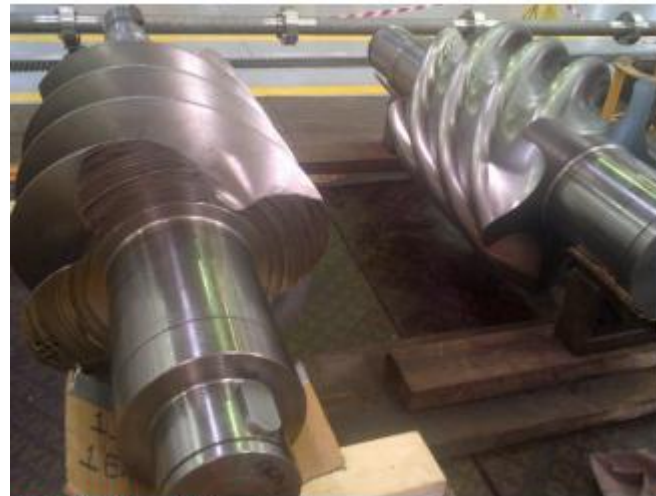
Male (left) and female rotors...

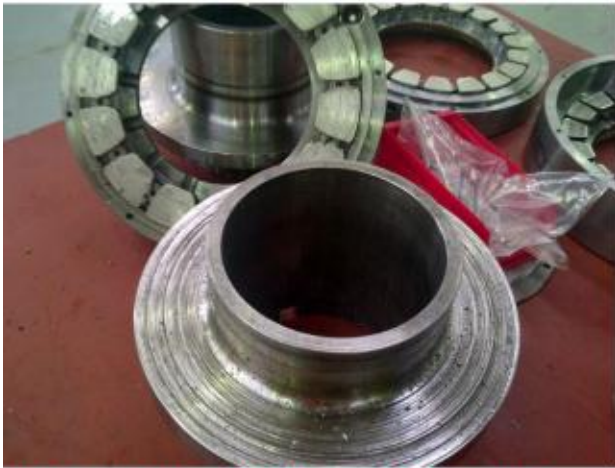
Thrust runner and thrust bearing of male rotor....

- Male rotor's active & inactive thrust pads severely wiped-out; thrust runner 'grinded-off.'
- Male-rotor shaft @ seal area worn-out
- Stuffing box – worn-out

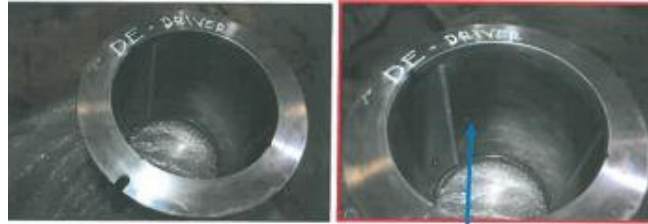
Main bearing Drive and driven side found with scratch marks.

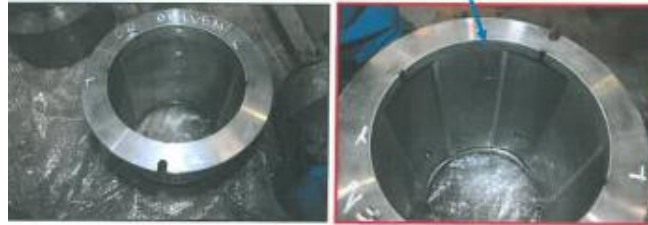
Side bearing Drive and driven side found with dents mark.

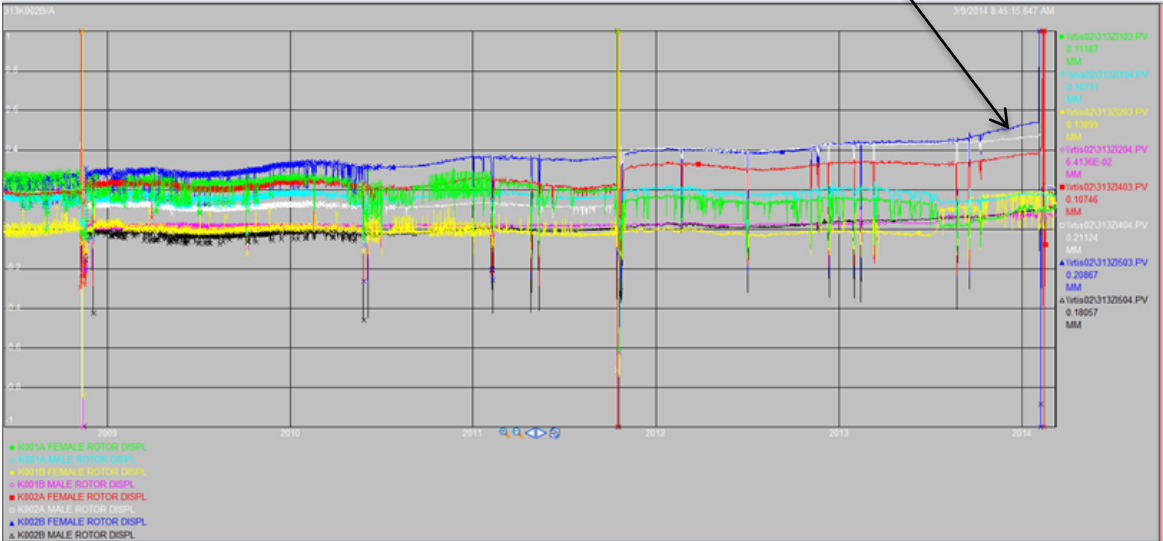
Increasing trends of both male and female rotors' axial position after ~ 6 years in service (2008 ~ 2014)

- All operating data indicated no operational issues which may have brought about the failures
- Motor's bearing radial vibs and compressor's casing seismic indicated no problems.
- The latent root-cause of the unit failure was most likely thrust bearing (fatigue) failures shown through gradual increases of both rotors and failure findings
- Alert and Trips set points were established as employed in other screw compressors

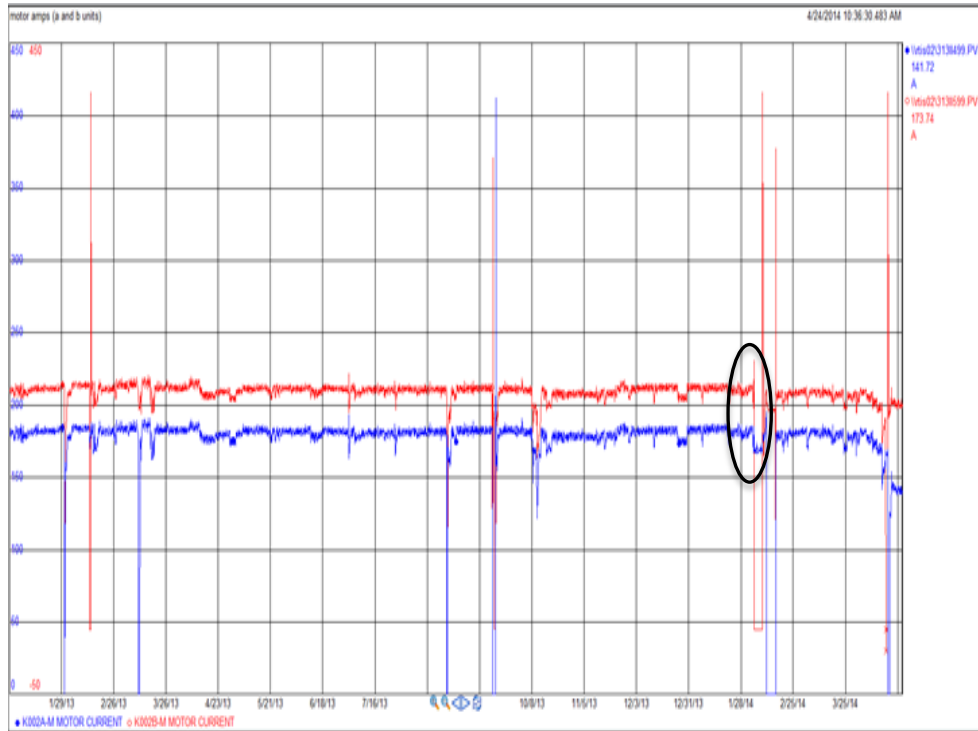
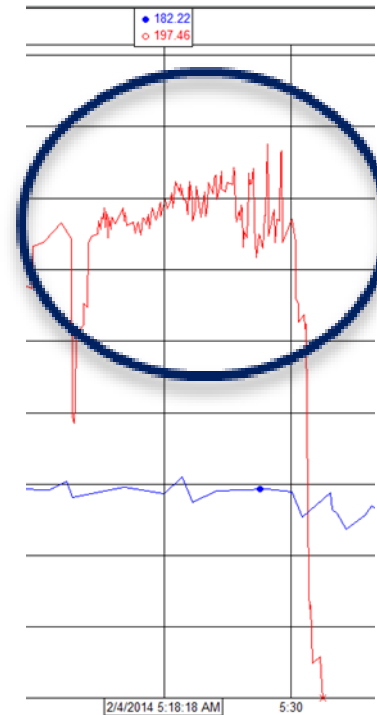
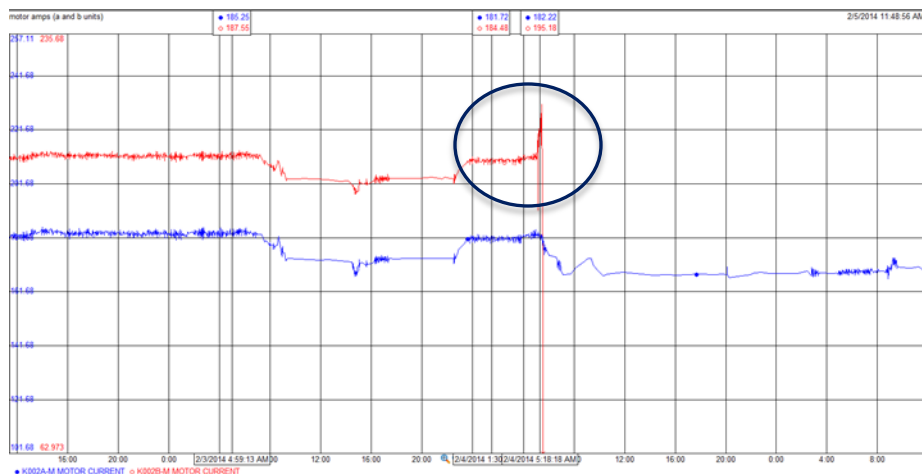
Failure analyses: motor amps

Motor amps decreased from normally ~ 182 by About 10 amps along ~ 15 hours, returned to normal Amps for about 5 hours prior to failure in which the "B" motor amps reached ~ 205.
