RCFA for Recurring Impeller Failures in a 4.7 Mtpa LNG Train Propane Compressor

ABSTRACT

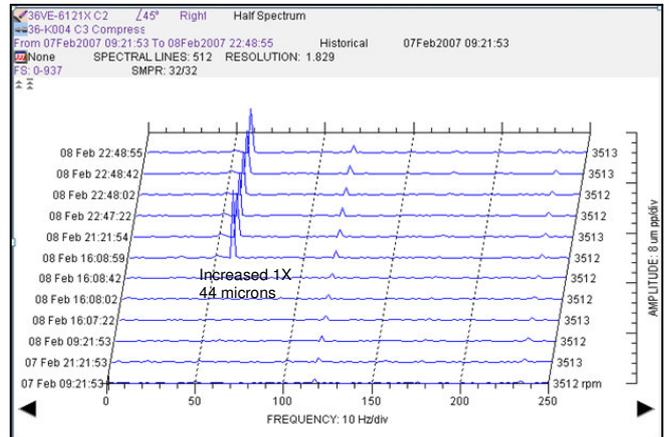
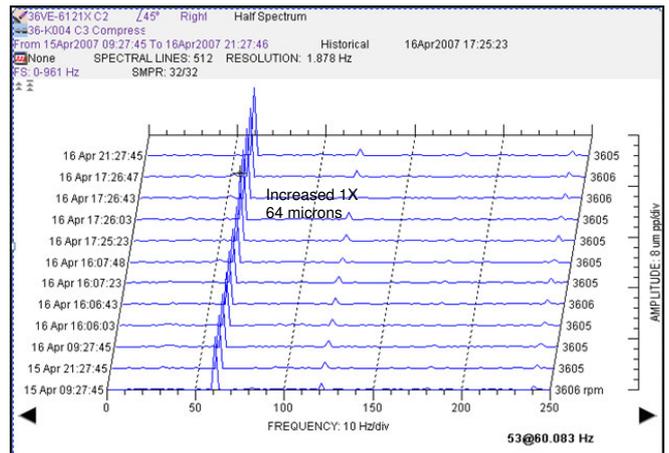
A vibration step change increase from 16 to 44 microns (0.63 to 1.73 mils) was measured at the non drive end journal bearing on 8th February 2007. This remained constant until 16th April 2007, when a second step change increase to 64 microns (2.52 mils) was measured. Analysis of the vibration spectra using waterfall diagrams is shown in Figure 3. The step change occurred during steady state operation at 3600 rpm indicating a rotor unbalance increase and possible mechanical damage.

Second Step Change on 16th April 2007, right half spectrum
Figure 3. Waterfall plots for non drive end journal

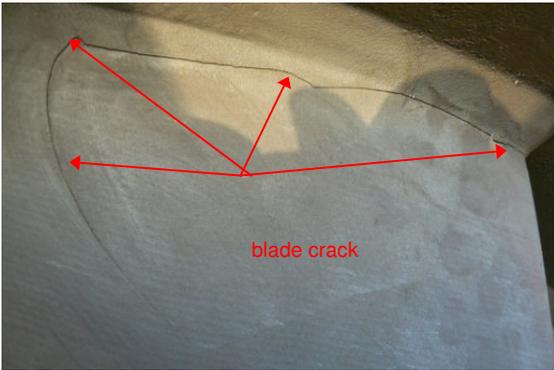
Although the vibration level was high, it remained steady and below the alarm limit of 80 microns (3.15 mils). The End User decided to accept the risk of continued operation until the next scheduled maintenance outage on 12th June 2007. At this point, the rotor had reached 29,000 operating hours. Upon inspection, one blade on the third impeller was found to have cracked and two adjacent blades on the fourth impeller had cracks with large released pieces. The fifth impeller had also

Figure 4. Third Impeller cracked blade leading edge – June 2007

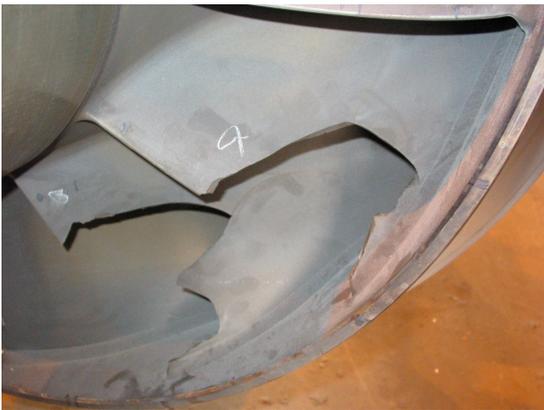
Figure 5. Fourth Impeller released pieces from blade leading edge – June 2007

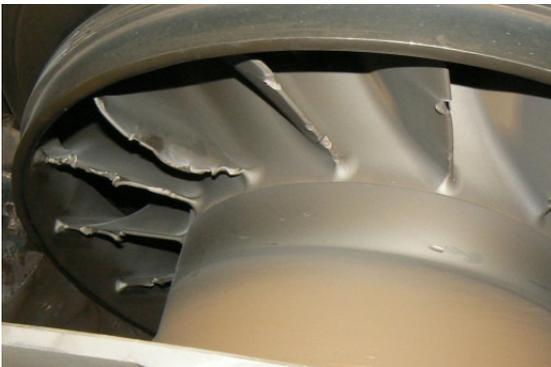
suffered blade leading edge damage from collision with the upstream released pieces. Photographs of each impeller are shown in Figures 4 – 6. The whole rotor was replaced with the warehouse spare during the scheduled shutdown. The damaged rotor was immediately packaged and shipped to the OEM for detailed inspection and repair. In total, the damaged rotor caused an additional six days of downtime, which resulted in significant losses in LNG production and revenue.

Figure 6. Fifth Impeller blade leading edge damage – June 2007

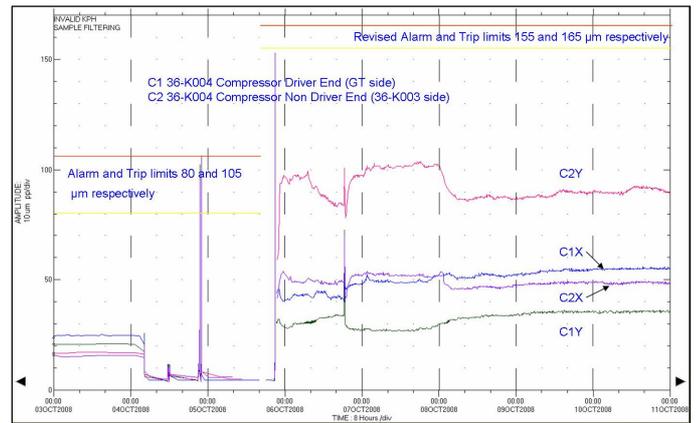
unbalance. The measured 1X vibrations on the non-drive end bearing before the trip were deemed too low to be reliable data. The overall and filtered 1X frequency vibrations, measured during the successful start up on 5th October 2008, indicated that the step change in the vibration amplitude was dominated by increases in the 1X running frequency component. No significant changes in the other frequency components were noted.

Figure 7. Bearing X and Y probe measured vibration amplitudes 3 – 11 October 2008

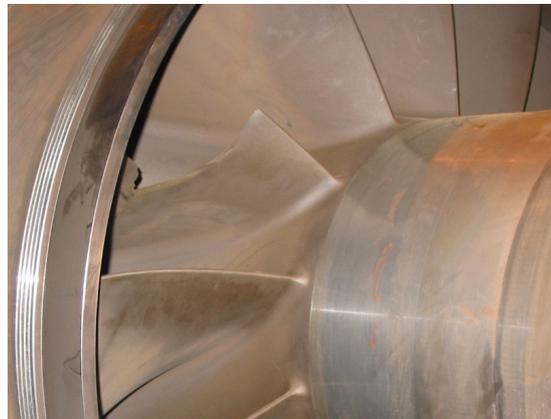
Inspection of the opened unit revealed that the fourth impeller had a single cracked blade with a large released piece (Figure 8). Similar to what was observed in 2007 (Figure 5), the crack appears to initiate at the leading edge of the blade close to the cover. It follows the toe of the weld before turning into the blade and returning back to the leading edge near the mid span of the blade.

Figure 8. Fourth Impeller released piece at blade leading edge – June 2009

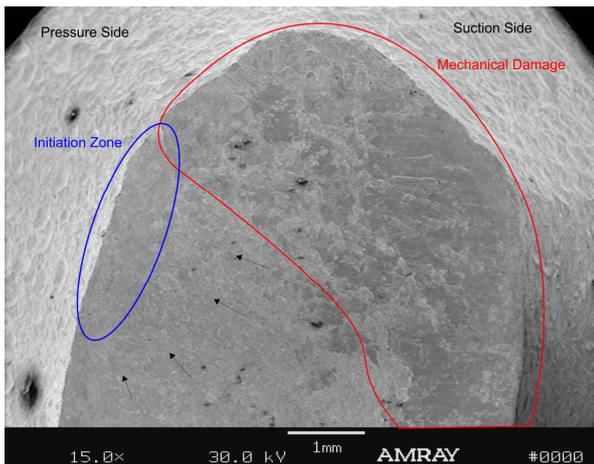
Figure 9. SEM image showing the fracture surface at blade leading edge

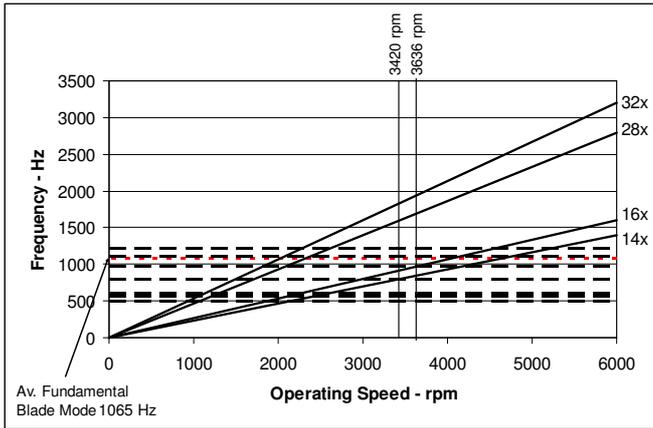
Figure 10 is the Campbell diagram generated from the test measurements on the 2007 failed third impeller. The 14X and 16X vane wake frequencies, as well as twice these frequencies (28X and 32X) are plotted. Three excitable 3-diameter modes were found, one of the disk and two of the blades. The minimum percent separation margin for minor resonance is 11 percent below the 16X return channel vane wake frequency and 36 percent below 32X return channel vane wake frequency. Five 1-diameter modes were found, three of the disk, and two of the blades. The minimum separation margin for each of these excitable minor resonances is 19 percent above the 14X side load vane wake frequency and 19 percent below 28X side load vane wake frequency respectively. The 1-diameter disk mode is inherently difficult to excite due to shaft coupling.

The highest vane pass excitation from the 16X return channel vanes of 970 Hz is 7 percent below the lowest blade leading edge mode of 1040 Hz which is considered marginal. However, the blade with a long crack without a missing piece still had a blade frequency with margin from 16X speed. Although not plotted in Figure 10, the 17X and 18X signals would intersect the lowest blade mode frequency of 1040 Hz below the maximum continuous shaft speed. This was the main potential cause of blade resonance discovered from the testing. The side load with 14 vanes is a 90-degree inlet so that flow is non-uniform giving higher harmonics above 14X that could excite blade modes for the third and fourth impellers.

Figure 10. Third Impeller Campbell Diagram from 2007 failure

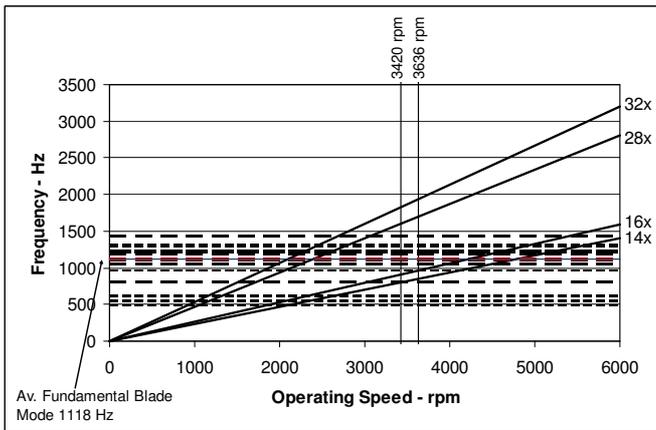
Figure 11 is the Campbell diagram generated from the test measurements on the 2009 failed fourth impeller. The same vane wake frequencies, as for the third impeller are plotted. One 3-diameter mode was found of the disk. The percent separation margin for excitable minor resonance is 11 percent below the 16X return channel vane wake frequency. Three 1-diameter modes were found, two of the disk, and one of the blades. The minimum percent separation margin for each of these excitable minor resonances is 16 percent above the 14X side load vane wake frequency and 23 percent below 28X side

Figure 11. Fourth Impeller Campbell Diagram from 2009 failure

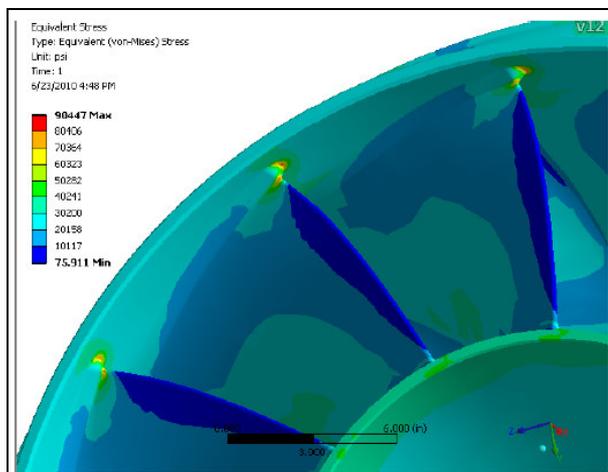
The FEA identified the maximum equivalent mean (von Mises) stress, due to impeller rotation, to be located at the leading edge cover weld fillet. A value of 90.5 ksi (623.9 MPa) was predicted, see Figure 15. From a static loading perspective this appears adequate since the yield strength is 110 ksi (758.4 MPa).

Figure 15. Fourth Impeller FEA result for maximum mean stress

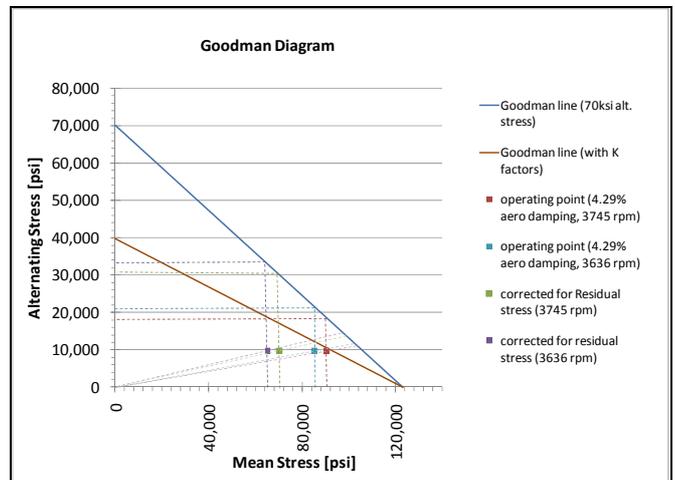
The Goodman Diagram (Figure 17) has four individual plotted points. Two endurance limit lines are plotted; one with and one without the alternating stress K factors. Moving from right to left on the diagram; the first point represents conditions at 3745 rpm, or 3 percent above maximum continuous shaft speed. The second point represents conditions scaled back to the maximum speed of 3636 rpm. Applying the compressive residual mean stress of -20 ksi (-137.9 MPa) to both points moves them on to the third and fourth points respectively. The fourth point, located at a mean stress of 65.3 ksi (450.2 MPa), is the one by which the impeller endurance limit should be judged. It indicates that a Goodman safety factor of 1.28 exists with an applied aerodynamic damping of 4.3 percent. If this value were to reduce to 2.1 percent damping it would exceed the lower endurance limit line and lead to probable blade failure.

In summary, the FSI prediction indicates that excitation of the 1-diameter cover/blades mode with the 16X return channel vane wake frequency results in significant dynamic stress at the toe of the weld on the blade.

Figure 17. Fourth Impeller Goodman Diagram for 1-diameter cover/blades mode

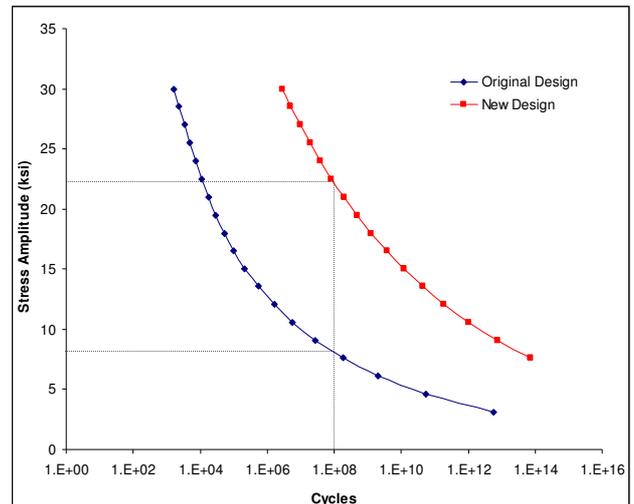
Figure 18. Plot of stress amplitude versus cycles for the original and modified designs

The major feature of the redesigned impeller was an increase in the radius of curvature at the failure location in order to affect the stress concentration. Since this could not be accomplished with the weld being located at the cover side, the weld was shifted to the hub side of the impeller. The blades will be integrally machined to the cover and welded to the hub.

This results in the peak stress location being a machined contour with reduced stress concentration (factor of two or more smaller) and greatly reduced probability of any defect being present. Strain life calculations using stress concentrations based on the change of radius of curvature show that for a mean stress of 65 ksi (448.2 MPa), the alternating stress at 10^8 cycles is approximately 15 ksi (103.4 MPa) higher for the machined contour or for the same alternating stress, the lifetime is increased by four or more orders of magnitude (Figure 18). This is the design of the third, fourth, and fifth impellers on the rotor currently running in the compressor. To date, these impellers have over 10,000 hours of trouble free operation. Further modifications include the removal of the leading edge taper from the lower portion of the blade where it will be welded to the hub, a localized increase in the blade thickness where it is welded to the hub (similar to a "T" head design) and the hub and cover thicknesses have been increased. Shot peening will be performed on and around the weld to add further compressive residual stresses. The material composition will also be changed to 13Cr-4Ni, which offers benefits including better toughness, through hardenability and manufacturability over AISI 4340.

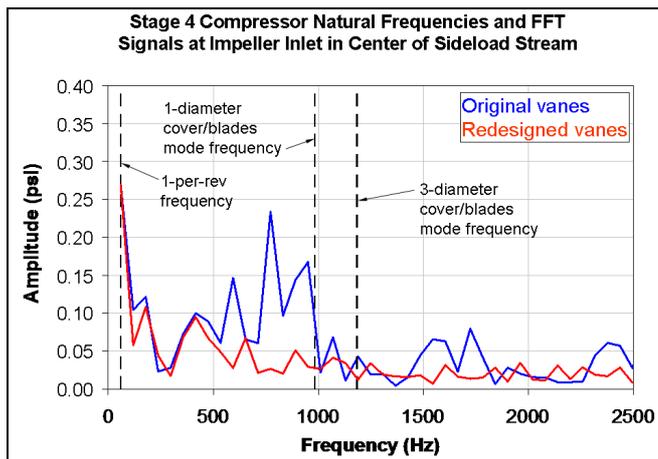
Figure 20. Original and Redesigned side load signals

To eliminate the 14X signal from the side load and weaken the side load signal in general, a new side load vane design was proposed and analyzed. These highly curved vanes are spaced at 8 per circle and are based on the OEM's current proven inlet design. This arrangement effectively removes the primary 14X wake frequency. The predicted change in side load signal to the impeller at design point (DP) is shown in Figure 20.

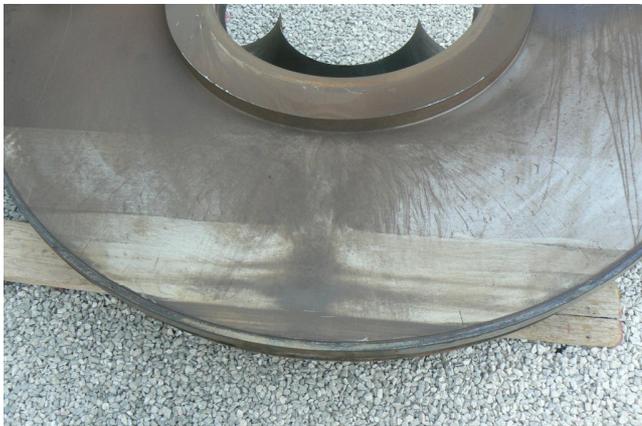
Evidence that liquid ingestion may have occurred was presented during the RCFA performed after the first failure. Figure 22 shows a horizontal stain on a diaphragm taken from the compressor. Swirl patterns (Figure 23) were found on all of the impellers. Erosion damage was found on the pressure side of both the third and fourth impeller blades. This possible cause was a point of contention, but was not pursued further since it was believed that sufficient precautionary measures were in place and the erosion damage was caused by the large amounts of solid deposits which were also found in the gas paths of the impellers. Because it was left as an unclosed item, it was revisited in more detail during the current RCFA.

Figure 22. Photograph showing stains on a diaphragm

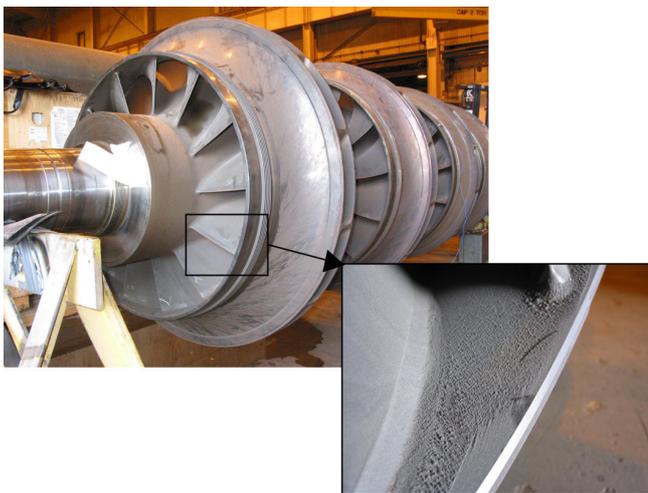
Figure 23. Photograph of the 2007 failed rotor showing swirl patterns on the impellers.

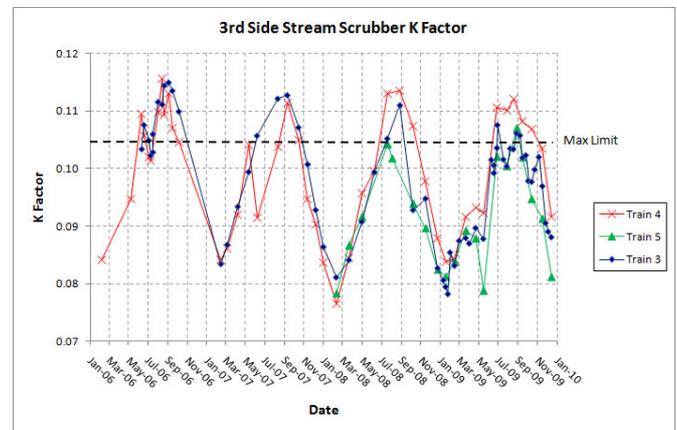
The analysis confirmed that the first and third side load scrubber mist eliminators had consistently exceeded their limits. Focus was however, given to the third side load because it was the worst case and is located immediately upstream of the fourth impeller. The results are plotted in Figure 24 for Trains 3, 4 & 5. The horizontal dashed line denotes the maximum limit. The plotted points were selected with the greatest measured flow rates to show the general trend throughout the year. A clear periodic swing is shown for each train as the volumetric flow rate varies between high during summer and low during winter. This is caused by the increased refrigeration duty as a result of the higher sea water cooling temperature in the hotter months. During the summer, Trains 3 and 4 exceeded the K-factor limit by as much as 10 percent. Train 4 was marginally worse in the latter two years. Data for Train 5, which began operating in early 2006, was unavailable before February 2008. This train only exceeded the limit by 2 percent in 2009.

Figure 24. K factor for Trains 3, 4 & 5 - third side load

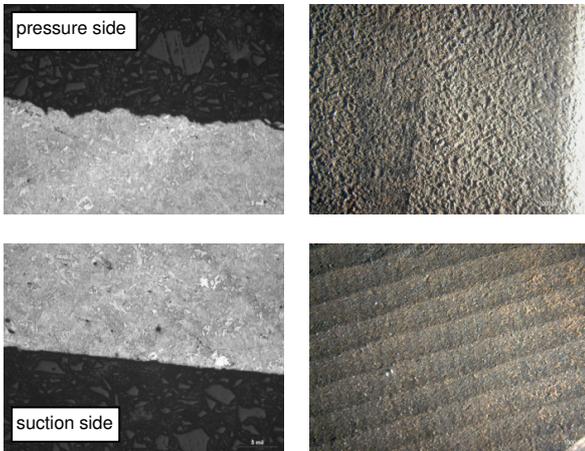
As part of the metallurgical analysis, the surface and cross section of samples taken from the 2007 and 2009 failed fourth impellers were examined using optical and electron microscopy. The location of the samples was just above the cover weld dressing marks at the leading edge. This region was close to the earlier identified high stress region and crack inception site. In both cases surface erosion was discovered on the pressure side of the sample. Figures 25 and 26 show the cross sectional images of each side of the blade on the left and the corresponding surface image on the right. Comparing the cross sectional images in both figures, it is evident that the

pressure side of the blade is irregular, while the suction side is essentially flat. As expected, the same observation can be made by comparing the surface images. The suction side surfaces still show the machining marks from the manufacturing of the impellers.

Figure 25. Images of 2007 Fourth Impeller released piece

These marks are no longer visible on the pressure side surfaces. It is very clear that the pressure side of the blades were subject to erosion by some media. Closer examination of the morphology of the surface shows that the erosion damage can be attributed to liquid droplet impingement.

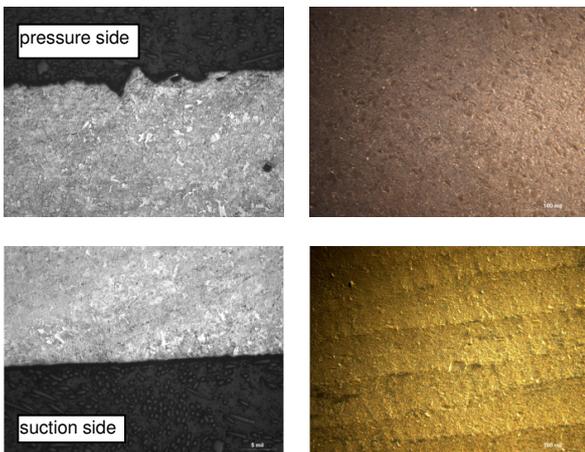
Figure 26. Images of 2009 Fourth Impeller released piece
