# Severe Casing and Impeller Erosion : Analysis and Resolution

Author: Tete Sedalo  
Technical Services Engineer

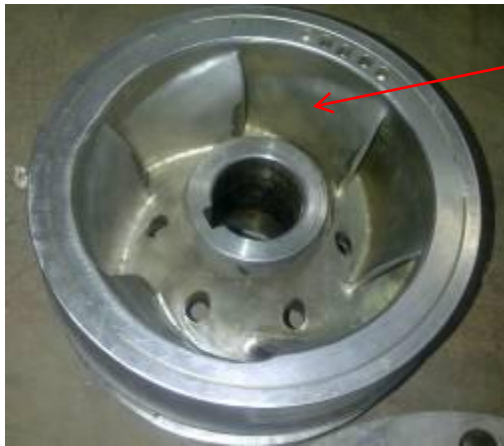
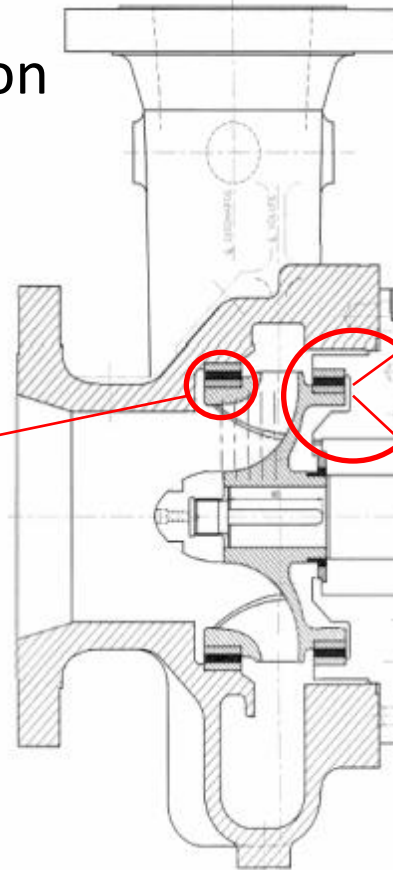
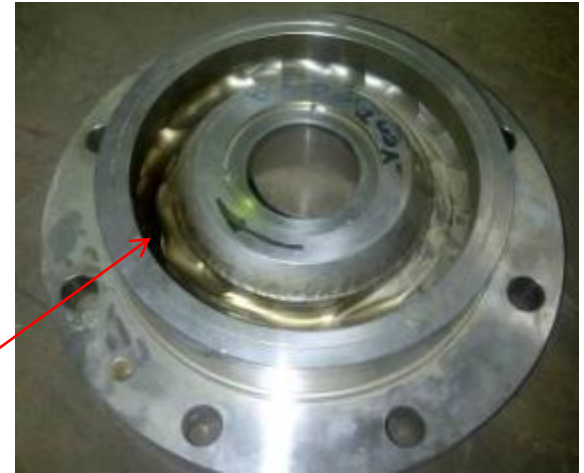
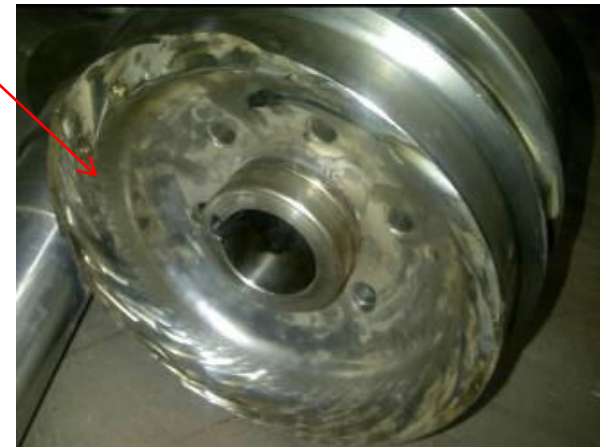
- No erosion damage on the front side
- Severe fish skin erosion
- Impeller back at wearing neck
- Cover inner side

- Erosion damage is more severe when operating off BEP with a high impinging energy thus resulting in a more severe erosion rate
- Current design more suggest to a dead zone on the back side of the impeller and cover. Trapped particles will remain and won't be flushed. Thus will machine out, erosion

- Increase of the back side area
- Bigger area = lower flow velocity , turbulence reduction
- Impeller balancing holes size increased and location changed
- Trapped particles will be centrifuged toward suction

- Design Enhancement has been implemented, main target was to reduce the turbulence level by increasing the back side of the impeller and cover area thus reducing local velocity and allowing hard particles to be flushed away.
- Pumps back to operation for a year

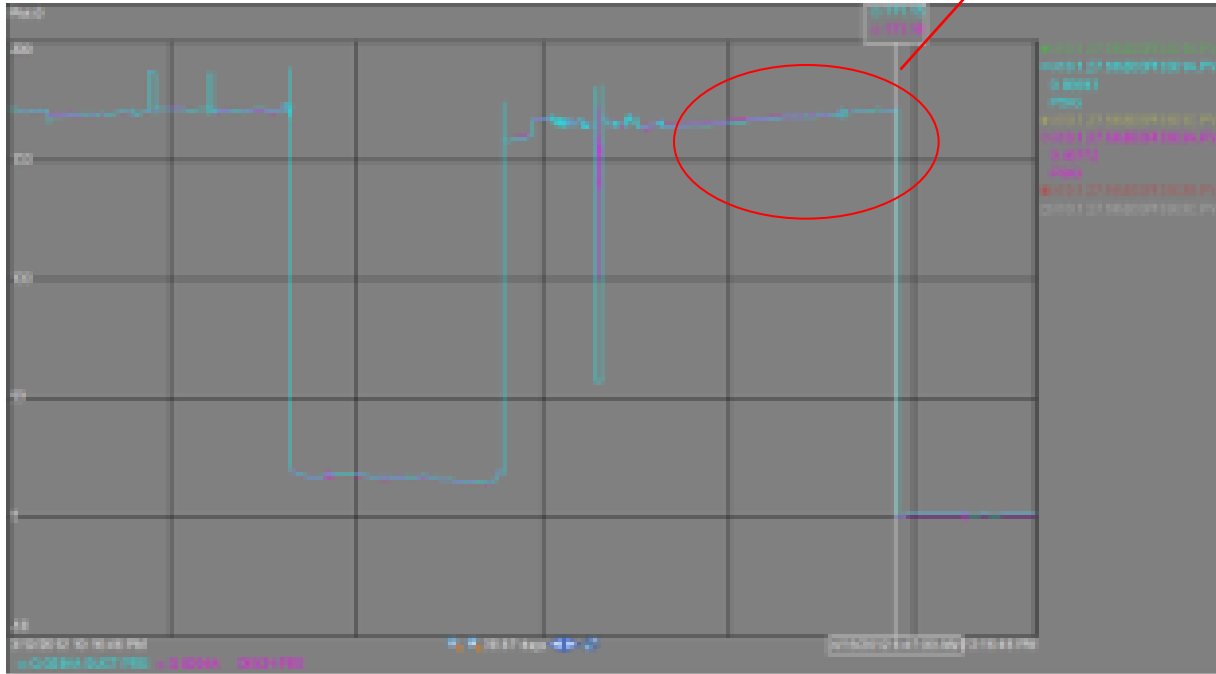
Main Discharge pressure  
around 170 psi g

- Tdh @ operating condition
- Total diff pressure = 114 Psi
- Total diff head = 258 ft

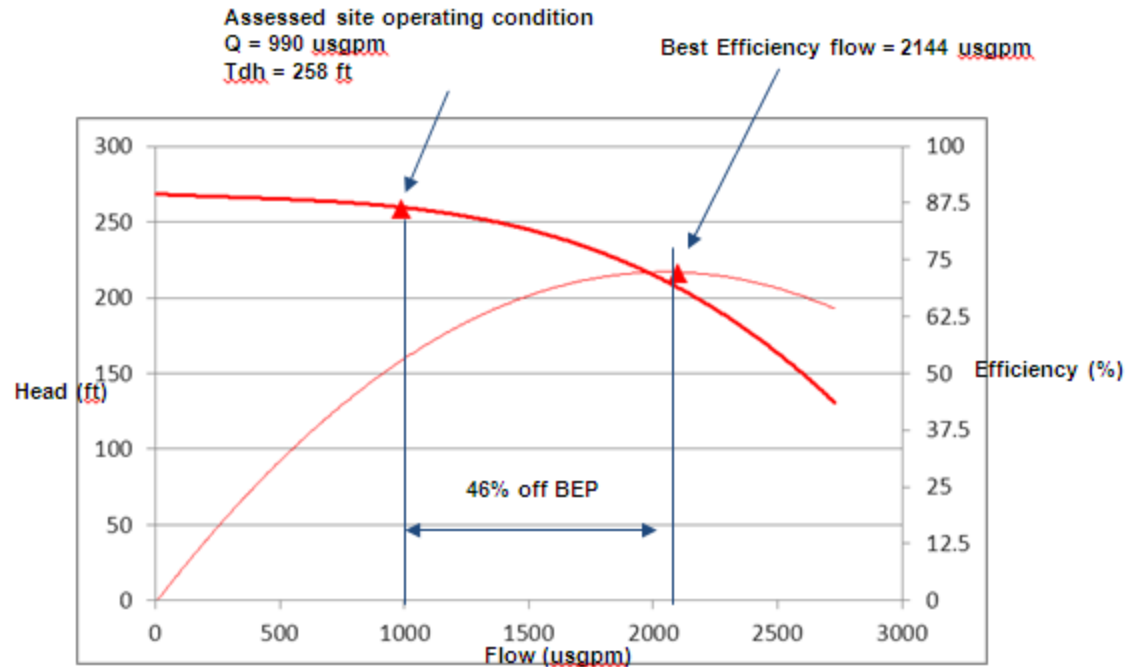
- If there is any discontinuity in the flow path it will accelerate wear at these special location
- Leakage flow on front and back shroud has higher impinging energy

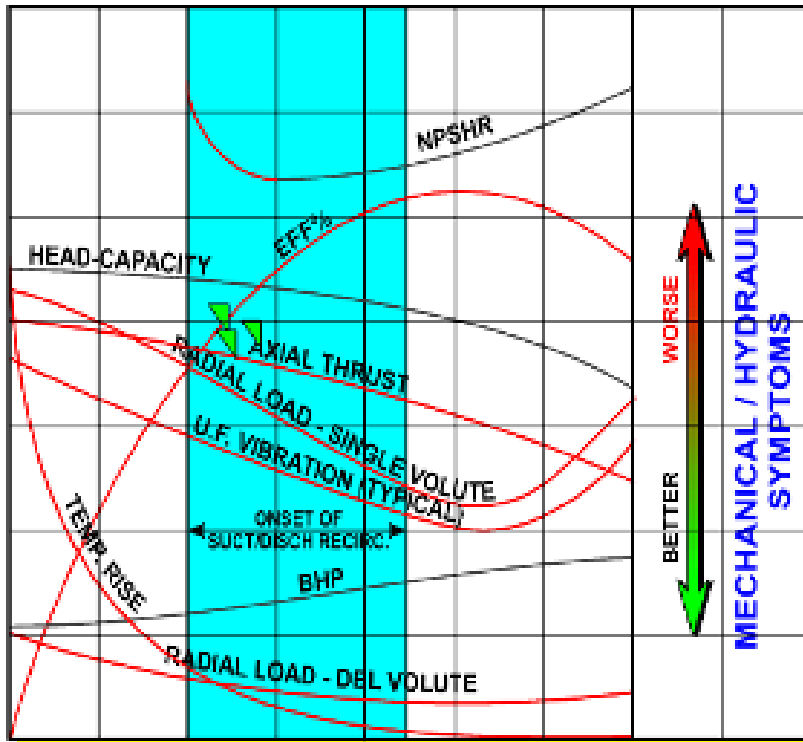
Operation far from BEP will result in:

- Amplification of known hydraulic phenomenon
- Pump fluid will transfer more energy to wall surface
- High turbulence in narrow clearance area

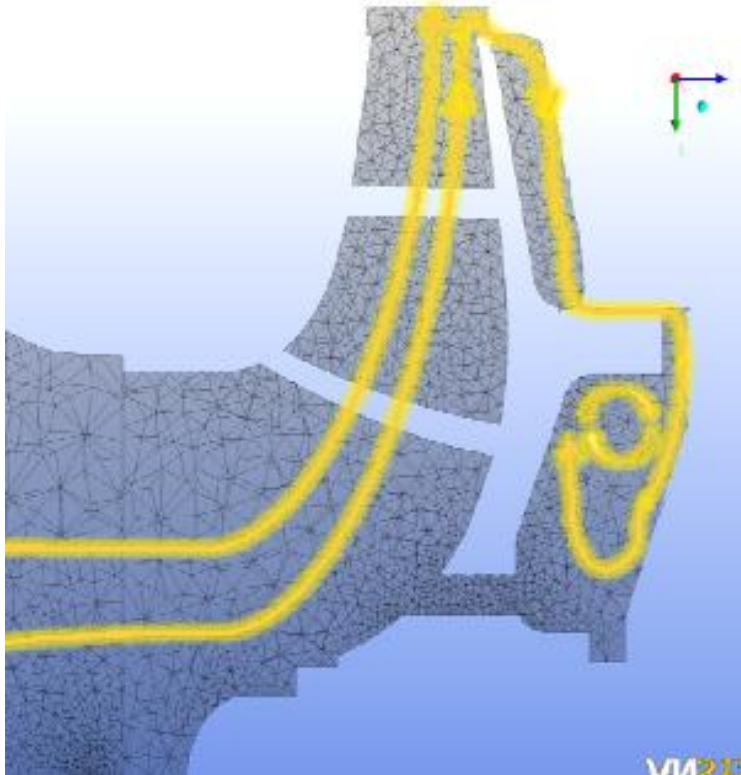
An analysis of the leakage flow path study done by Flowserve in a more severe abrasive service environment has demonstrated:

- Particle diameter plays an important role, only particles with smallest diameter enter the back shroud chamber
- A portion of the flow entering in the back shroud chamber is trapped, thus particles suspended are trapped in this chamber resulting in an accelerated erosion damage
