# Hydraulic Upgrade of Hot Water Circulation Pumps in a District Heating System

Erik Roosch & Frank Visser\*

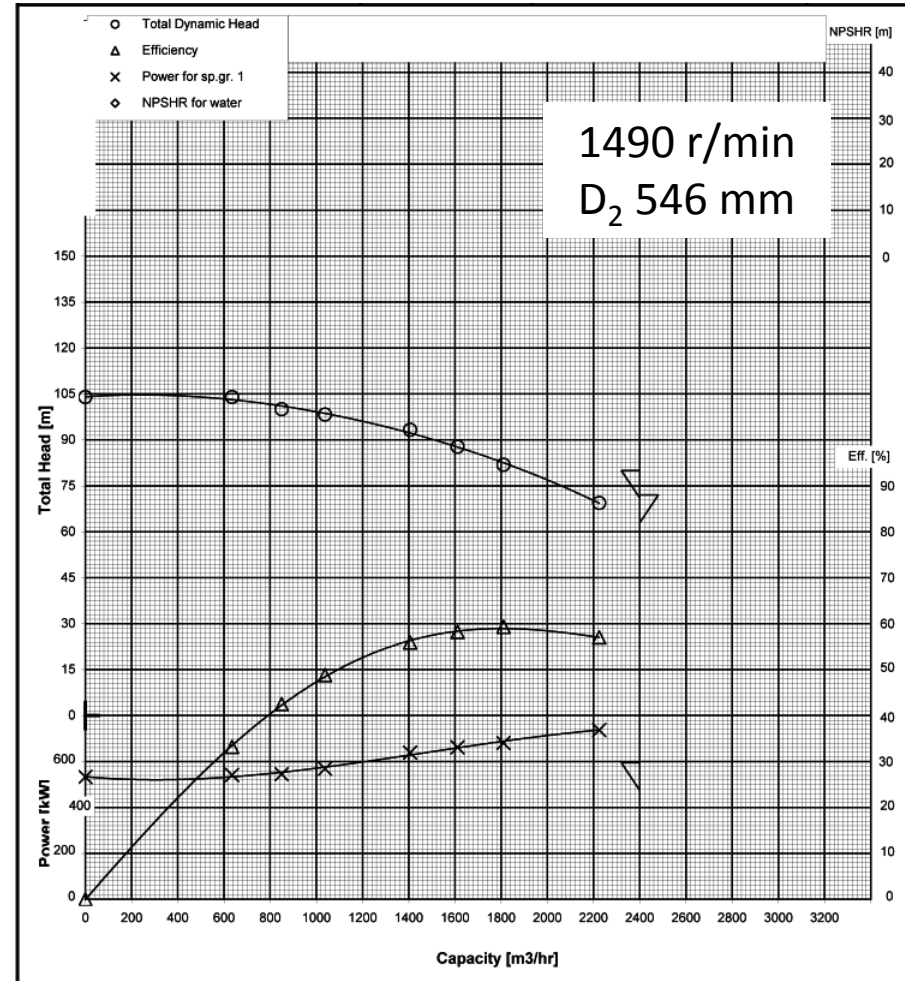
## First Test Result:

- ❖ Failed to make the head
- ❖ Efficiency too low
- ❖ Power too high
- ❖ BEP at too low capacity

## Suspected Cause:

- Choking casing discharge (narrow throat passage)

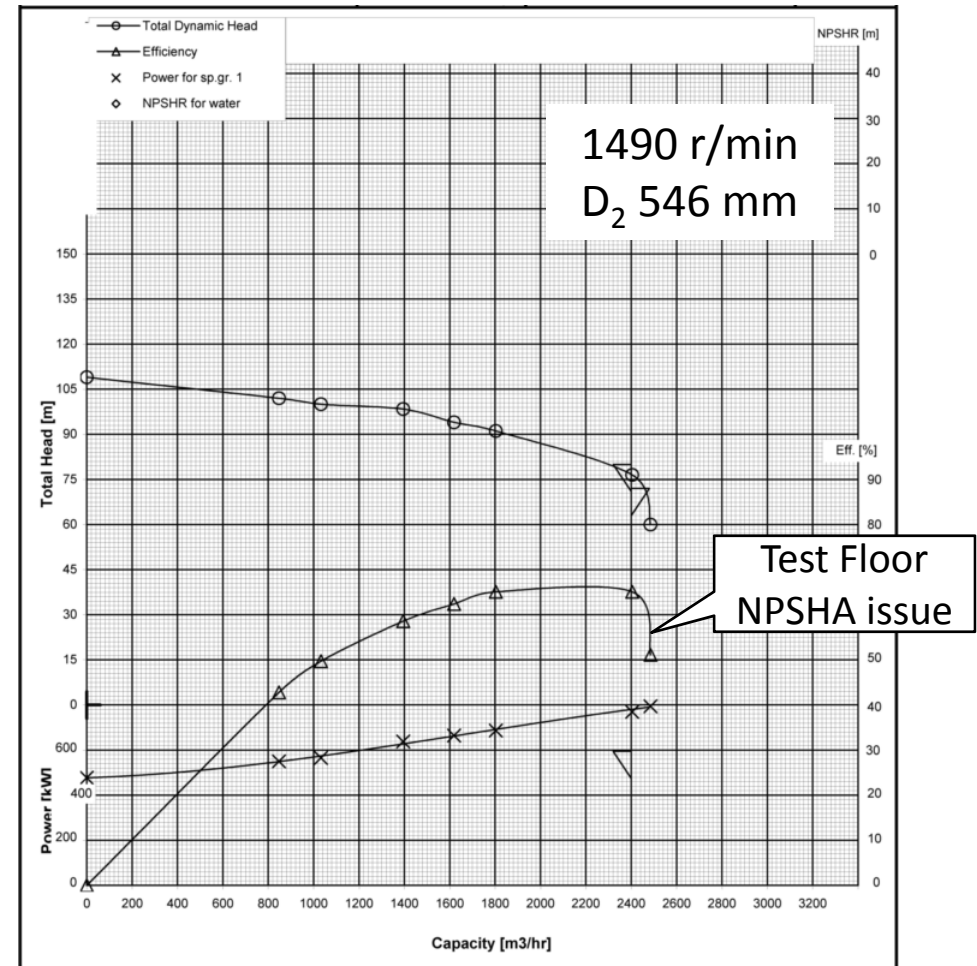
## Second Test Result:

(After opening up casing discharge throat area)

- Head picked-up
- Efficiency improved
- BEP shifted to higher capacity

**BUT**, pump still not making expected performance

## Suspicion:

- Incorrect diffuser design?

## Remedy:

- Volute insert

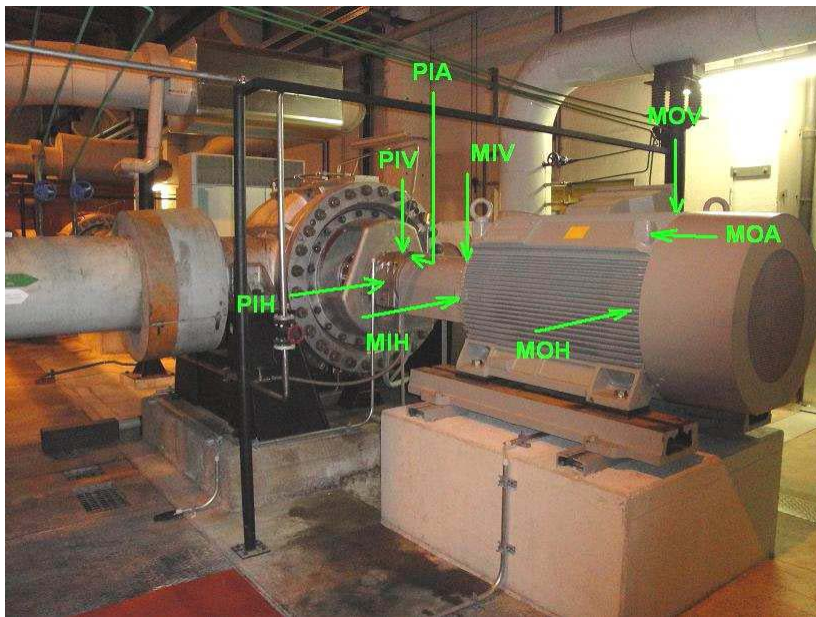
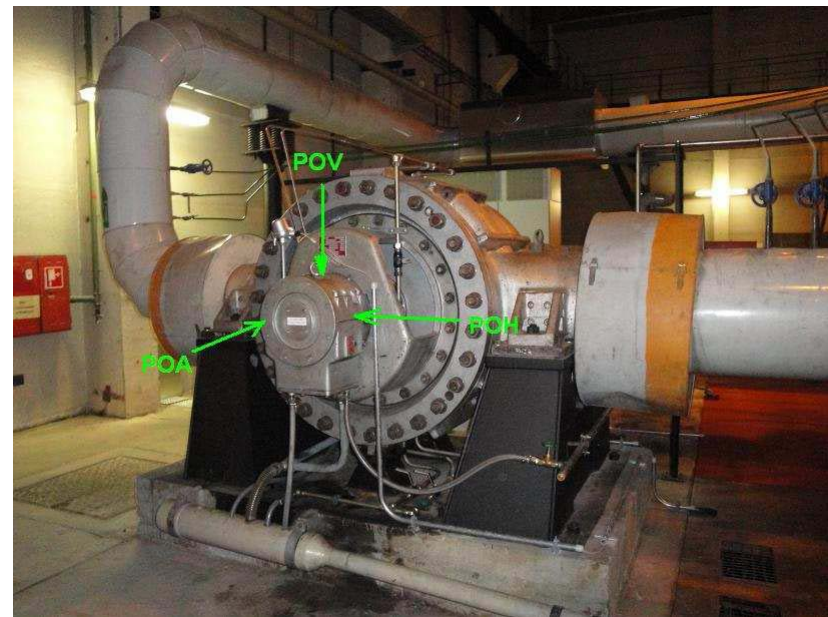
**Vibration measurement locations**

- While developing volute insert and manufacturing parts pump was shipped to site.
- At site an **8X vane pass vibration** issue @ PIH emerged when running **around 1200 r/min.**

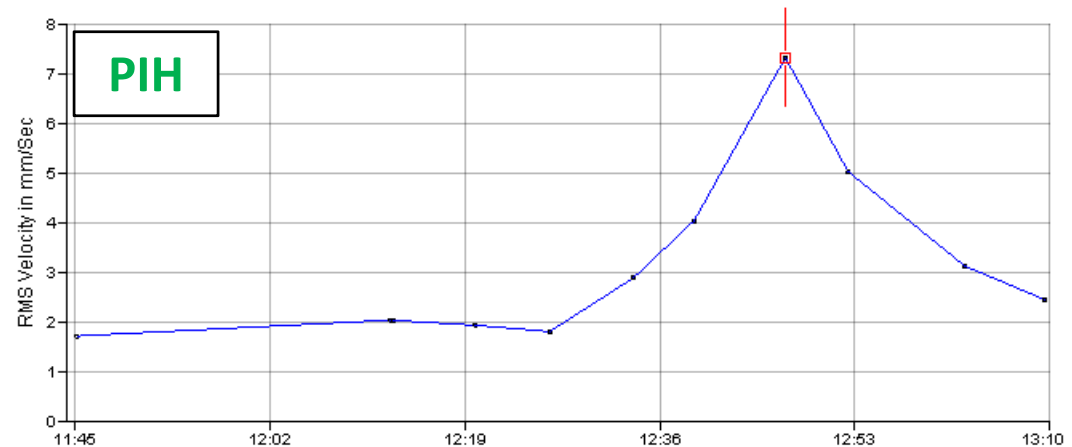
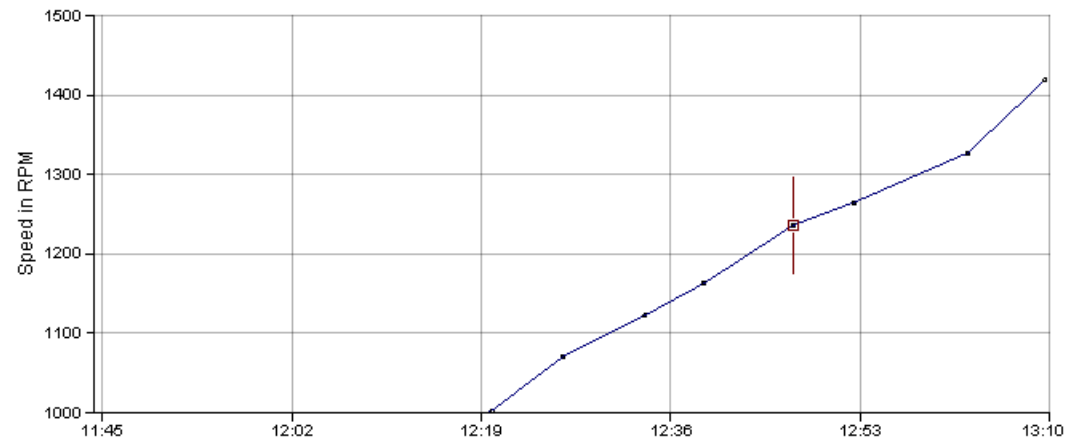
## Order Tracking

1000 – 1420 r/min

- **PIH: 7.3 mm/s**  
@1236 r/min  
(8X, or **165 Hz**)

## Bump Test:

- **169 Hz** natural  
(resonance)  
frequency (Hor.)

## Elevated vibration levels due to:

- 8X vane passing excitation forces @ **165 Hz**
- Natural (resonance) frequency in horizontal plane @ **169 Hz**.
- **Very small impeller tip (“Gap B”) clearance**, causing **strong vane passing excitation forces**

$$(D_3 - D_2) / D_2 = 553 - 546 / 546 = 0.013 \text{ or } \underline{\underline{1.3\%}} (!)$$

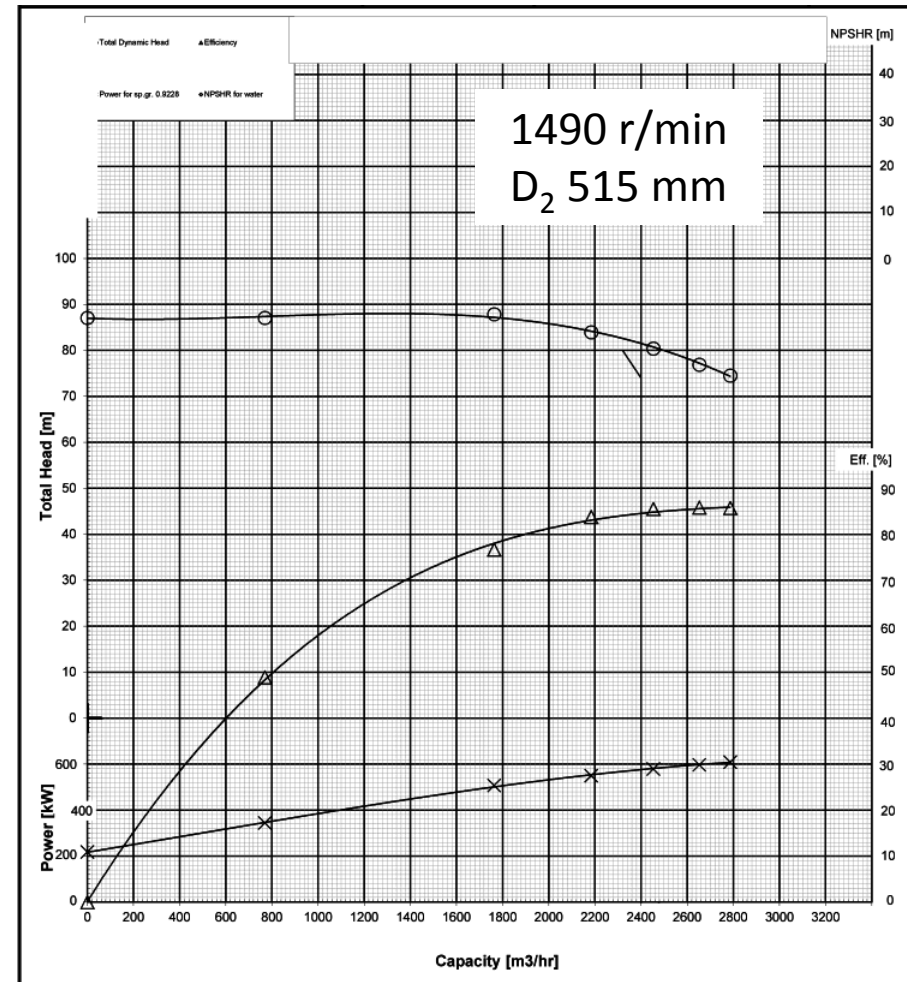
## Test result:

- ✓ Head okay
- ✓ Efficiency okay
- ✓ Power okay
- ✓ Tip clearance (Gap B) okay

$$\begin{aligned} (D_3 - D_2) / D_2 &= \\ 578.2 - 515 / 515 &= \\ 0.123 \text{ or } \underline{12.3\%} \end{aligned}$$

- ✓ No 8X vane pass vibration issue anymore
