Centrifugal Compressor Over Speed Trip Case Study

Authors: Thota Praveen Kumar

Qatar Shell GTL Limited-Doha Qatar.

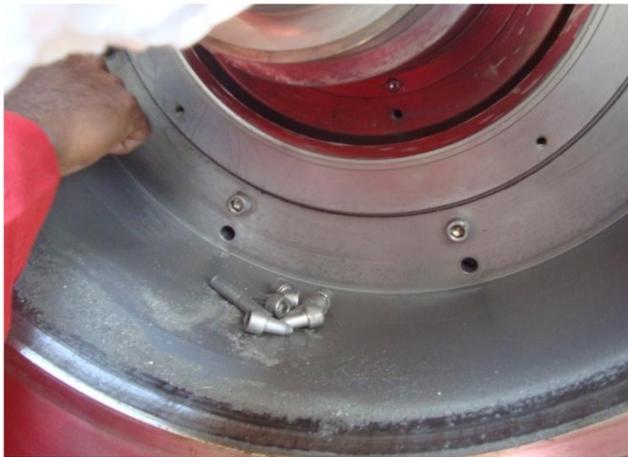
- ❖ Seven of the eight Allen head bolts holding diffuser plate in position were broken. One bolt was completely missing.
- ❖ Seven of the bolt heads were found sitting in the bottom of the balance chamber.
- ❖ One bolt broken had backed out and was found in balance chamber.
- ❖ 5 of bolts had been elongated.

After opening Casing end cover- Balance chamber area

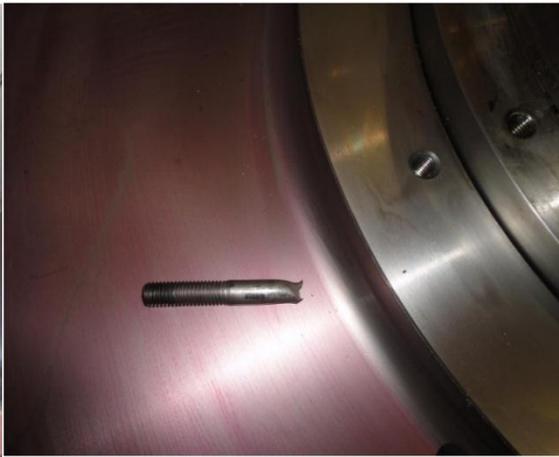
Broken bolt found the section of discharge cover

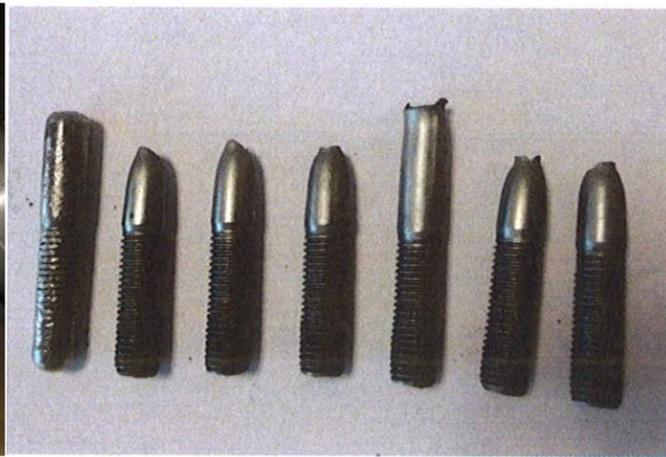
Broken bolts after remove

- ❖ Rotor sent back to vendor for repair. Used the spare Rotor for assembly.
- ❖ The threads of the diffuser plate increased from M12 to M16 as they were found loose, and holes in the volute also increased to match.
- ❖ Diffuser plate Dye penetrant test carried out and found that there were no crack caused by the contact.
- ❖ All bolts were tightened with 130NM torque as per vendor recommendation and found no gap between diffuser plate and volute insert.
- ❖ Thrust and Radial bearings were reused.

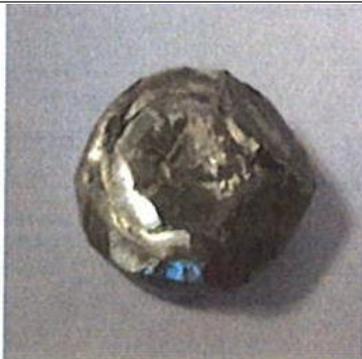
Allen head back side

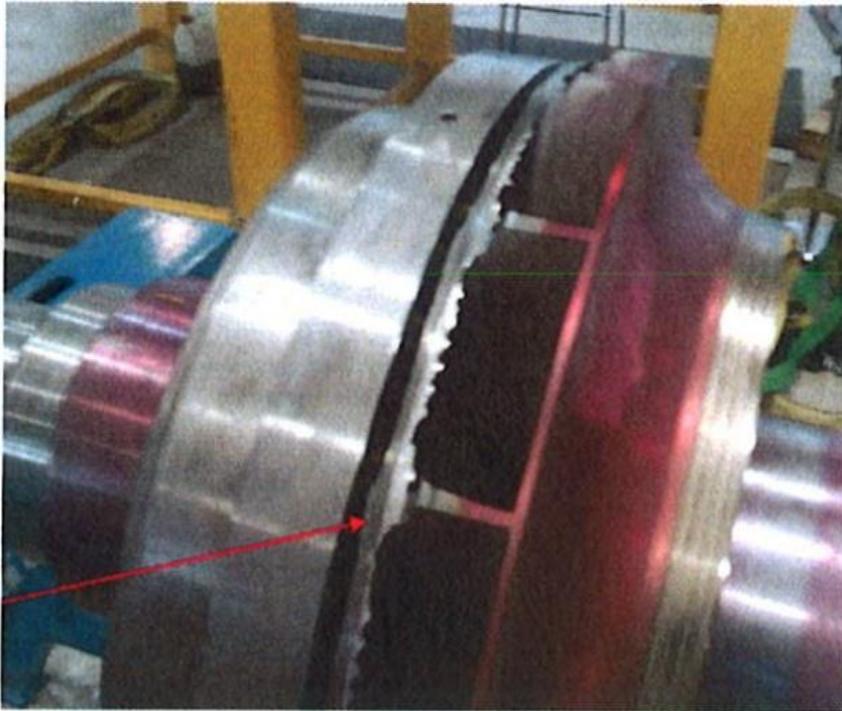
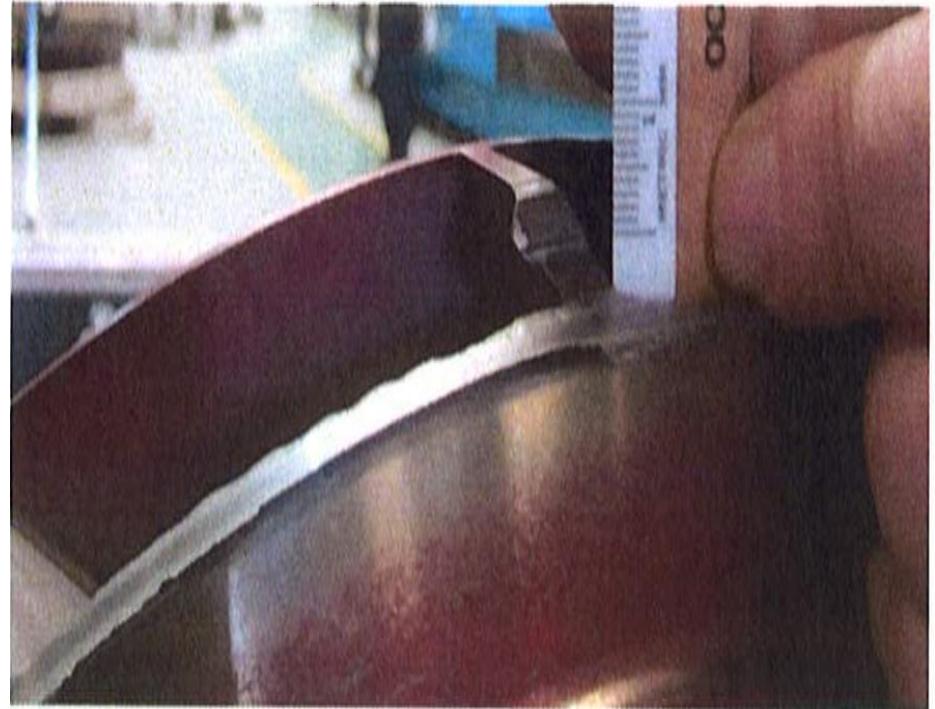
- ❖ The compressor was dismantled and found that outer diameter of the impeller was cut axially 18mm by the diffuser. The cut removed 16 mm from the impeller OD.

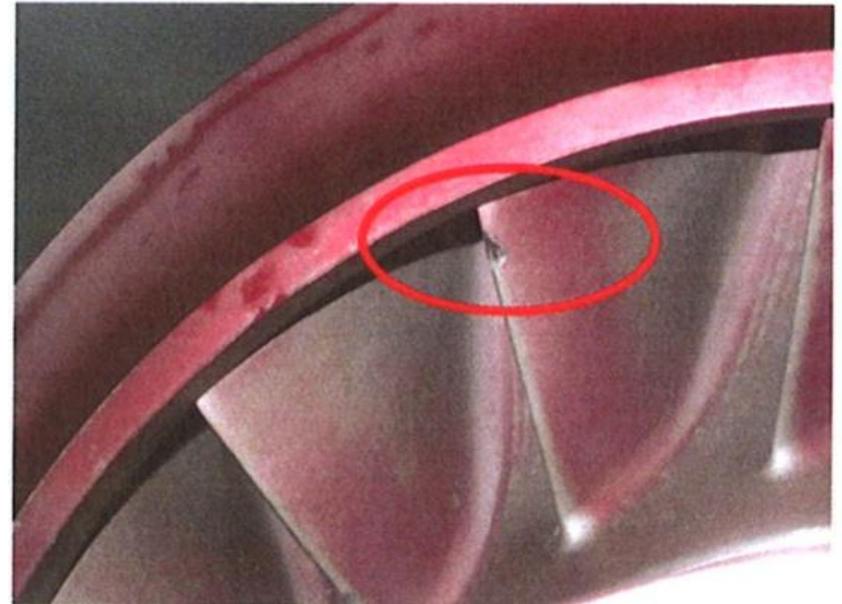
- ❖ At the impeller inlet one blade was found in significant damage and another 2 blades were with minor dents.
- ❖ Balance piston and all labyrinths are found in good condition
- ❖ The both radial and axial bearings were found in good condition.
- ❖ The missing bolt passed through the balancing line to the compressor suction and hit the impeller vane.

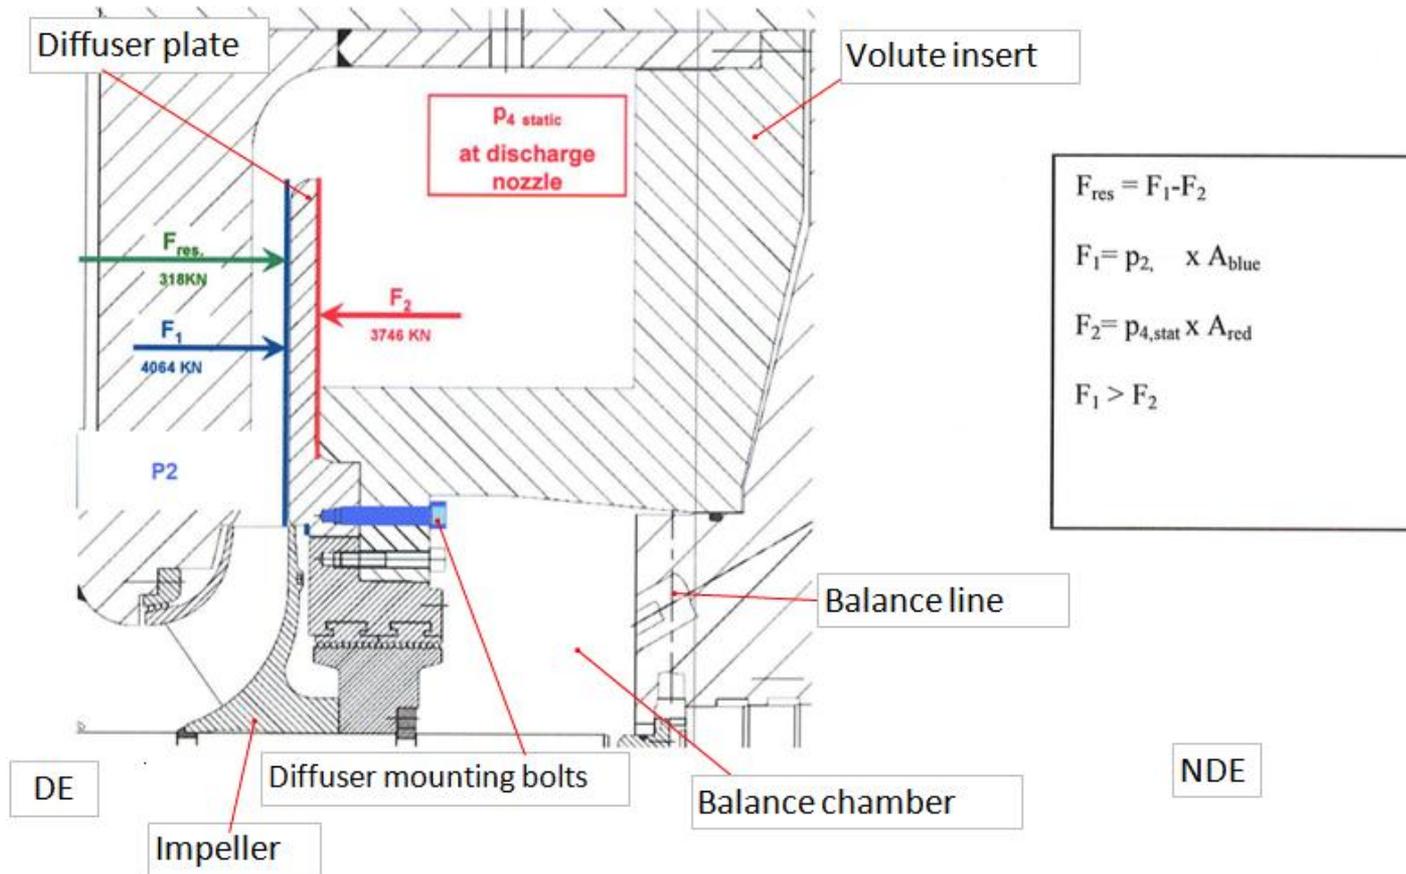
Diffuser Design

- The diffuser plate is fixed with 8 bolts. The resultant force during operation pushes the diffuser plate towards the NDE side of the compressor.

- ❖ The bolts holding the diffuser plate in position were not tightened properly.
- ❖ Additional area behind the diffuser was eventually exposed to discharge pressure (P4) effecting forces on the diffuser.
- ❖ The orientation of the resultant force on the diffuser changed to opposite direction (towards Drive End).
- ❖ The new resultant force exceeds the yield strength of the bolts.

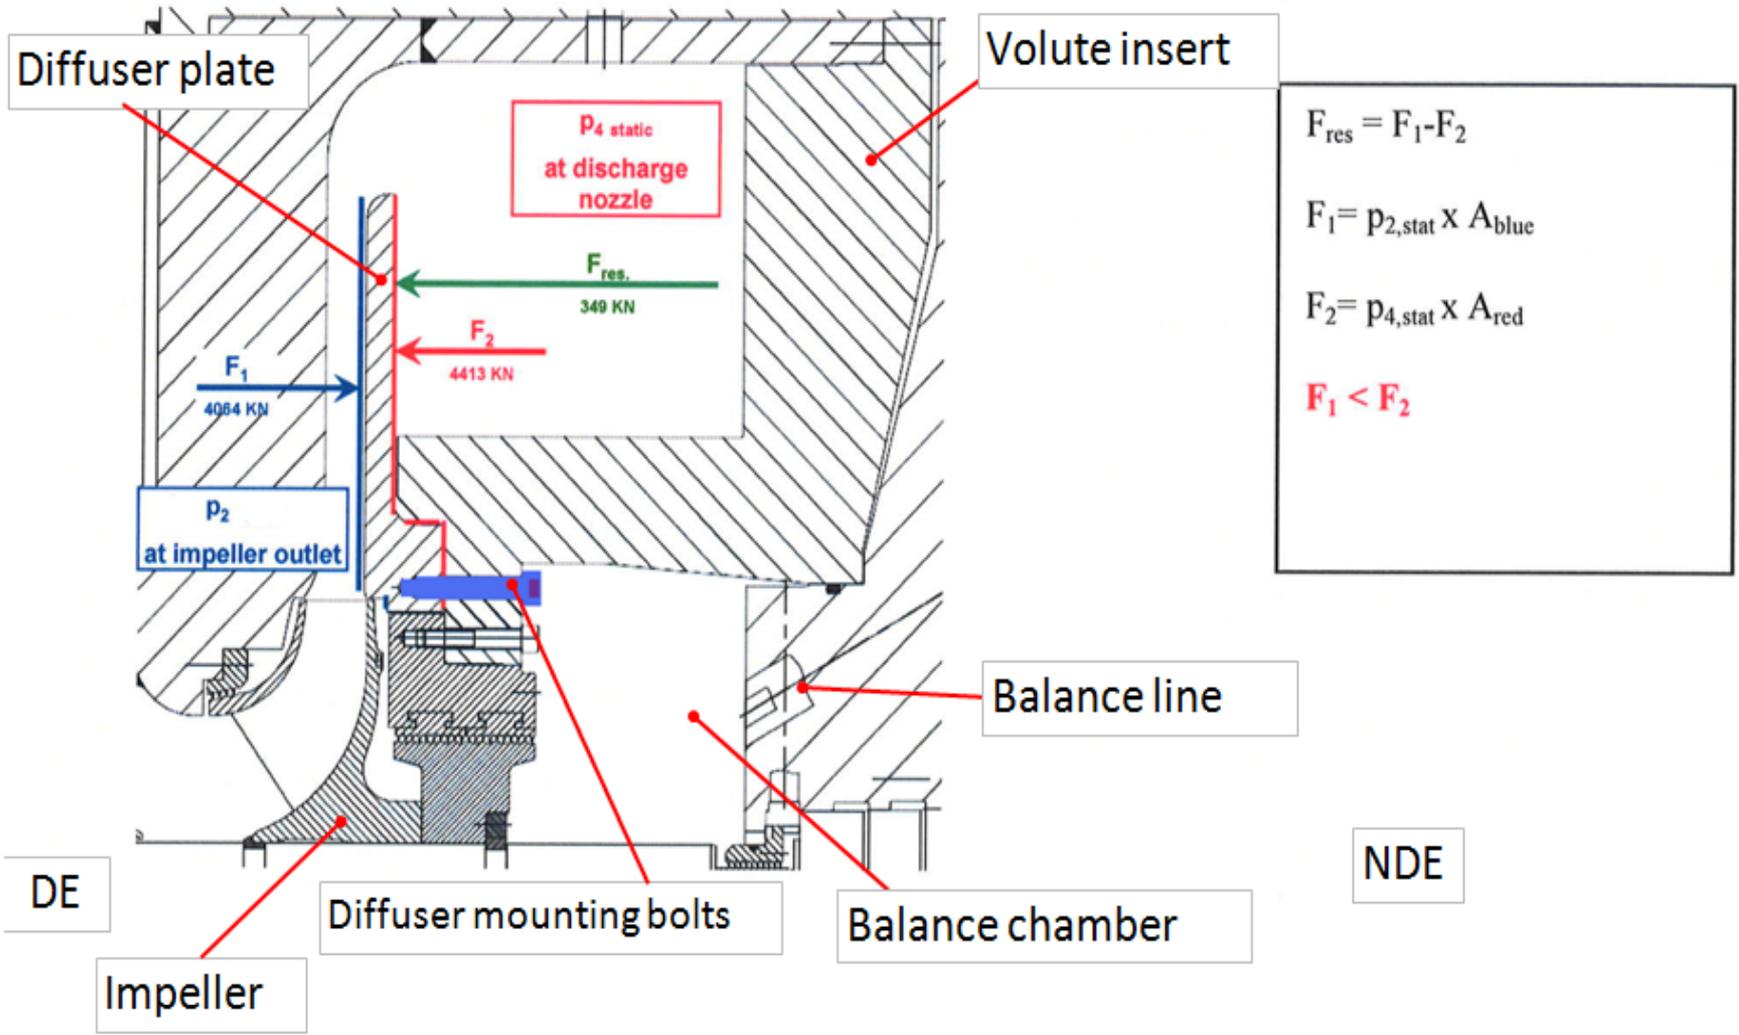
Root cause analysis –cont,

- ❖ The pressure in the balance chamber increased due to a bypass at location of missing bolt head and changed the axial position of the rotor.
- ❖ The diffuser plate pushed towards the impeller and caused the damage of the Rotor

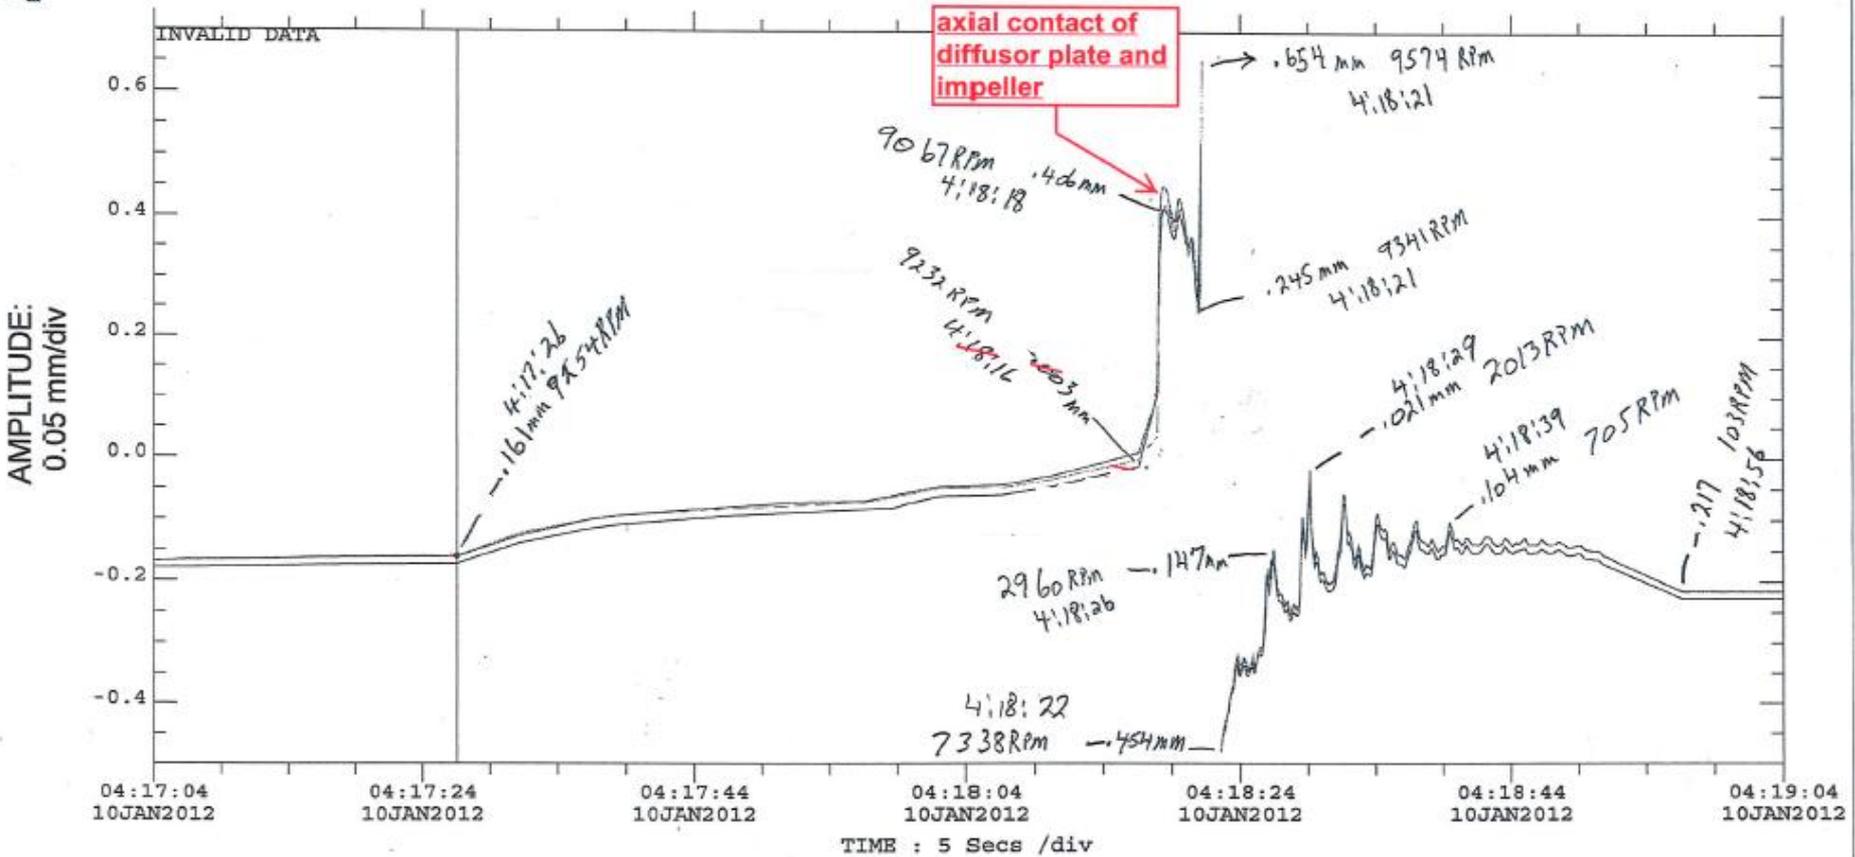
shaft displacement monitoring

Historical 10JAN2012 04:17:26 -0.161 mm 9254 rpm
 Historical
 Historical

- ❖ As per the trends analyzed, the failure is due to the bolts improper tightening.
- ❖ Metallurgical failure analysis also concludes that one bolt is fractured by fatigue and others are due to tensile over load.
- ❖ The OEM did not have as QC step for ensuring the diffuser bolts were properly tightened.
- ❖ There are no other evidences that could lead to this failure other than improper tightening.
