# Large Seawater Intake Pump Upgrades

Author: Ahmed Al Dossary

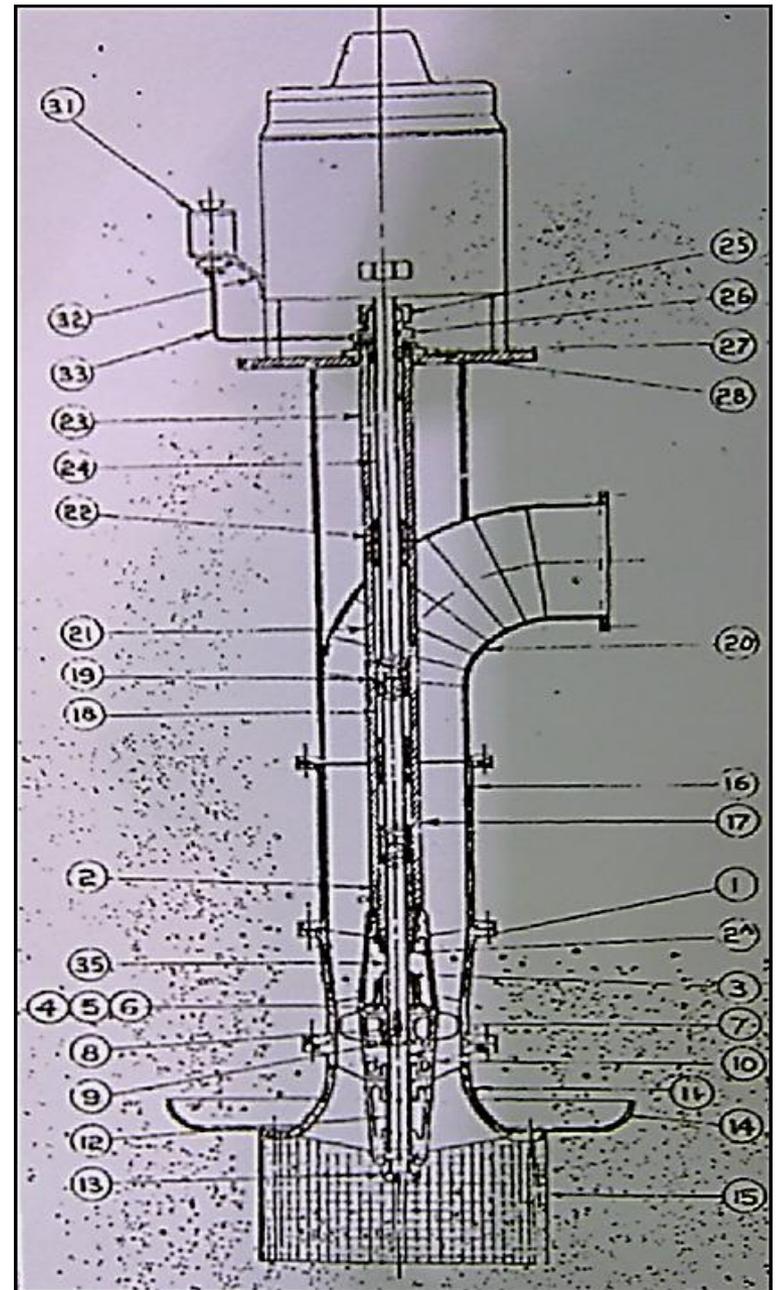
- Vertical pump with enclosed shaft tube.
- Flow rate 35,000 GPM.
- Over than 50 years old.
- Obsolete and no spare parts available.

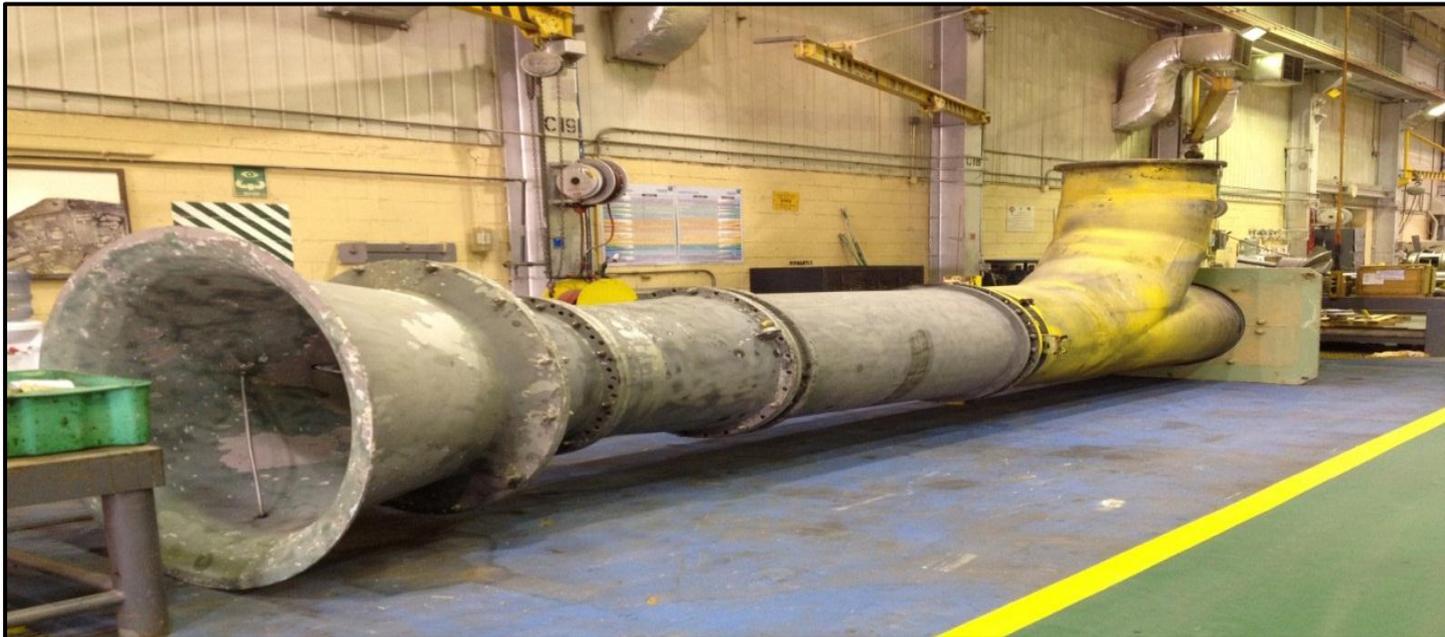
- Frequent pump seizure.
- Enclosed tube oil sealing failure and seawater contamination.
- Repeated failure in the bushings.
- Enclosed shaft tub difficult to fill due to improper venting.
- Pump head weak base plate.

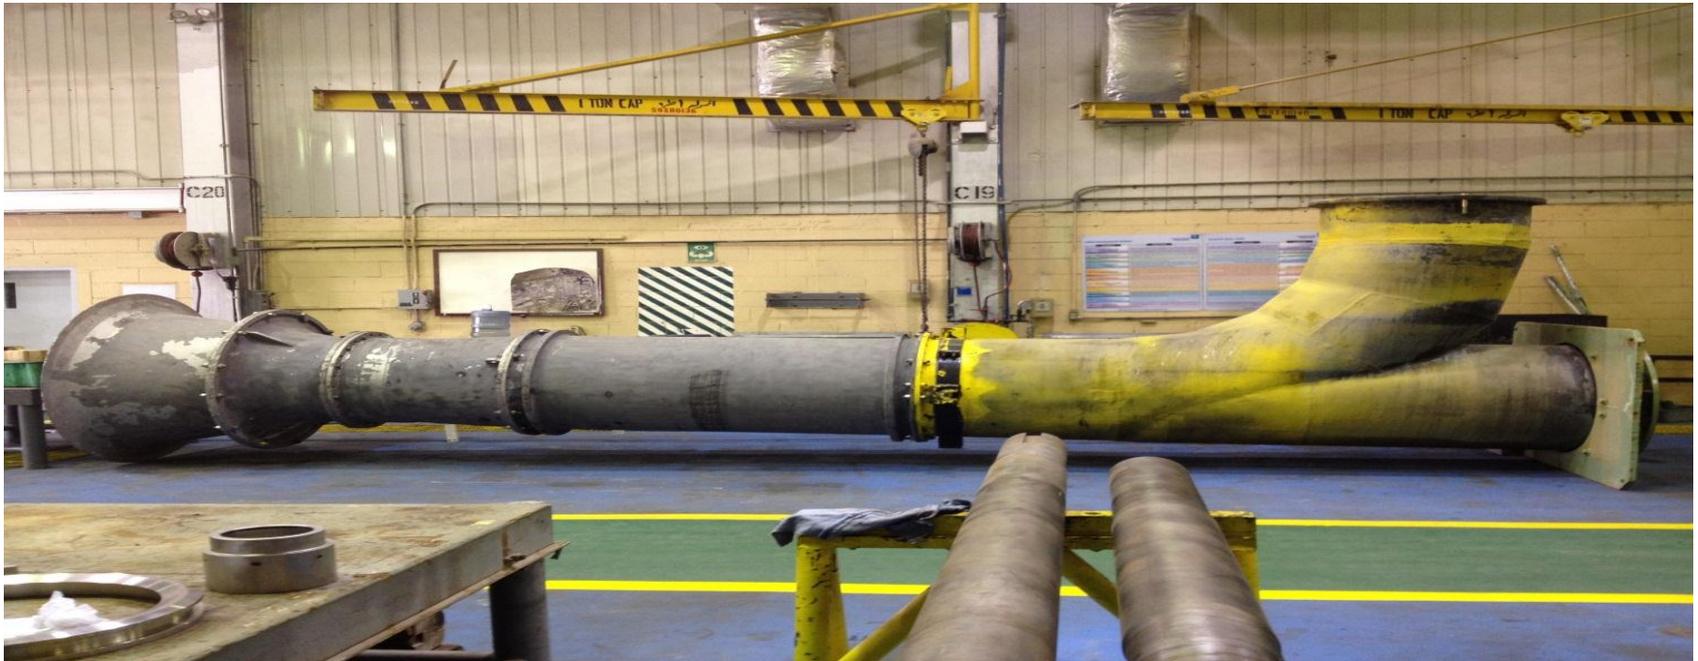
- Excessive rubbing on all bushings.
- Damaged O-ring at lower side of enclosed tube.
- Oil leak between enclosed tubes.
- Lack of lube oil at enclosed tube.

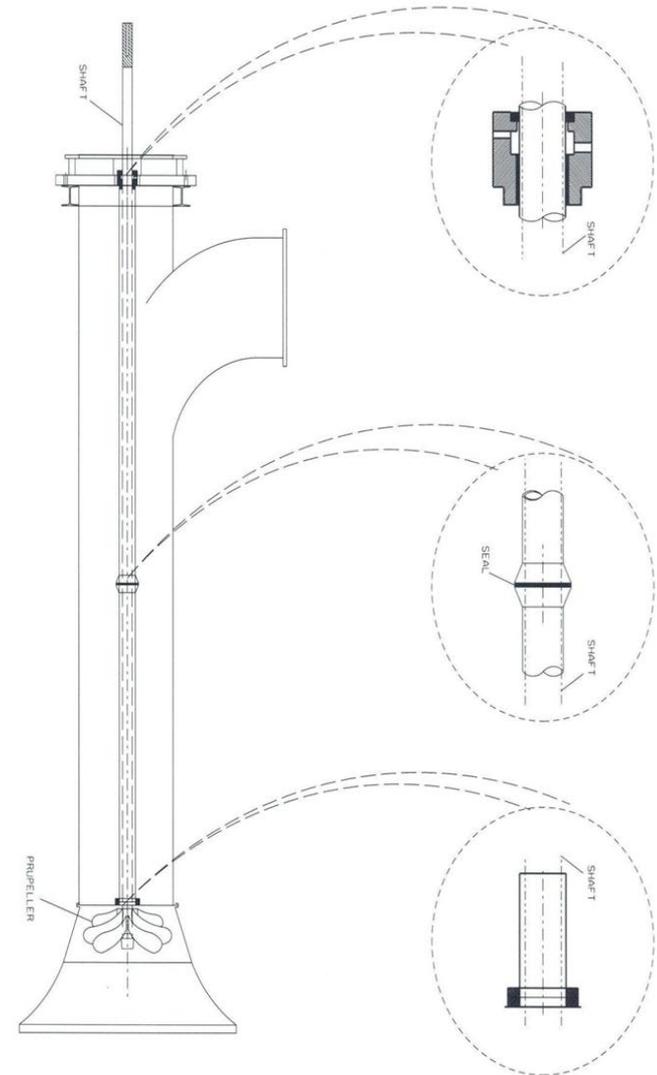
- Insufficient oil flow in the stuffing box.
- Upper bushing is not totally submerged in the oil.
- Oil leak between enclosed tubes segments.
- Insufficient oil flow between un-grooved bushings.
- Repetitive oil leaks from lower side tube O-ring.
