Resolving Intermittent Vibration Spikes on Steam Turbines

Rajakumar Thiagarajan

Rotating Equipment Engineer

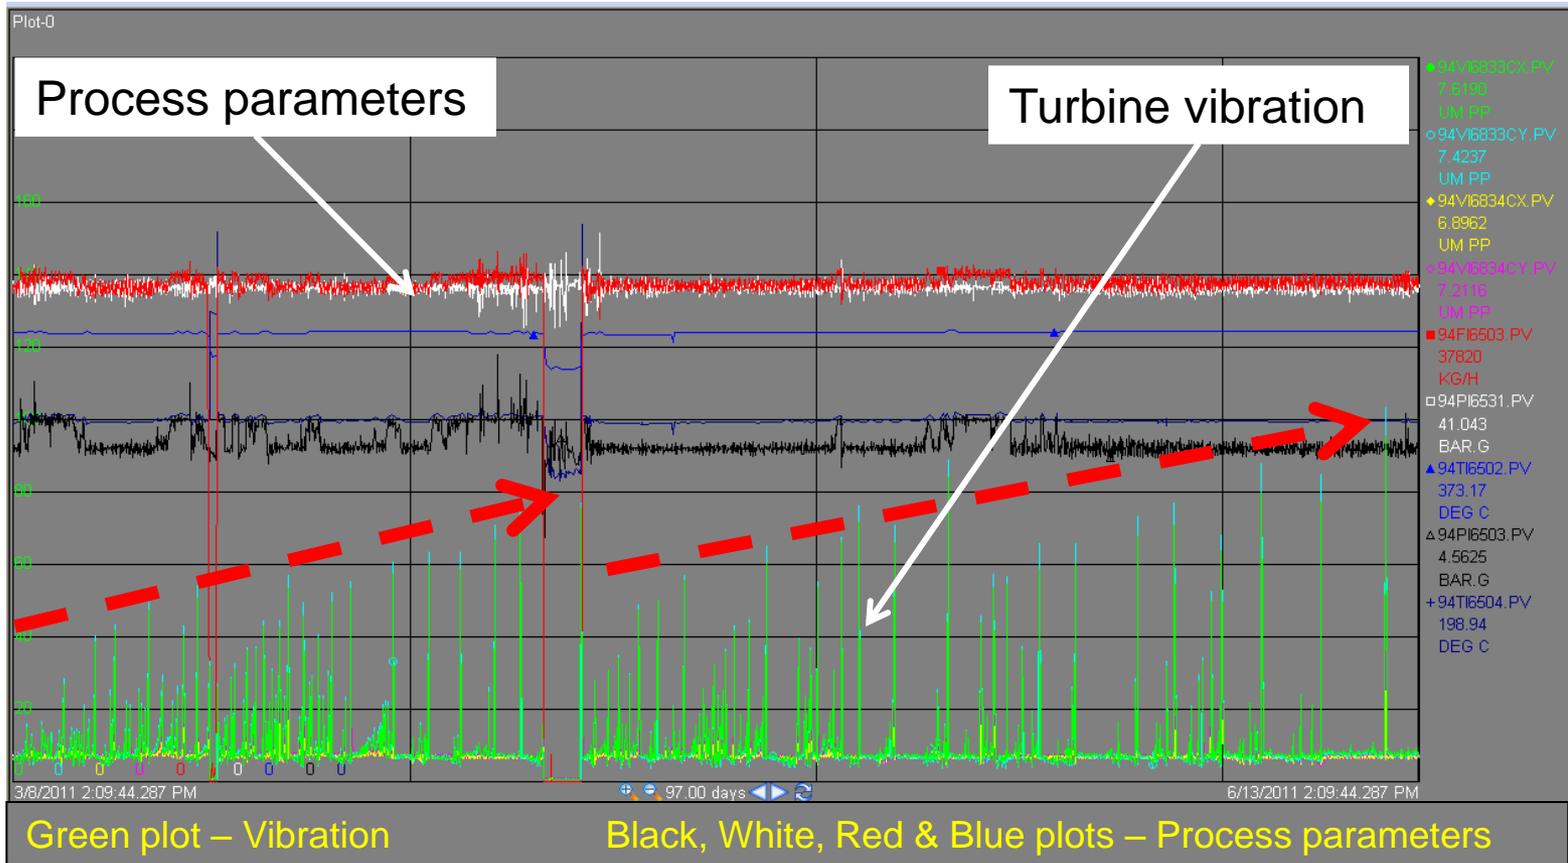
Overall Vibration vs. Process data

- Vibration is on the increasing trend and trips on high vibration
- No correlation with the process parameters

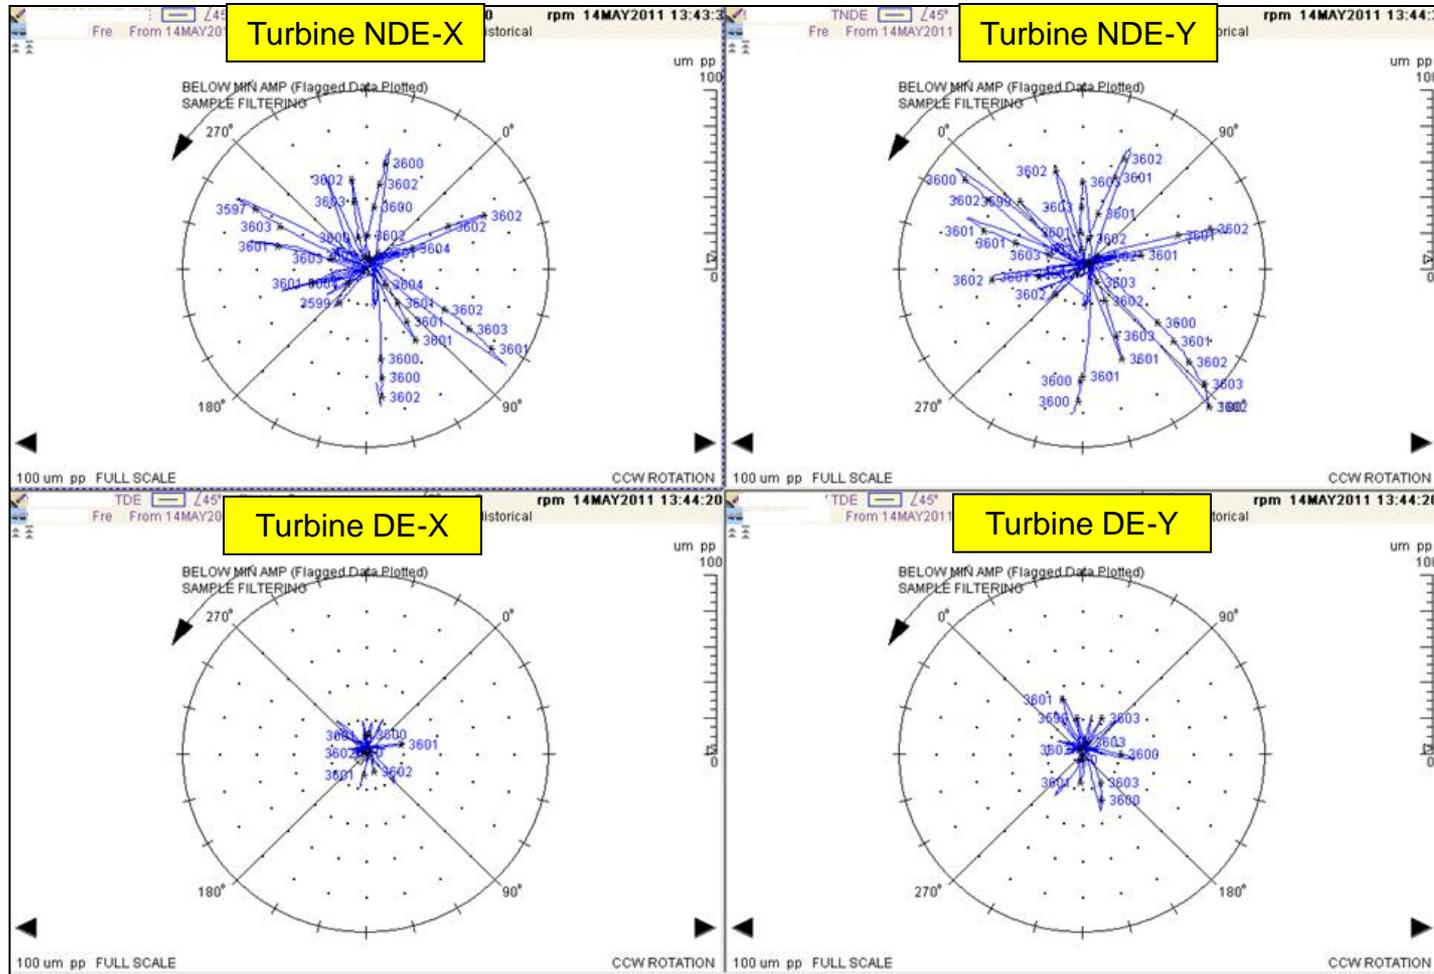
Polar Plot – 1X Amplitude & Phase Angle

Abnormal Behavior – Significant Phase Angle Change During Steady State (All Over 360°)

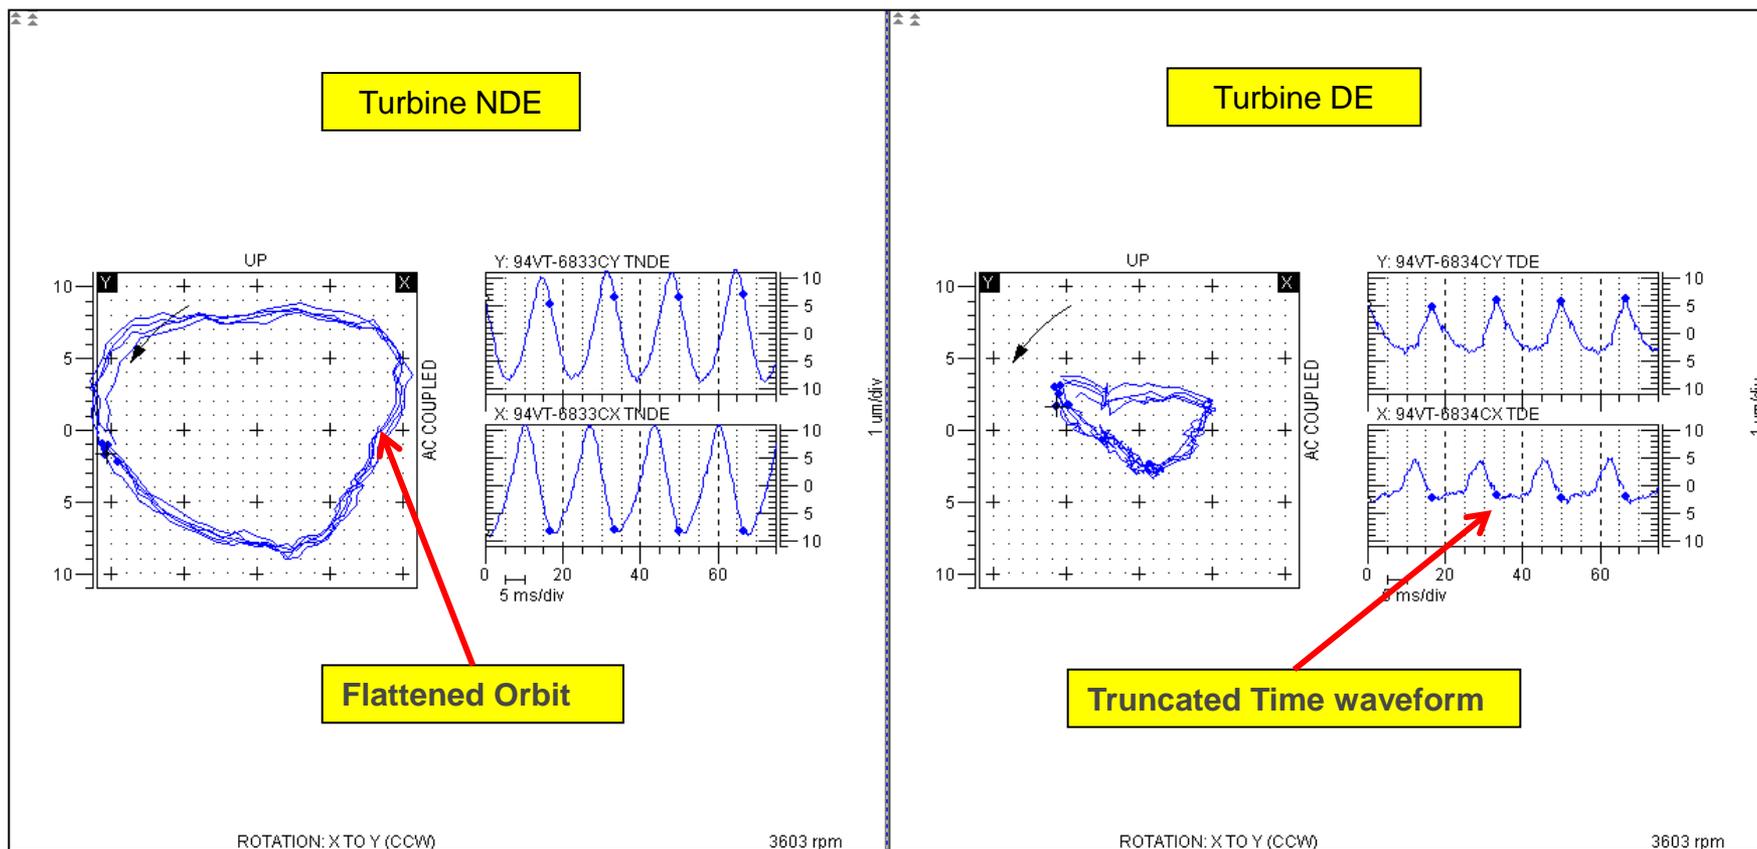
Direct Orbit Review During Vibration Excursion

Flattened Orbit & Truncated Time Waveform due to Rub

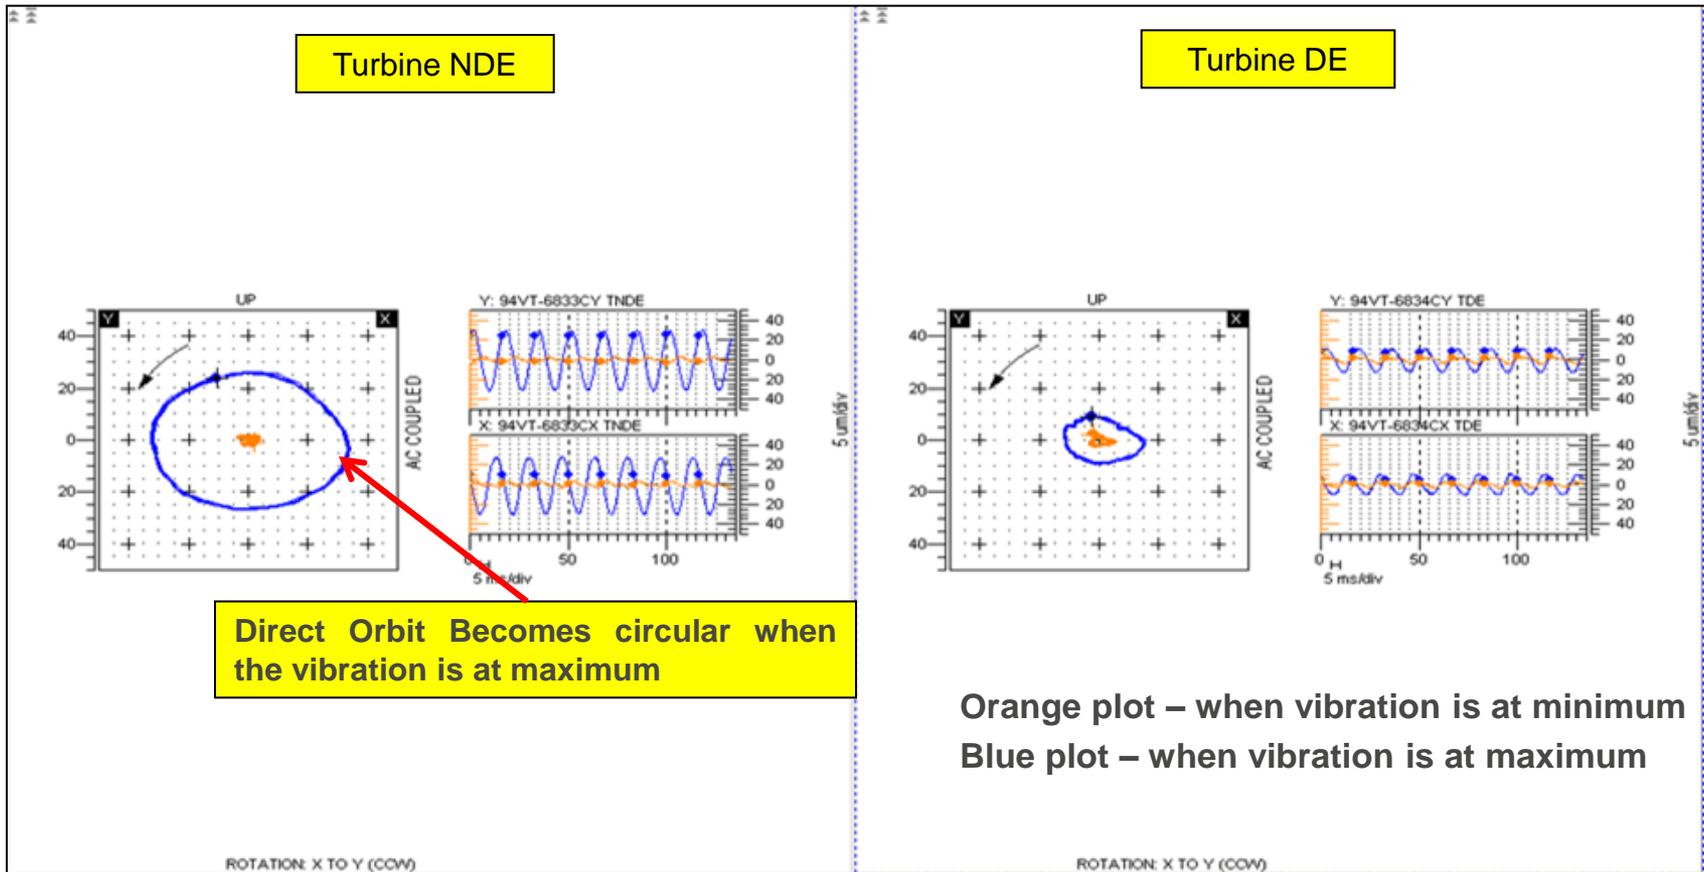
Direct Orbit Overlay – Comparison of Low & High Vibration Amplitudes

Significant change in the Orbit Shape & Amplitude

(Change in Balance Condition Due to Thermal Bow)

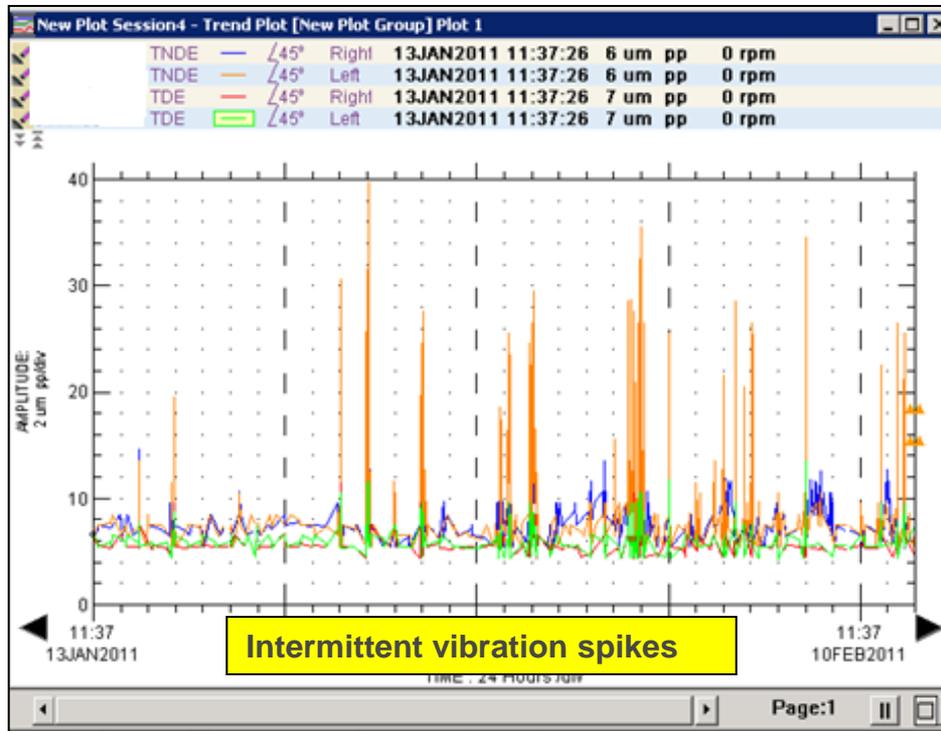
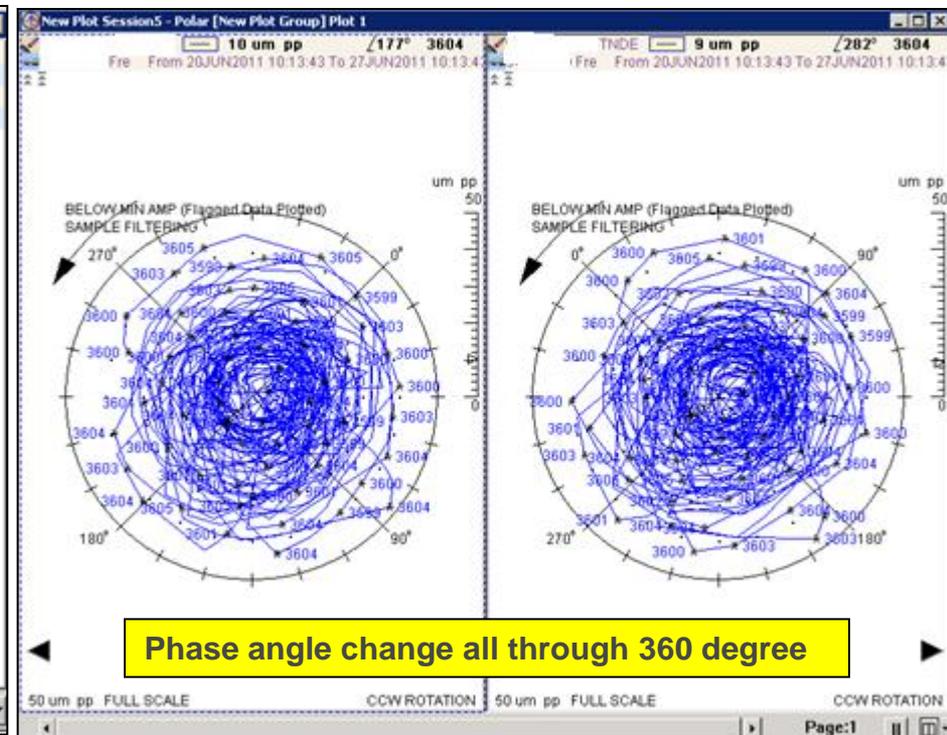
Vibration Trend and Polar Plot – Reviewed for 2nd Steam Turbine

Similar Behavior - Intermittent vibration Amplitude & Change in Phase Angle

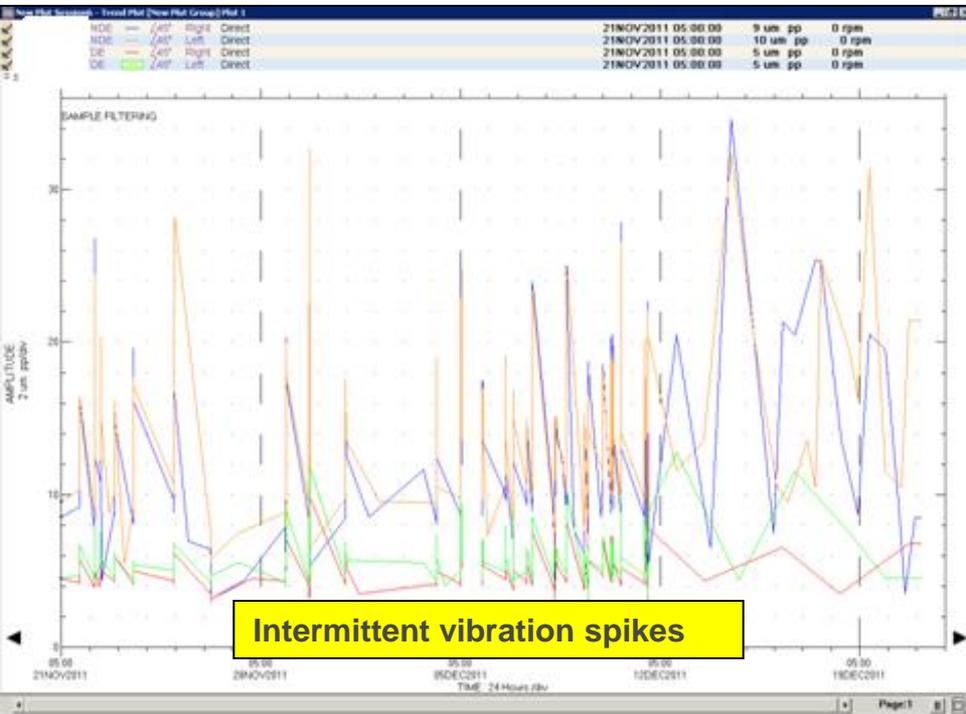
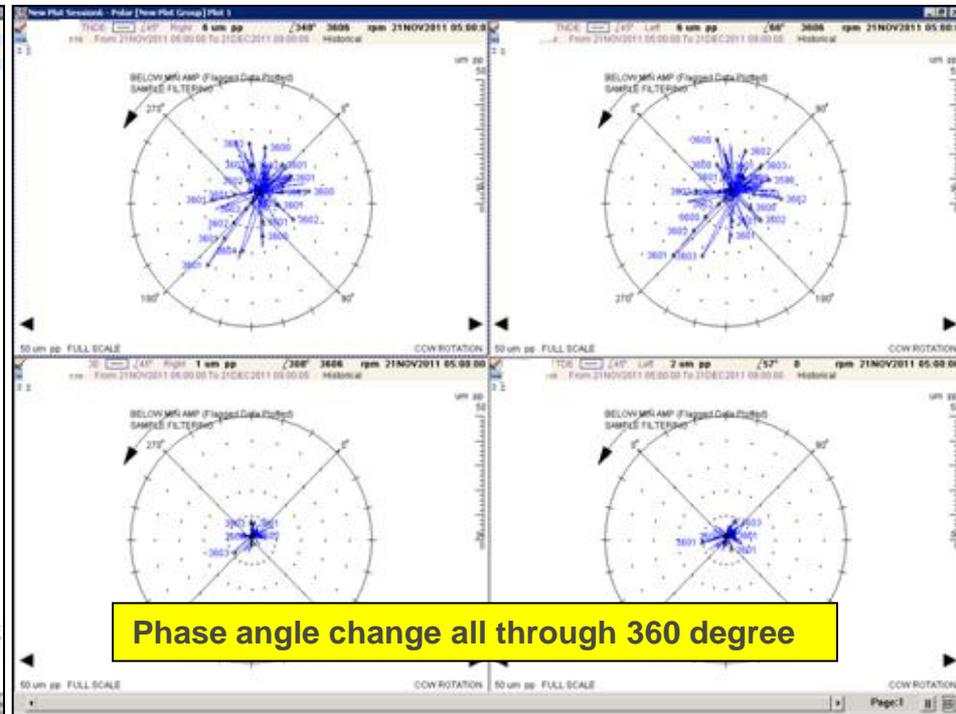
Vibration Trend and Polar Plot – Reviewed for 3rd Steam Turbine

Similar Behavior But Less Severity - Intermittent vibration Amplitude & Change in Phase Angle

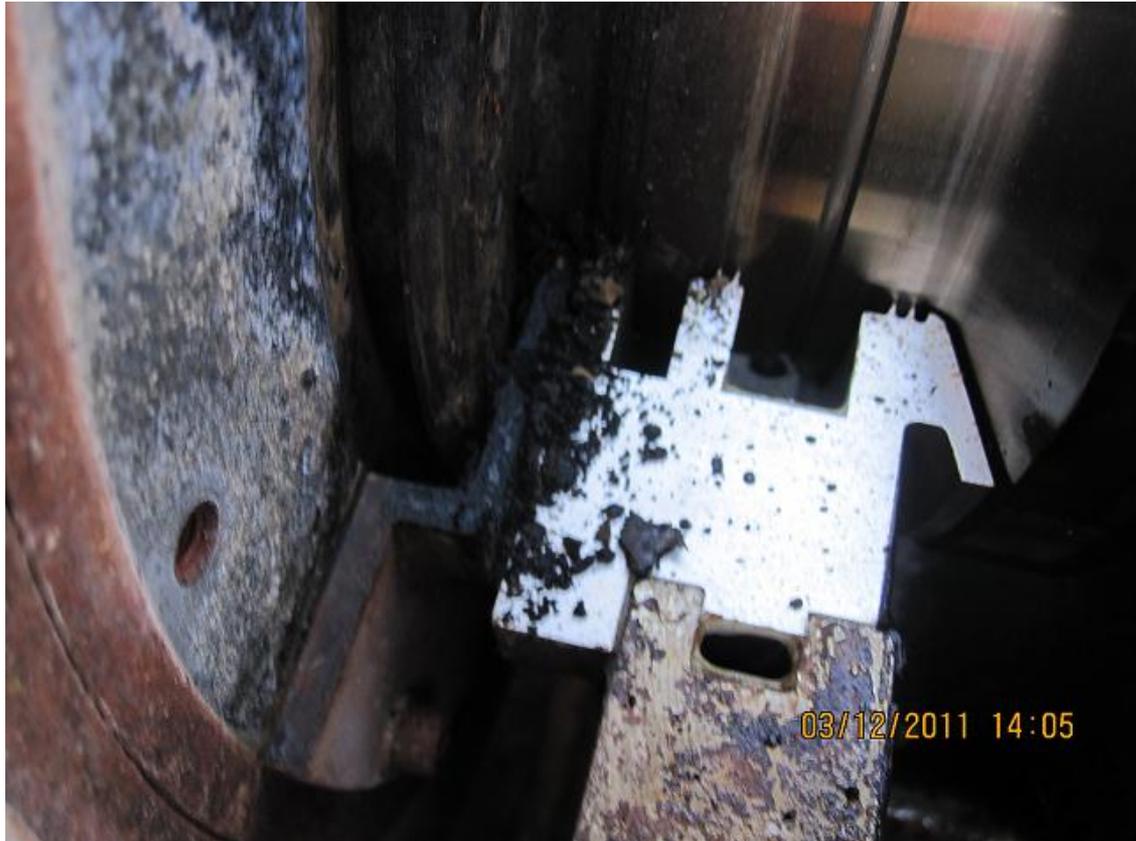
- *Carbonized oil buildup in the oil deflector / seal area.*

Carbonized deposits at NDE seal area

Rubbing Marks at the seal area due to oil carbonization is evidenced.

- ✓ *Inspect oil/steam seal areas for rubbing marks due to deposit built-up / carbonized oil.*

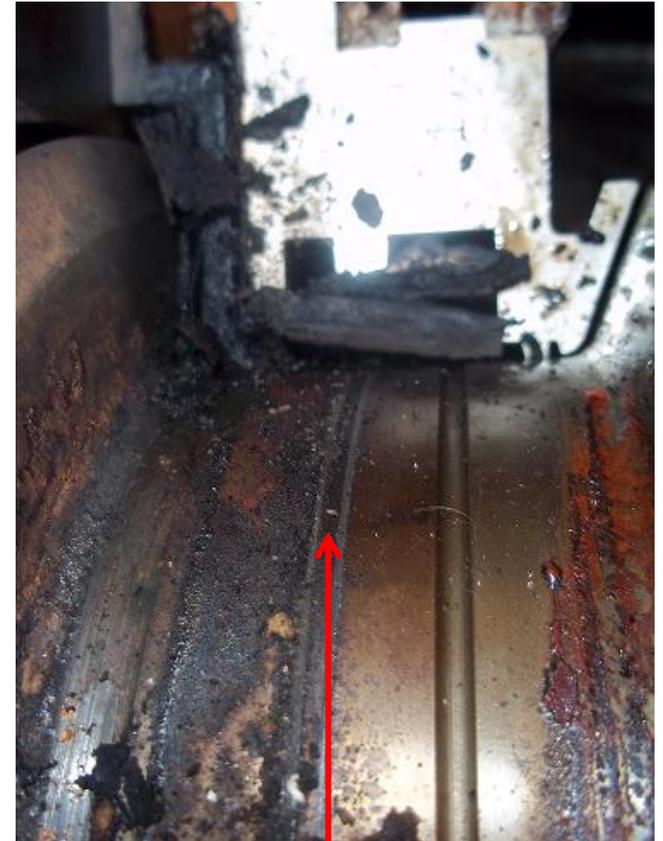
Rubbing Marks on the shaft

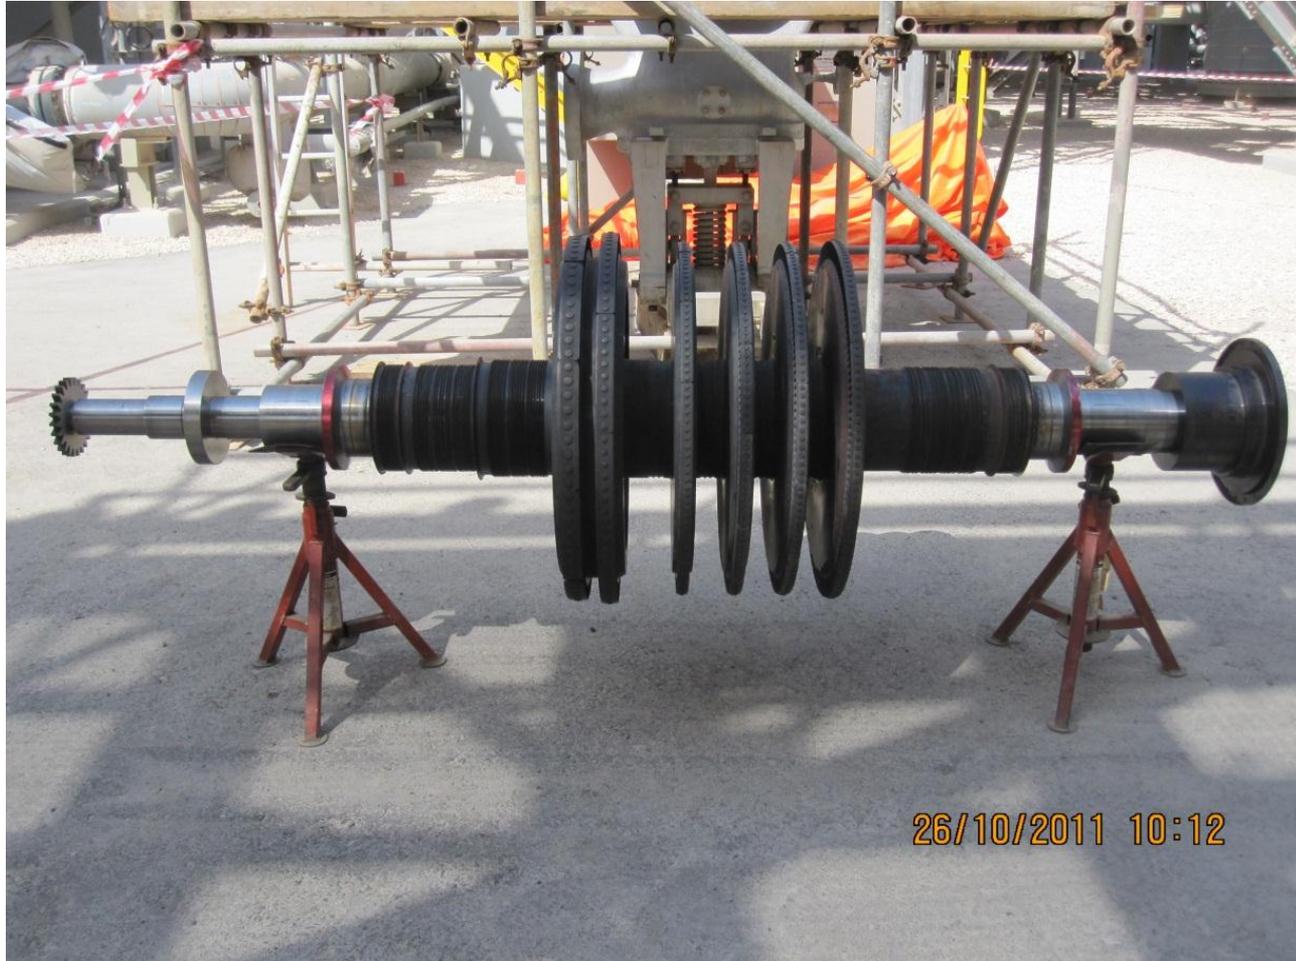
Rotor Internals of 1st Turbine

No abnormalities noticed on the Rotor internal components.

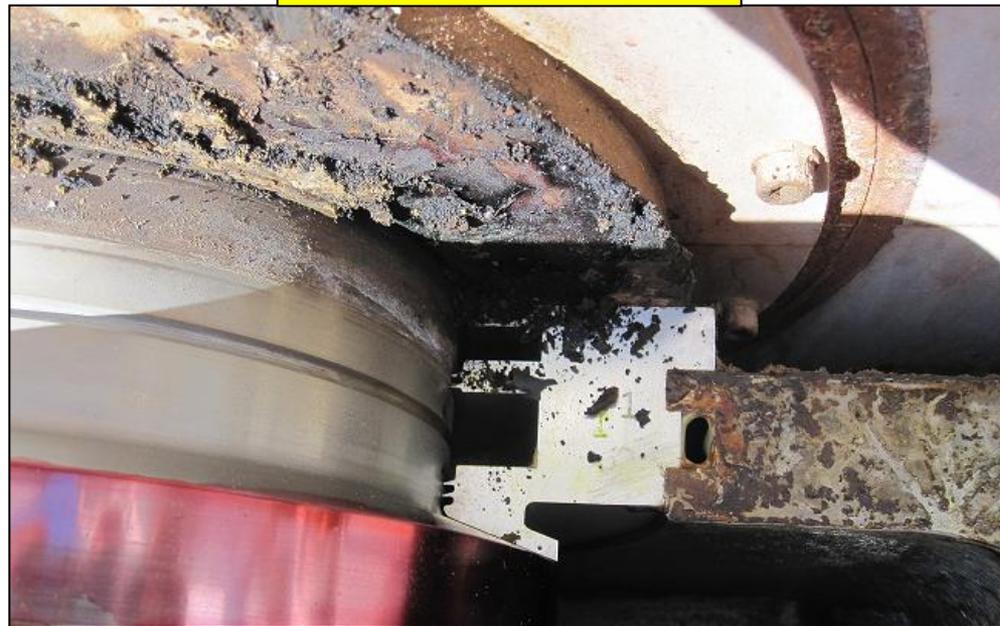
Seal Area of 2nd Turbine

- Oil Carbonization deposits and Rubbing Marks at the seal area
- Based on the inspection results of 1st Turbine, no internal checks carried out for the 2nd & 3rd Machines
