Separation Seal Upgrade to overcome Repetitive Failures

Author : [RasGas](#)

[Pradip B Sonavane](#)

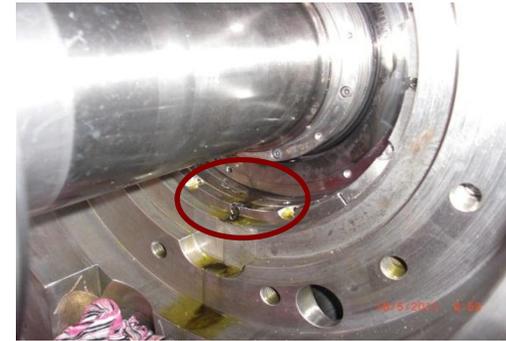
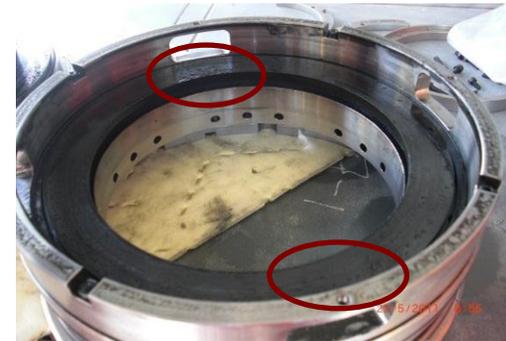
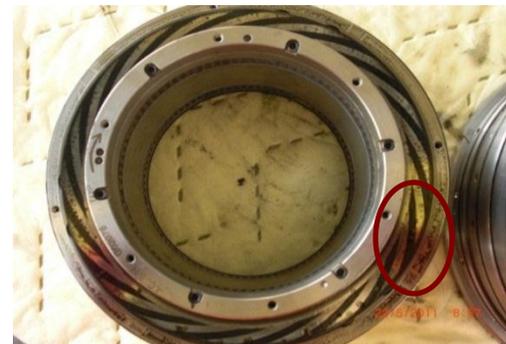
- Lube oil accumulation inside seal bore
- High/hard spots
- Sharp edge / Irregularities
- Oil film on Secondary seal ring faces

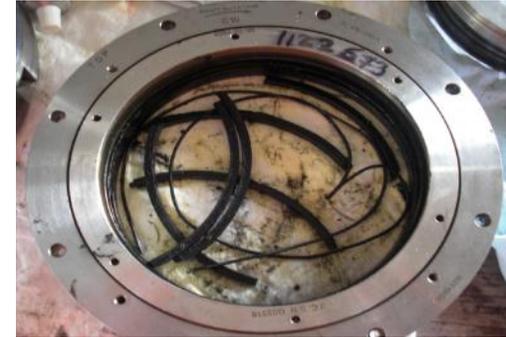
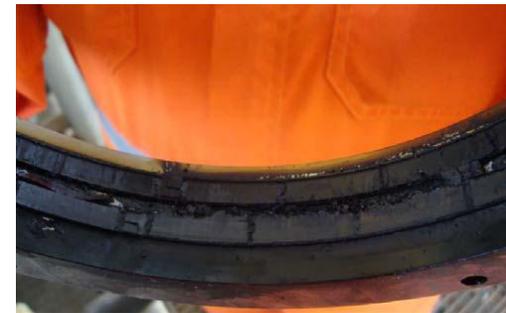
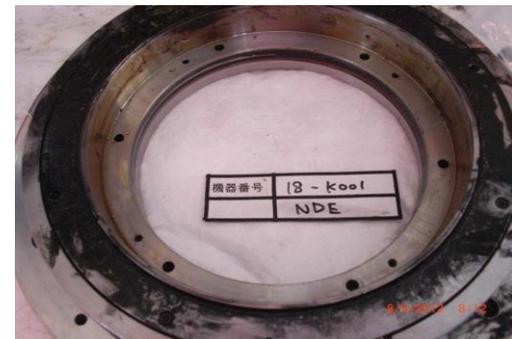
- Separation seal carbon segments in damaged and dislocated condition
- Worn out seal rings
- Carbon deposit

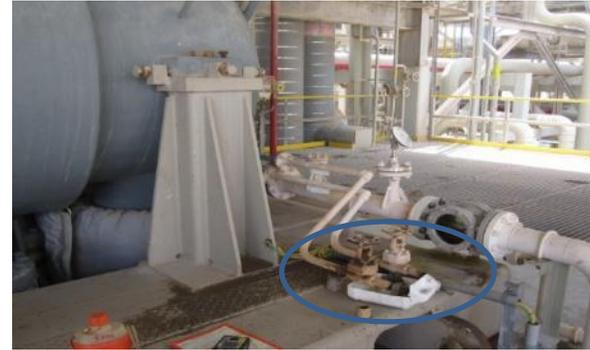
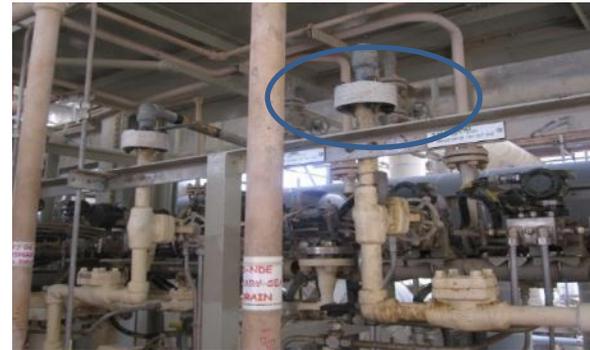
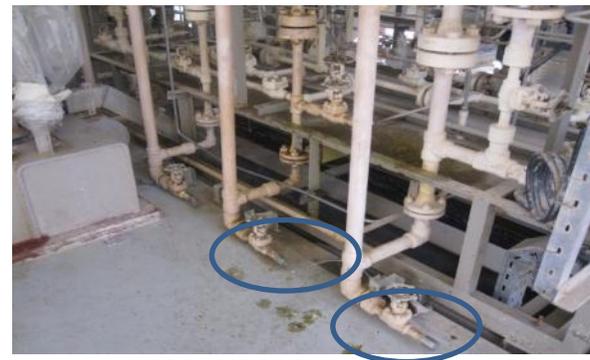
- Excess oil collected from both Primary & Secondary drain line
- Oil reached up to primary vent line
- Oil collected from vent line drain points

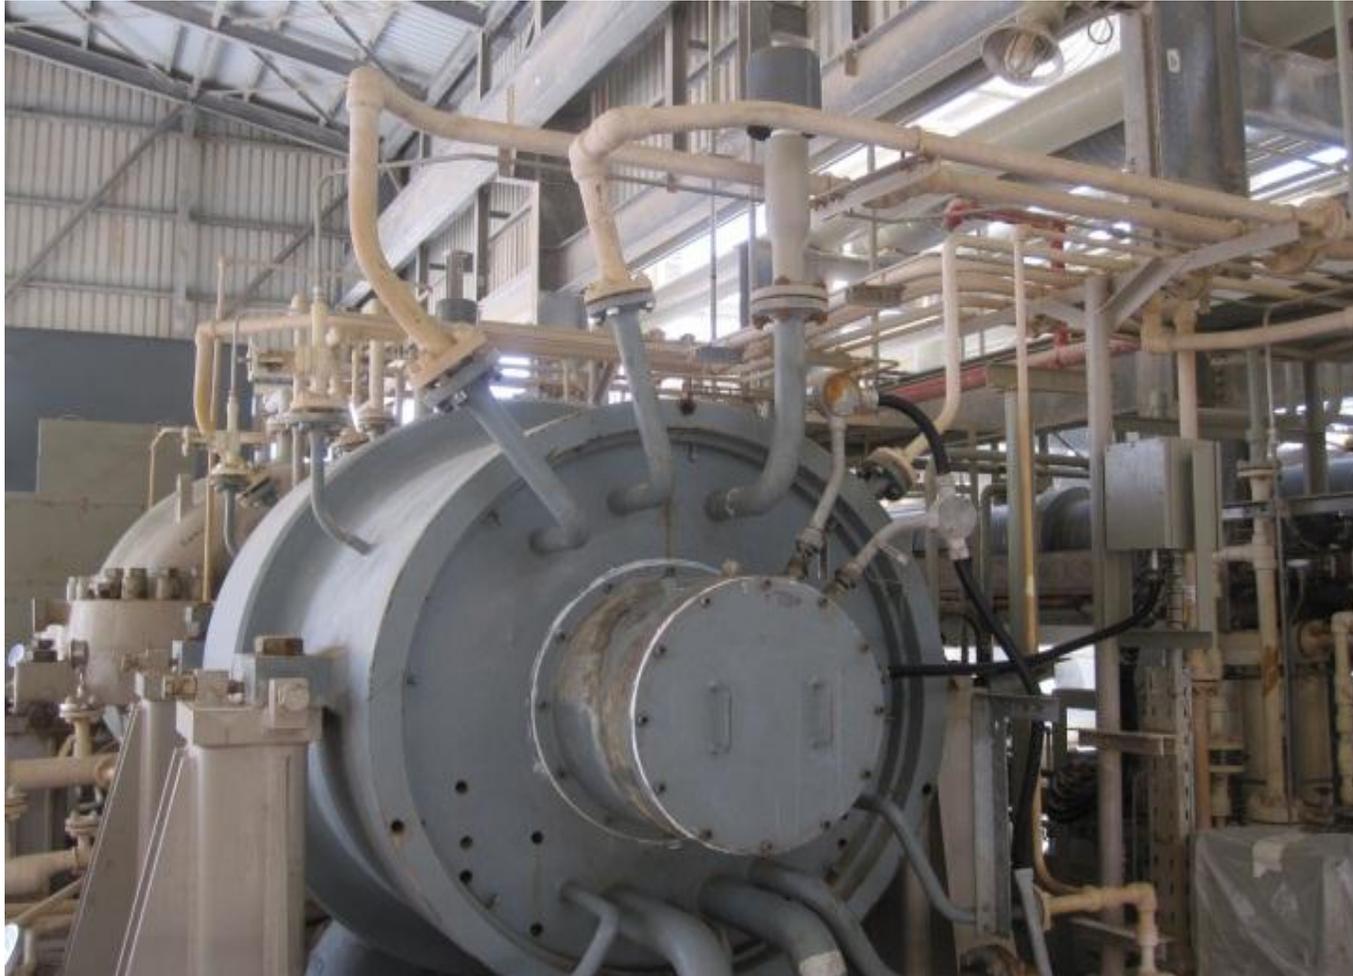
- Lube Oil migration issue found more severe at NDE (Thrust Bearing) relative to DE (Non Thrust) DGS assembly.
