Reliability Improvement for Turboexpander-Compressor System

Marc S. LeDuc Atlas-Copco Mafi-Trench Co. Hassan A. Mazi Saudi Arabian Oil Company

Hawiyah NGL Plant

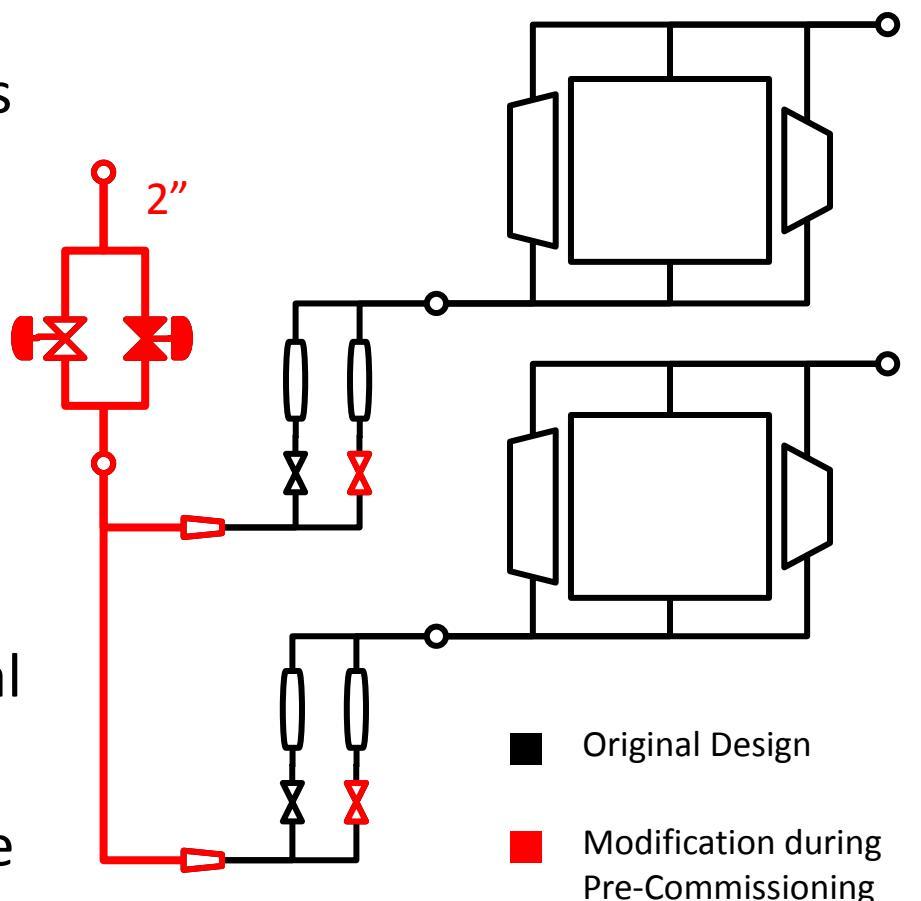
Challenge 1: Description

- Piping vibration at seal gas supply valves.
- → Increased valves and piping from 1" to 2" for stiffness.

- High dP across on-skid seal gas filters.
- 2. Potential machine trip due to low seal gas dP.

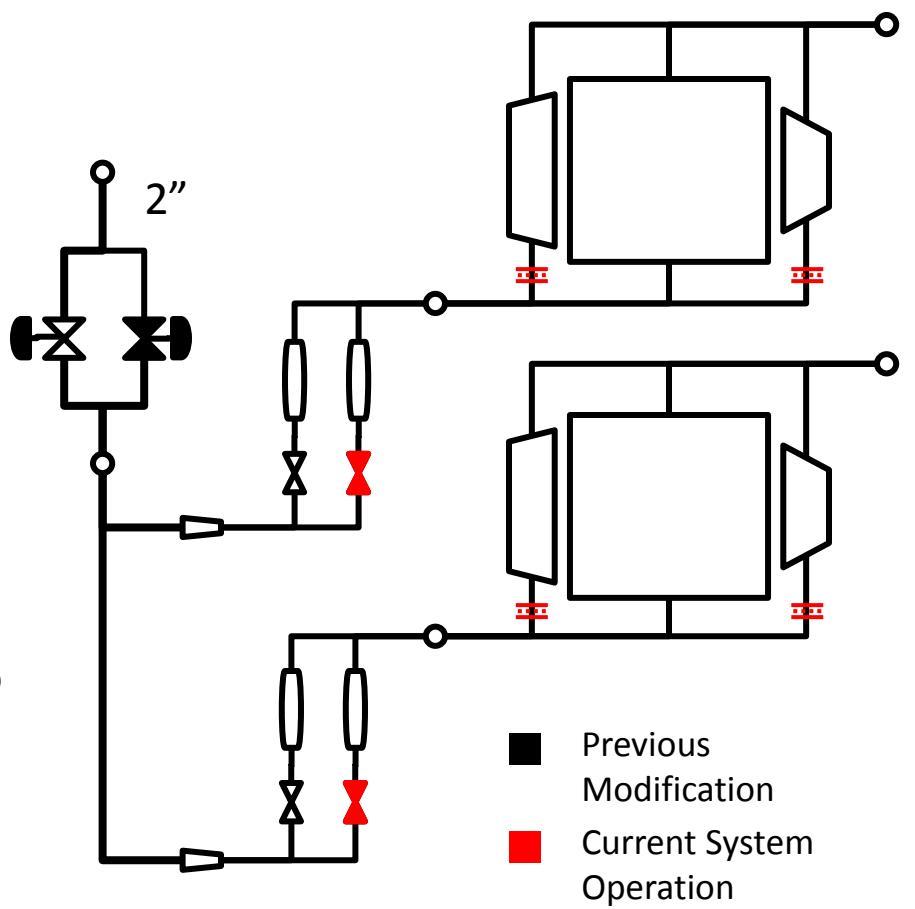
Cooling gas flow could be reduced, such that bearings temperatures remain < 230 °F.

Reduced the size of internal orifices to 1/8" to restrict the cooling gas flow.

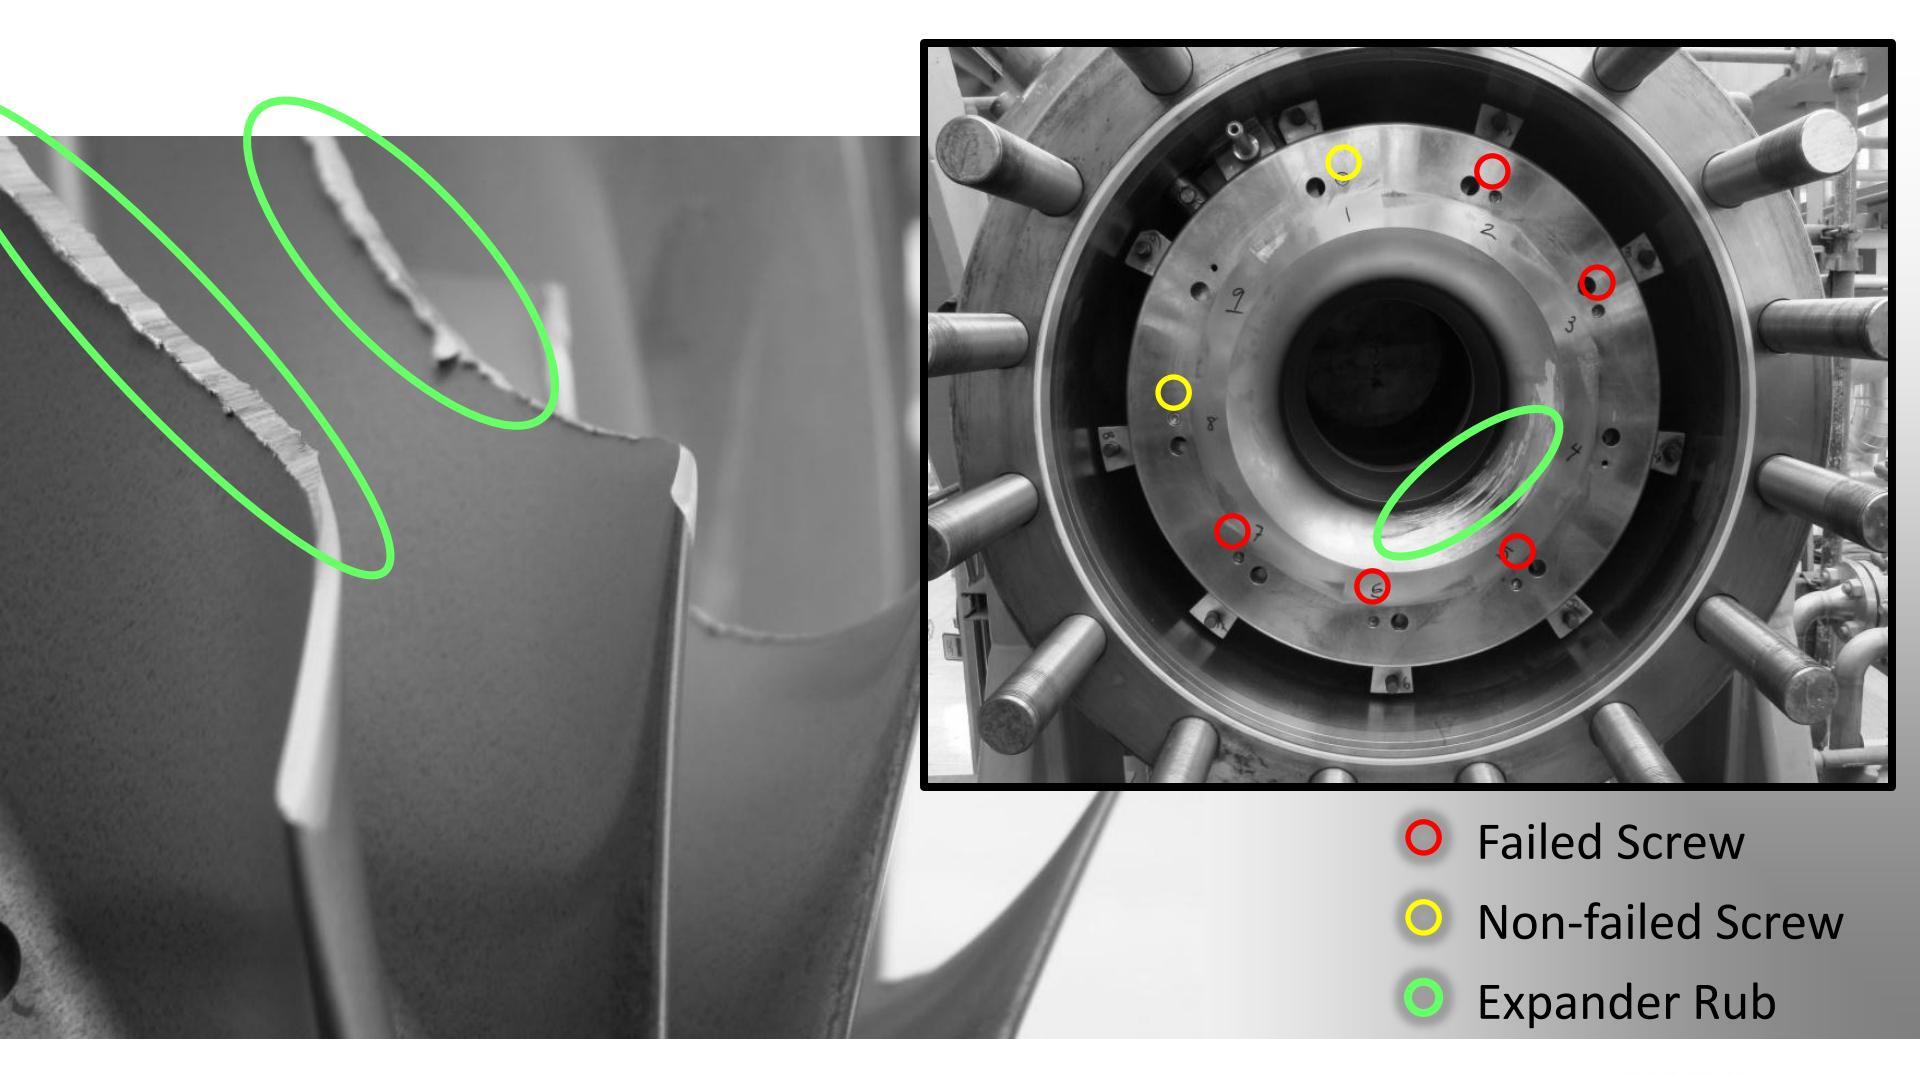
Challenge 2: Internal Inspection

- Some machines could not be placed back online after planned shut down.
- Once started up, machines exhibited high magnetic bearing current on expander side.
- When the machine was shut down, high current still persisted.
- Lateral shaft translation by AMB control system was necessary to restore magnetic bearing parameters to acceptable levels.

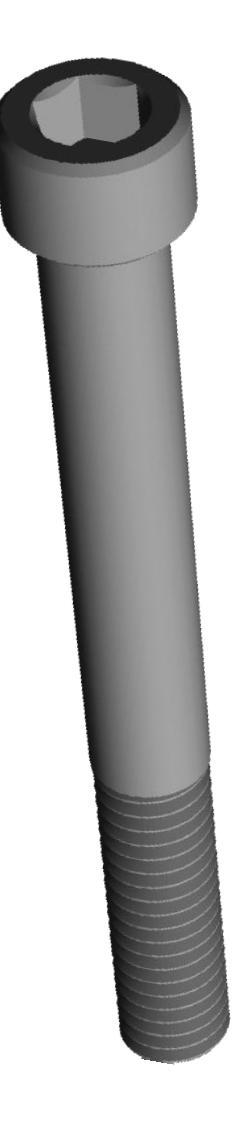
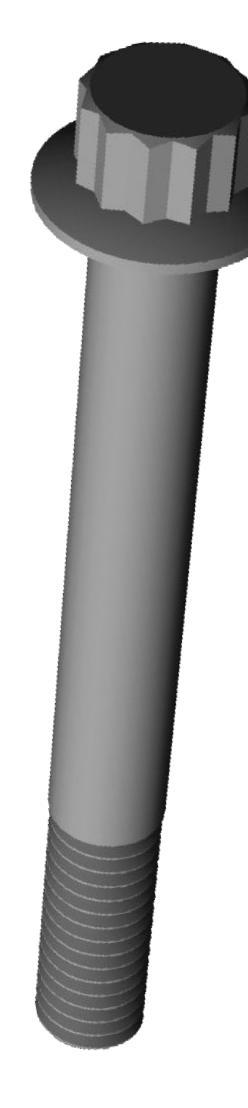
Old vs. New Screws

Cap Screw Design

Fillet between head and Shank

Small radius	Larger radius
	Beveled washer

A320-L7	A286
	个 60% tensile
	个 500% fatigue

- Modified expander follower design:
 - a) Adjusted component geometry to ensure mounting stability of IGV assembly members.
 - b) Improved mounting screw material and geometry.

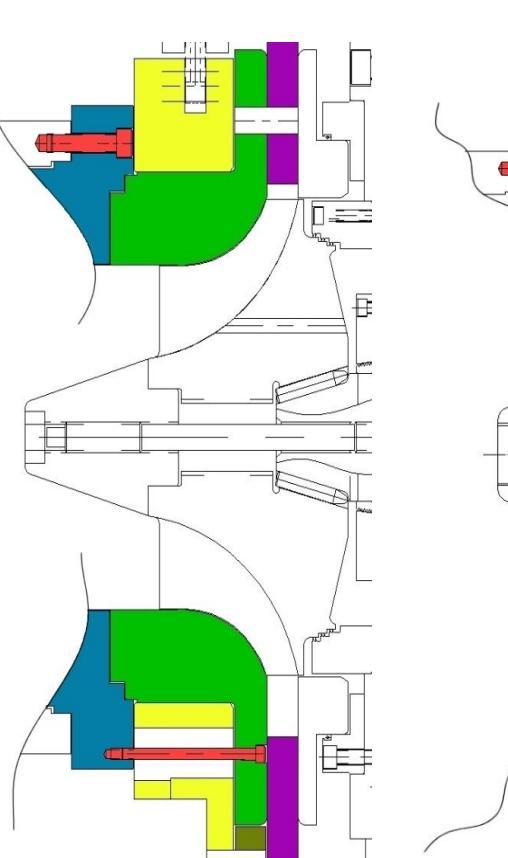
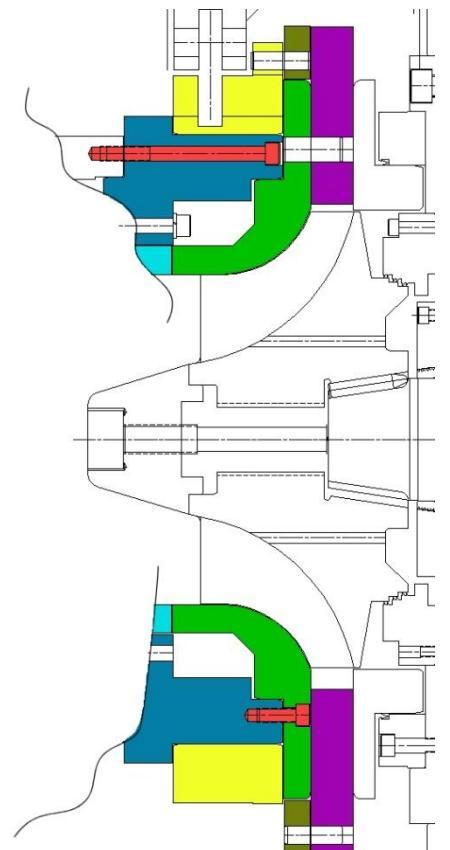
Original Design

Modified Design
