Fr7AE Gas Turbines
Dry Low-NOx Combustion System
Operating Challenges in O&G Plants

Atul W. Deshpande – RasGas
Luis A. Rojas – RasGas
V. Venkatachallam – RasGas
Mustapha Chelghoum – RasGas

Executive Summary:

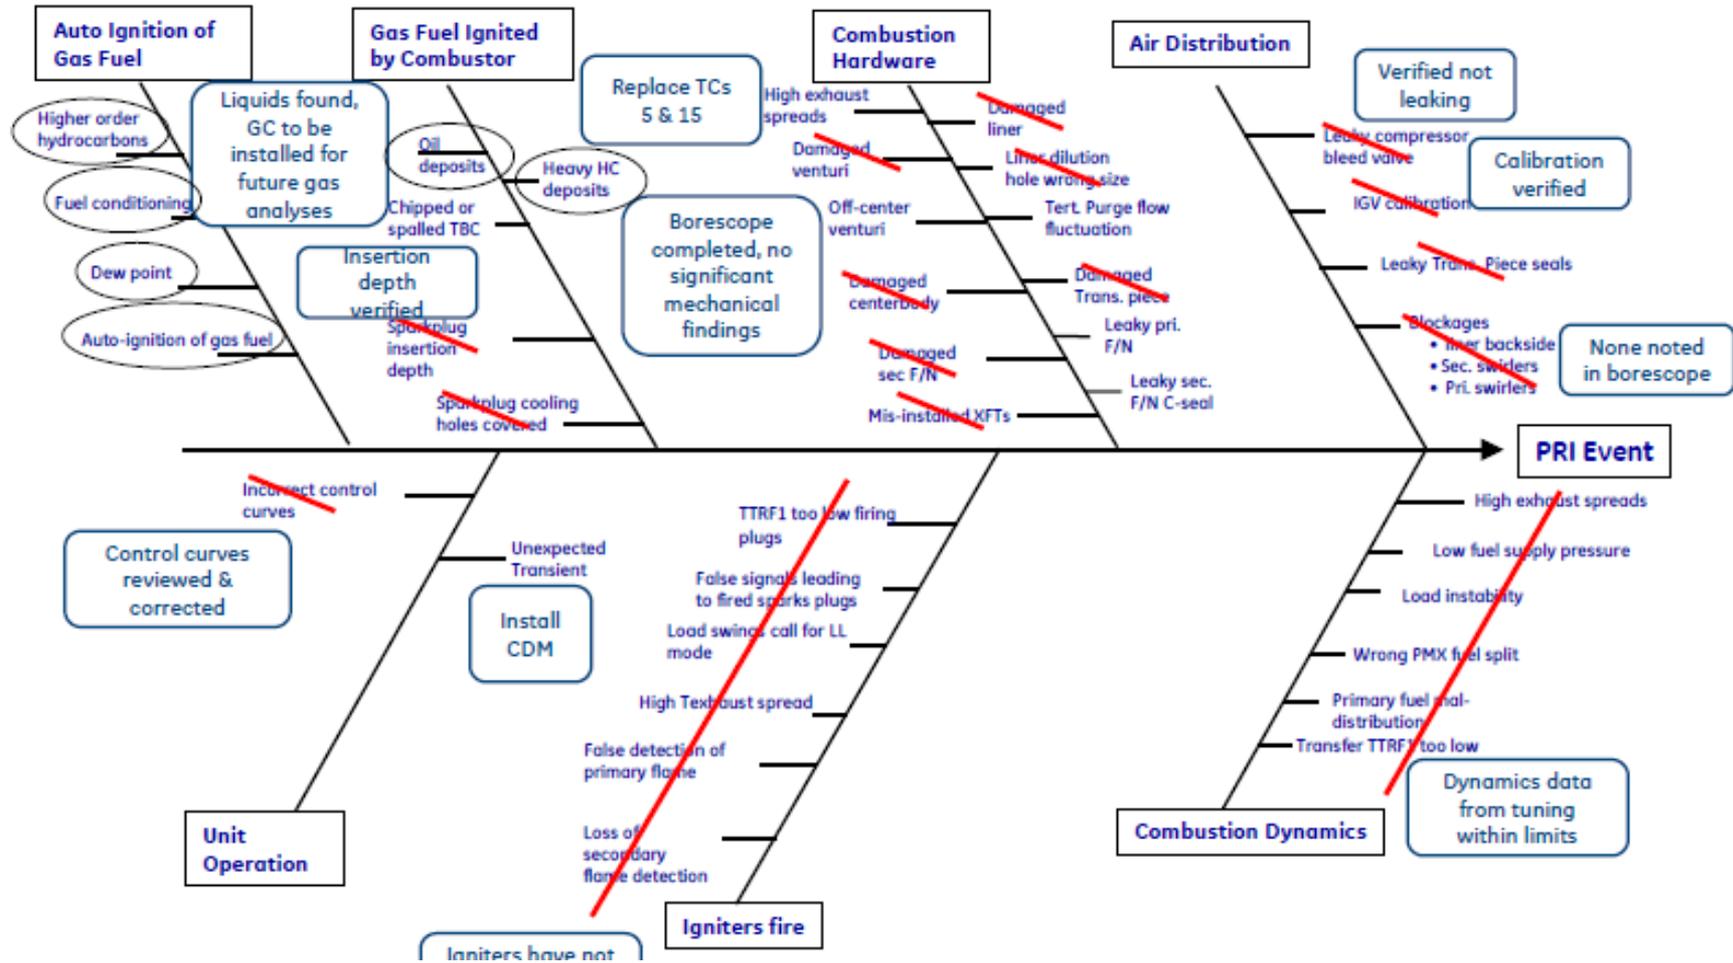
Fishbone Diagram for Online Troubleshooting

05 Days of online troubleshooting using Fishbone Diagram, to determine why the unit couldn't sustain on PMSS mode after several transfers.

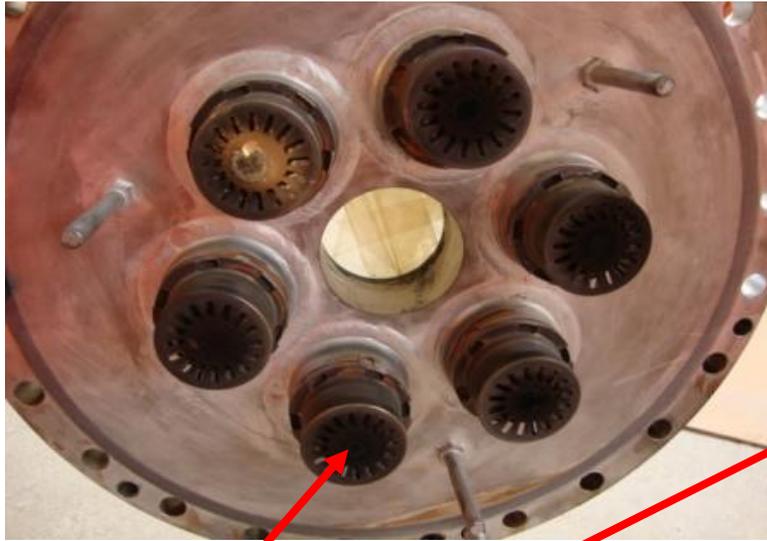
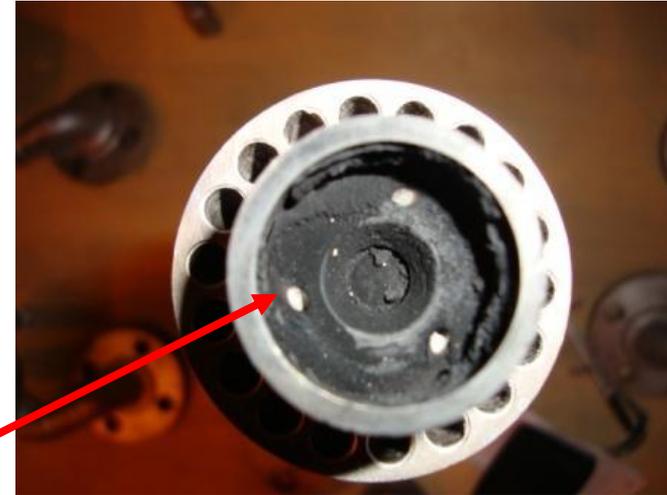
**Carbone Deposits
On Primary and
Secondary Nozzles**

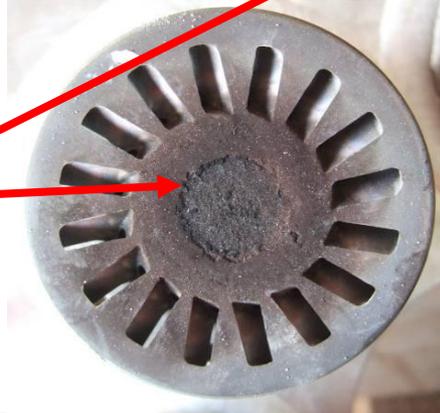
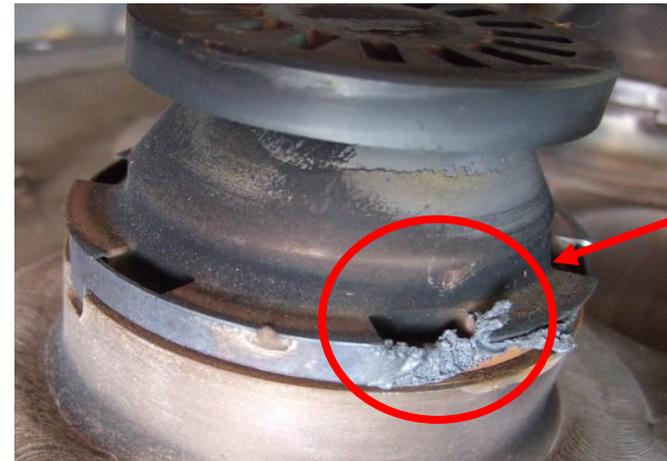
**Thermal
Damage**

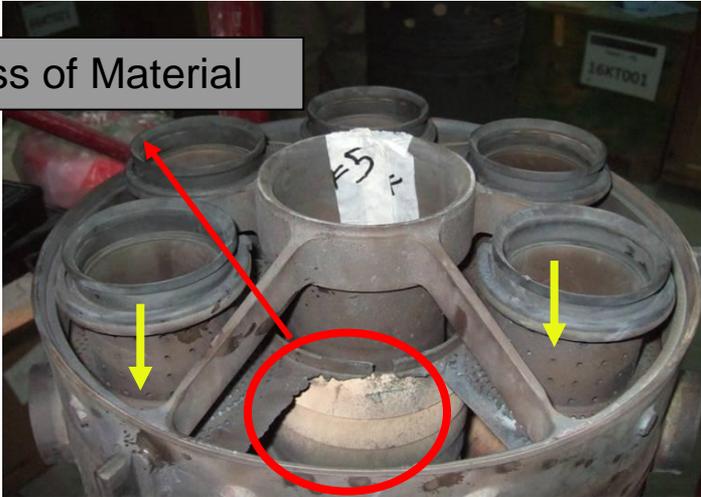
Combustion Inspection Findings: Combustion Liner No 5: Major damage

Loss of Material

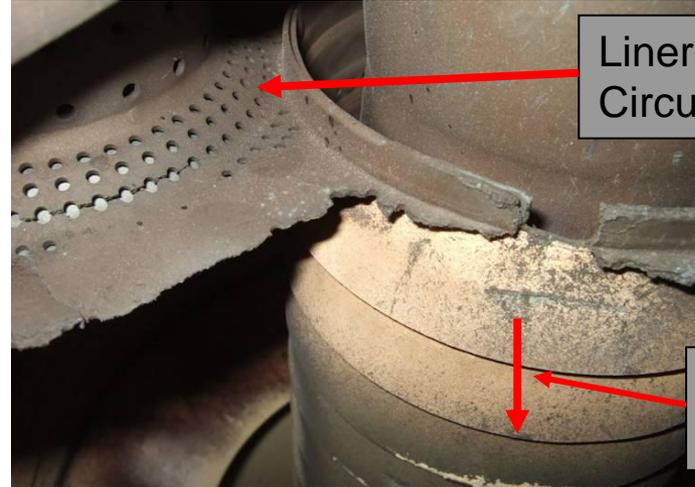
Liner #5 Cracked Circumferentially

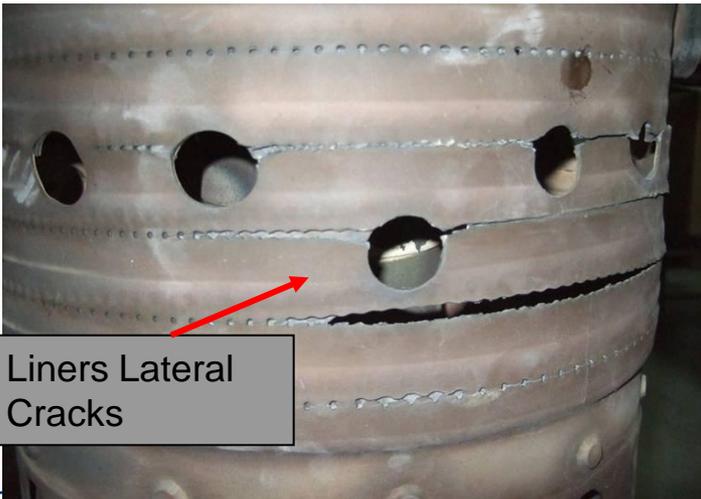
Liner Caps Deformation

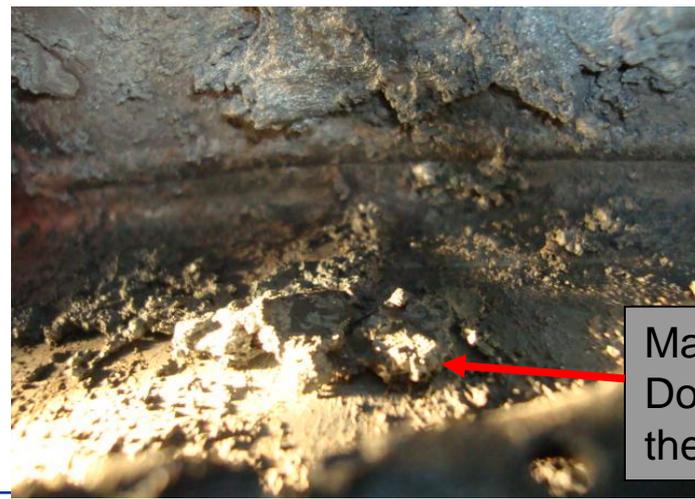
Liners Lateral Cracks

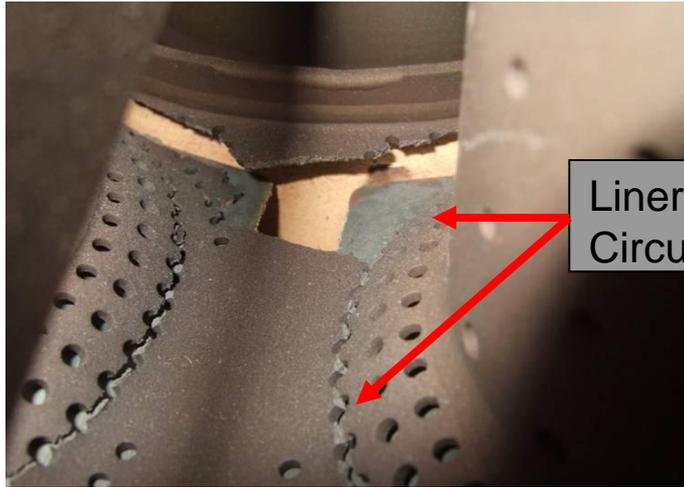
Material Melted Down Inside the Liners.

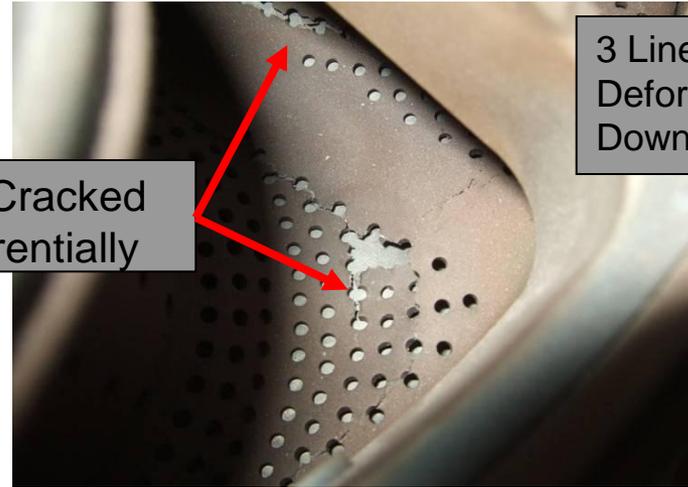
Liner #4 Cracked
Circumferentially

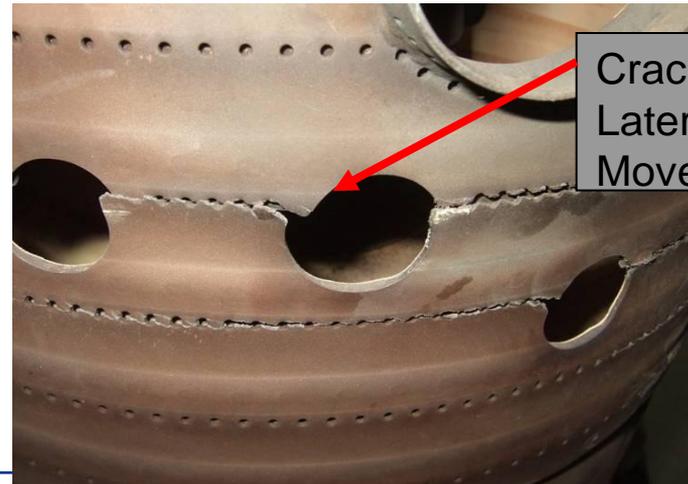
Missing Piece
Near Hula Seal

Cracks and
Lateral
Movement

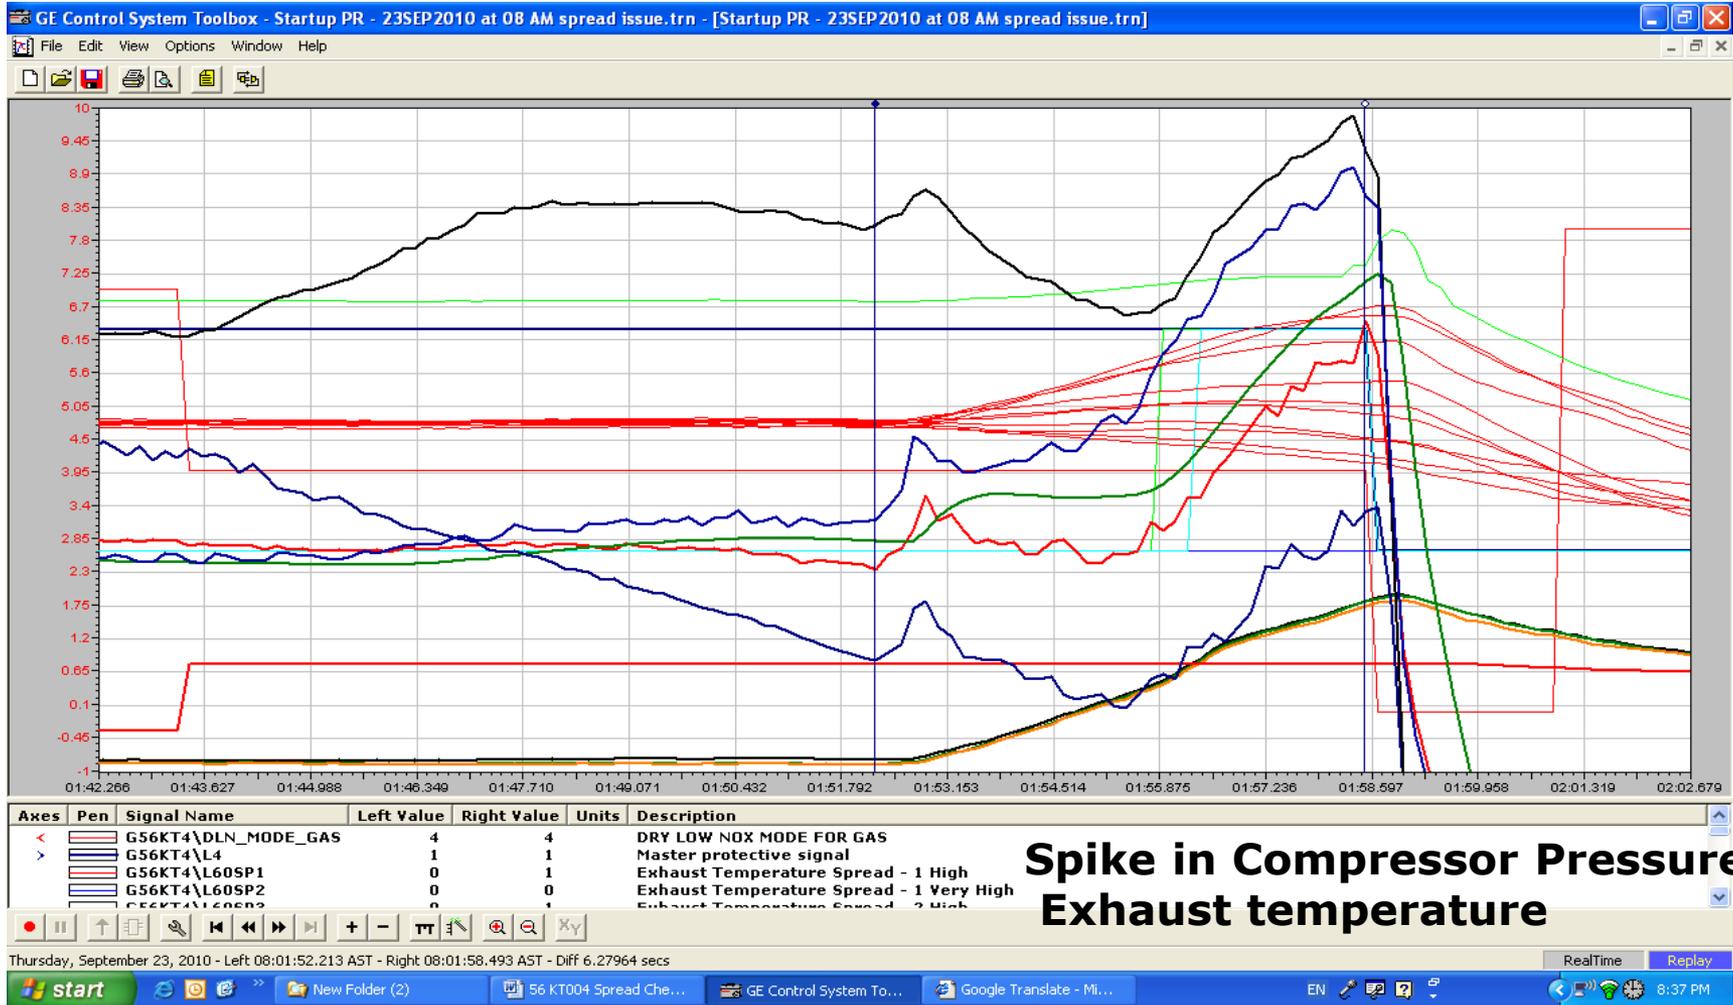
Control System Event Trends during transfer

Spike in Compressor Pressure & Exhaust temperature

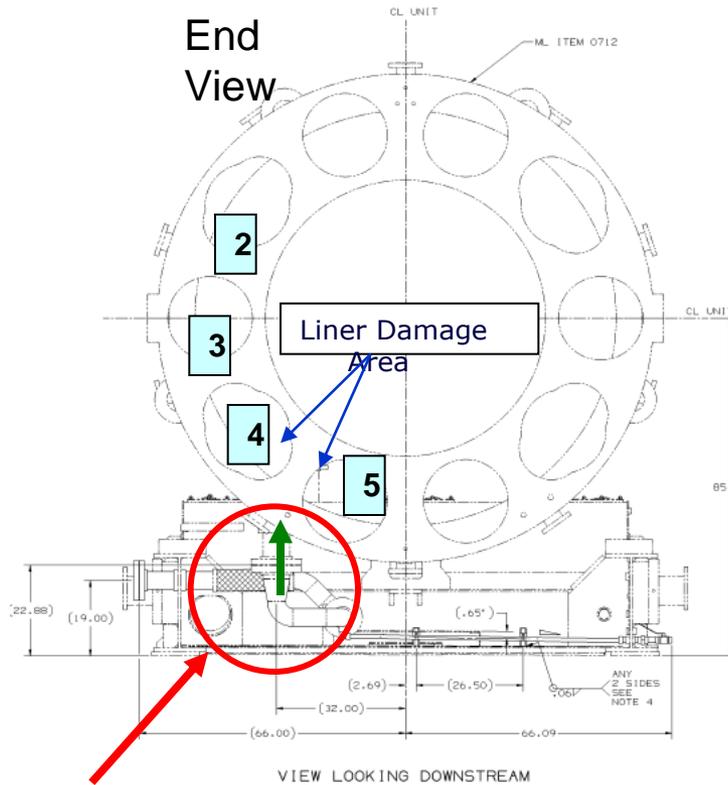
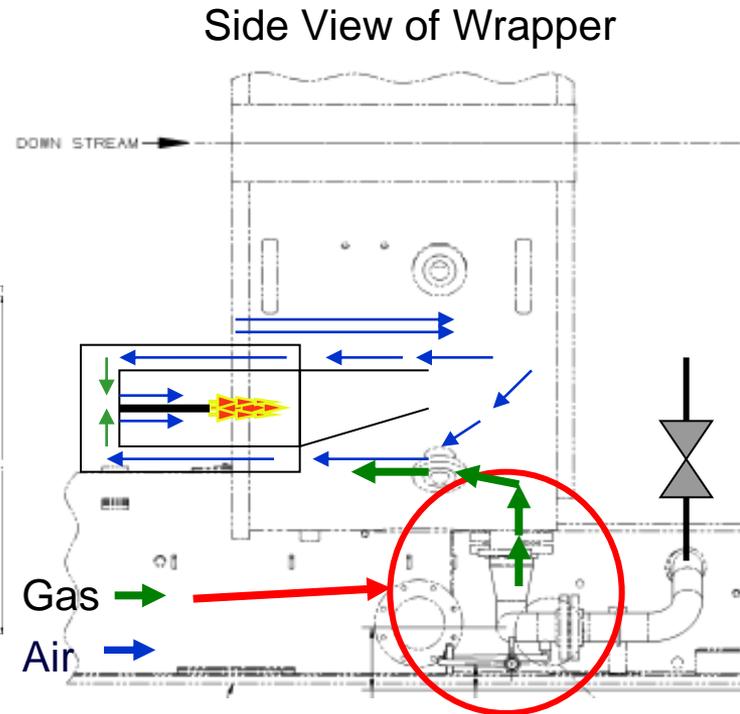
Purge Air
Connection
To Wrapper

Purge Air Connection on Wrapper Close to combustion can #4&5

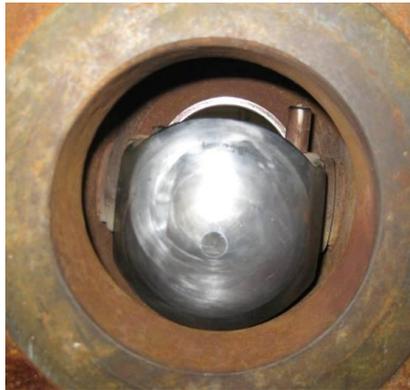
CORRECT CLOSED POSITION

Same SAP number Normally close actuator & Normally Open actuator

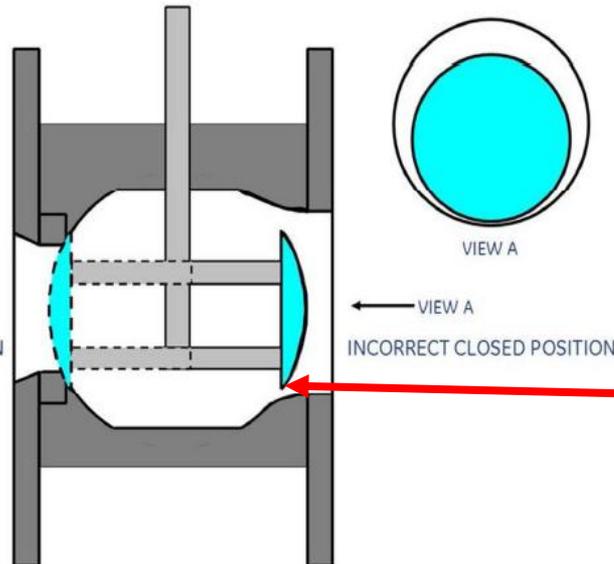
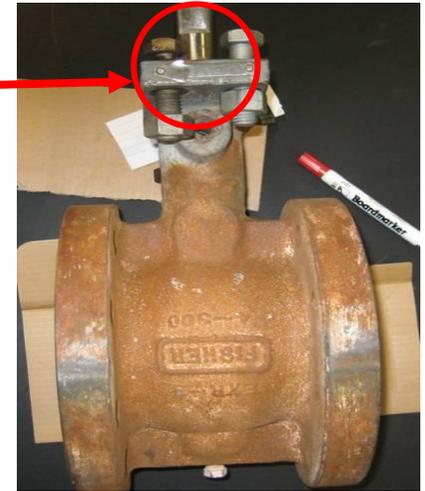
Ball closes opposite to seat leaving wide gap in closed condition

Closing opposite to seat/Incorrect SAP material number

- Change SAP material code for the purge valve actuator.
- Develop Purge Valve Installation Procedure.
- Time based purge valve replacement.

- Upgrade purge valves, actuators, solenoid.
- DLN mode transfer software modification.
- Upgrade fuel gas filtration system & DLN valve skid layout.
- Upgrade demisters of Selexol Absorber & mixing drum.
- Install Combustion Dynamics Monitoring system for all Frame 7 DLN Gas turbines.

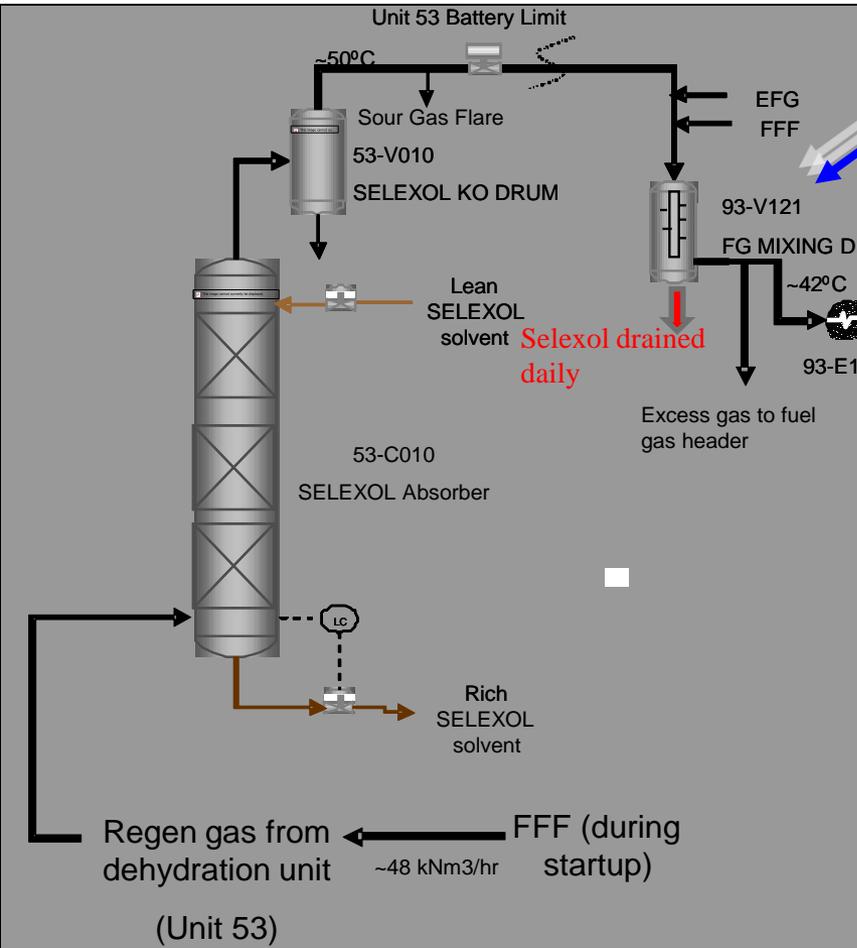
Investigations..5 Fuel Gas System.

- Mixing drum not a knock out drum (no demister)
- Upstream demisters not effective

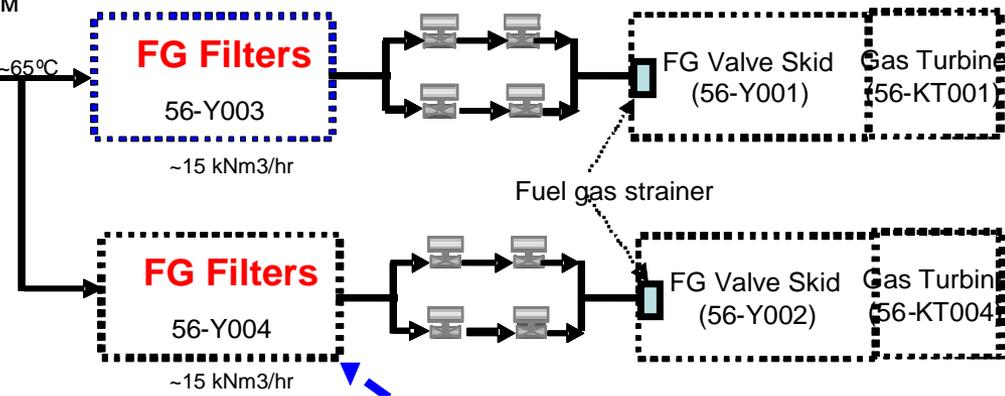
Filters Specification 0.3µm for solid & liquid removal, existing 3µm for solid only.

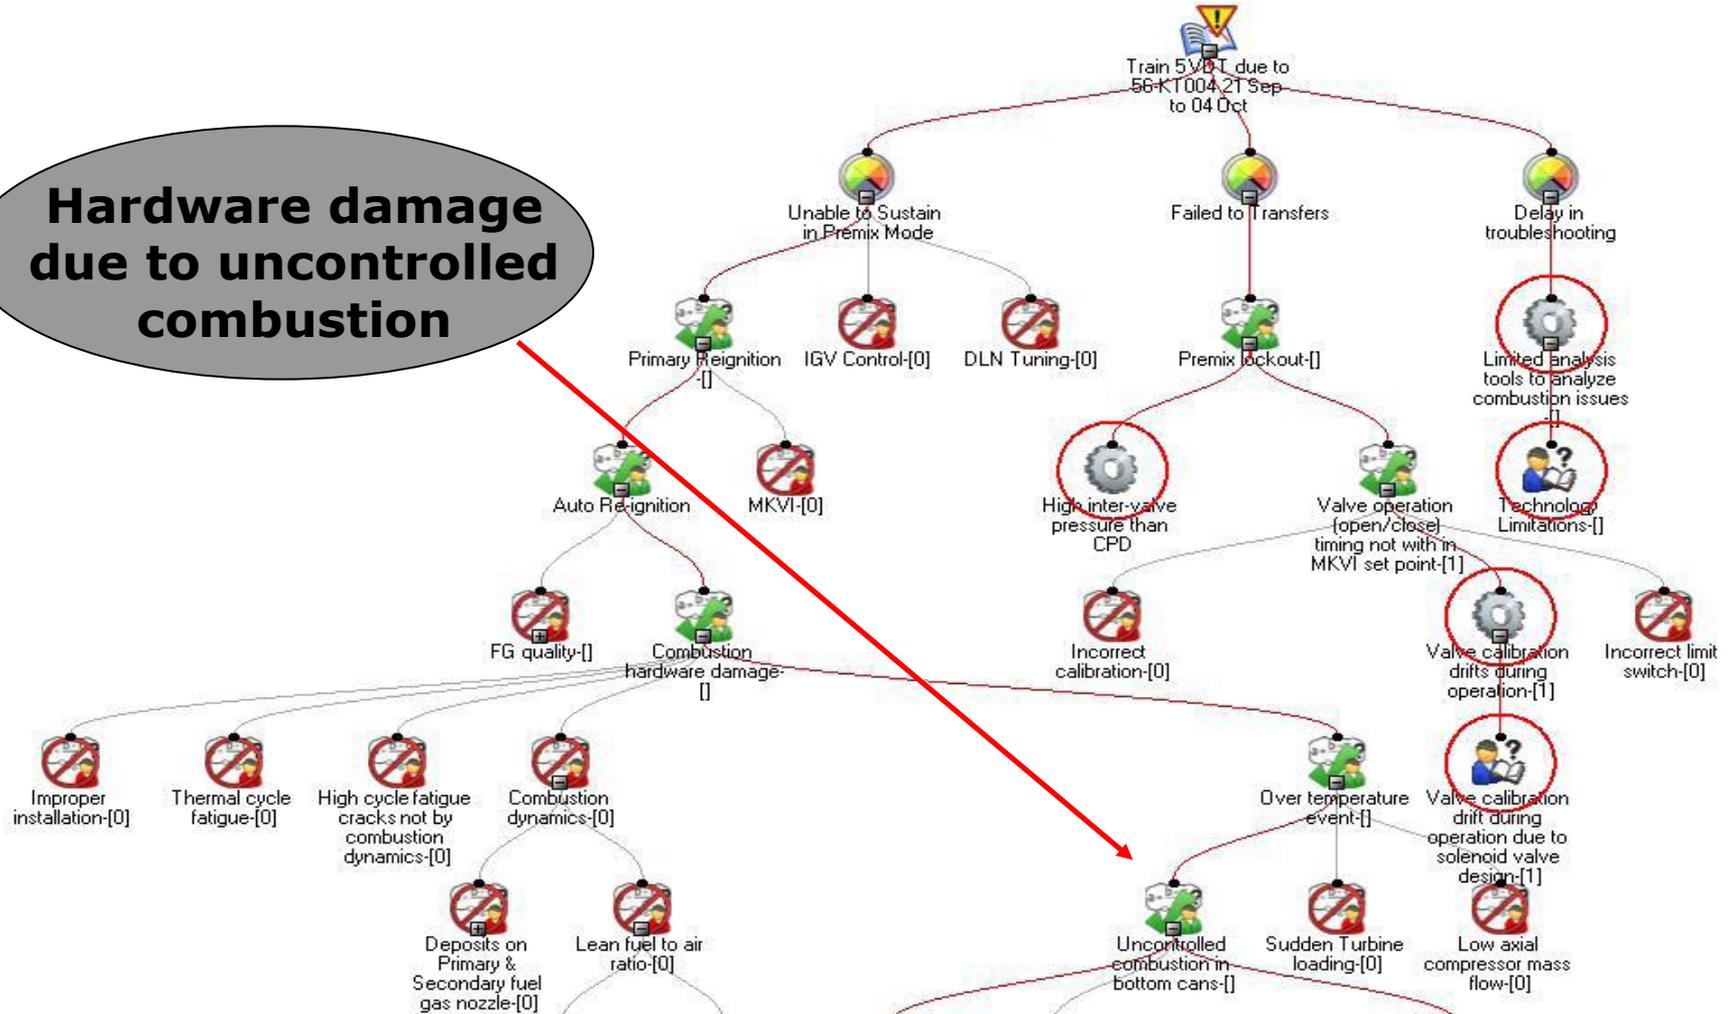
Hardware damage due to uncontrolled combustion

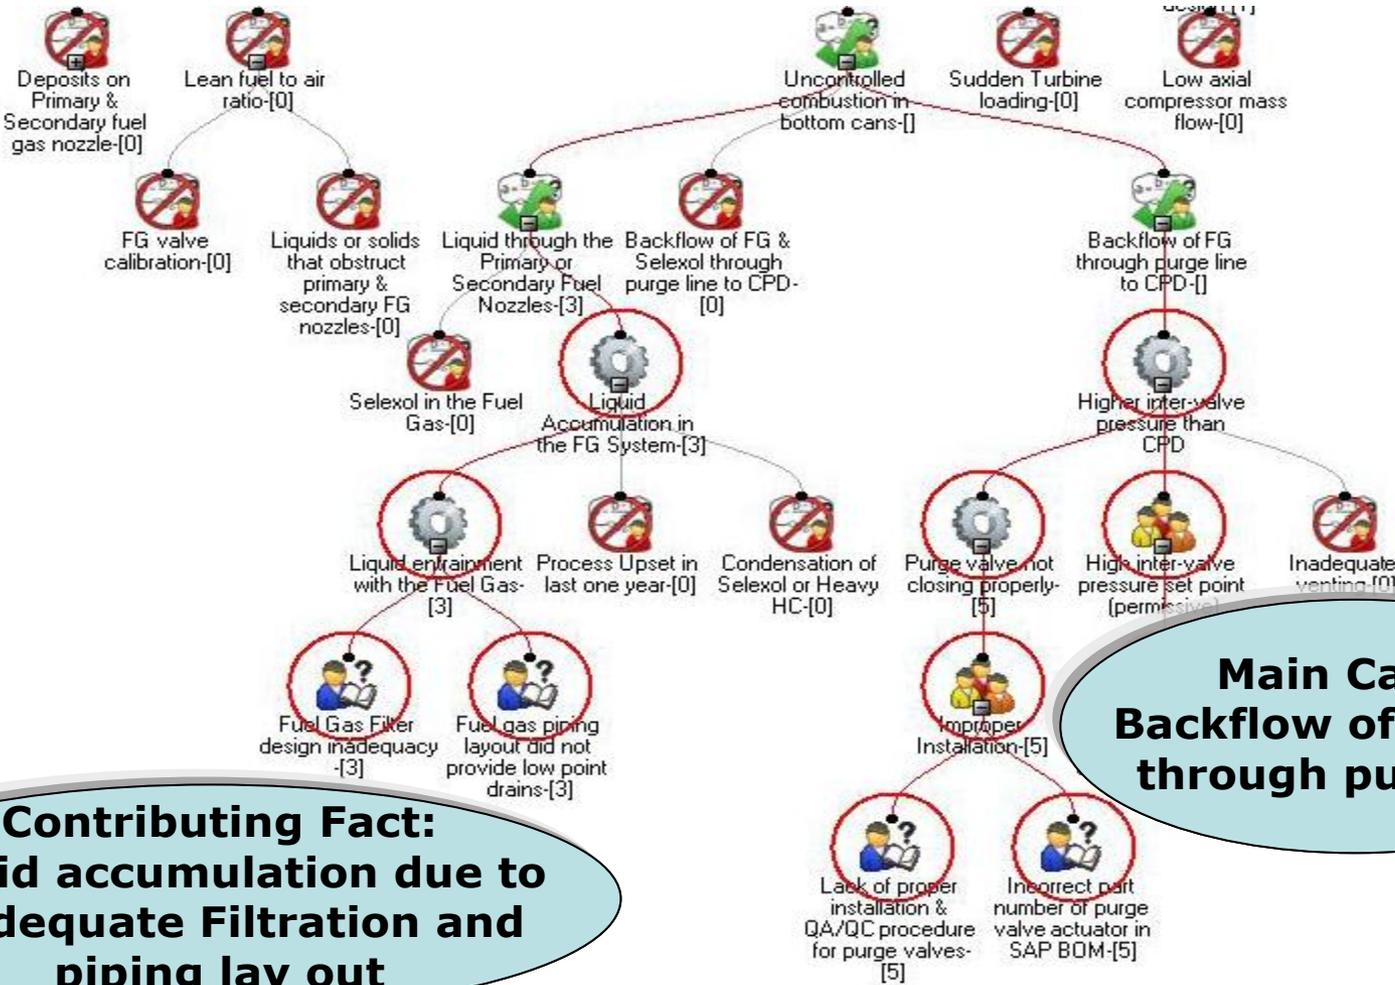
RCFA Logic Tree (suite)

**Contributing Fact:
Liquid accumulation due to
inadequate Filtration and
piping lay out**

**Main Cause:
Backflow of Fuel gas
through purge line**
