Investigation of Corrosion Fatigue Phenomena in Transient Zone of Mechanical Drive Steam Turbines and its Preventive Measures

For mechanical drive steam turbines, the investigation results of corrosion fatigue phenomena in the transient zone are introduced, including basic phenomena on expansion line and actual design and damage experience. These results were analyzed from the standpoint of stress intensity during the start of cracking. In order to resolve such problems, preventive coating and blade design methods against fouling and corrosive environments are developed. Detailed evaluation test results are given for coating performance using a unique test procedure simulating fouling phenomena and washing conditions. Finally, the results of the successful modification of internals and on-line washing results on site are introduced.

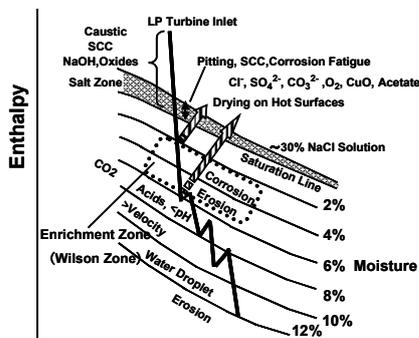
Figure 1. Turbine Expansion Line and Typical Damage ⁽³⁾

In the physical process of the low pressure stages of a steam turbine expanding from the superheated zone to the saturated zone, possible causes of mechanical damage are shown in Figure 1. On dry and wet areas around the saturation line, we tend to observe SCC caused by high concentrated NaOH, pitting, corrosion fatigue related to NaCl enrichment in the special zone (Wilson zone) in which dry and wet conditions continuously occur in the moisture range of 2% to 6% and heavy drain erosion in high moisture zones of over 12%. As shown in Figure 2, a fatigue endurance limit for 13Cr stainless steel under NaCl distilled water decreases drastically, and in this Wilson zone we have to pay particular attention to blade design, whilst considering the critical importance of controlling impurities in steam for actual continuous operation. It is necessary to understand the corrosive environment in actual operation to evaluate fatigue life. However, it is very difficult to expect concentration level changes of corrosive chemicals under conditions of rapid expansion in complicated high velocity flow fields. In this sense, it is important to evaluate mechanical integrity with a combination of detailed static and dynamic stress analysis and operation experience.

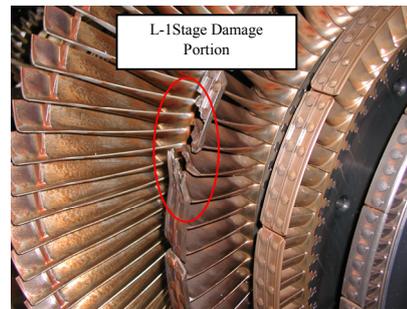
Figure 3 Typical Blade Damage of LP Section

Figure 3 shows a typical failure of blades in the low pressure section (tenon and finitely grouped type of L-1 stage) ⁽⁵⁾. The tenon and shroud plate have failed. Detailed conditions of the fracture surface and crack propagation direction (arrows) are shown in Figure 4. This is conformed cracking initiated on the internal side of the tenon and this failure is HCF according to the observed fine spacing striation ⁽⁶⁾.

The results of static stress and dynamic stress analysis for the actual failed blade shown in Figure 3 are shown in Figure 40 to Figure 42. The tenon has the maximum peak static stress at its outside, which is a different location from the actual crack initiation point. However, the location of crack initiation has a minimum safety margin and this margin has to be evaluated according to both static and dynamic stress on a Goodman diagram. To analyze the dynamic vibration stress, a 3D solid model is made for one group of blades, including the rotor disk to take account of the couple modes of the blades and disk as one vibration system. The natural frequency for each mode is calculated and plotted on a Campbell diagram as shown in Figure 41.

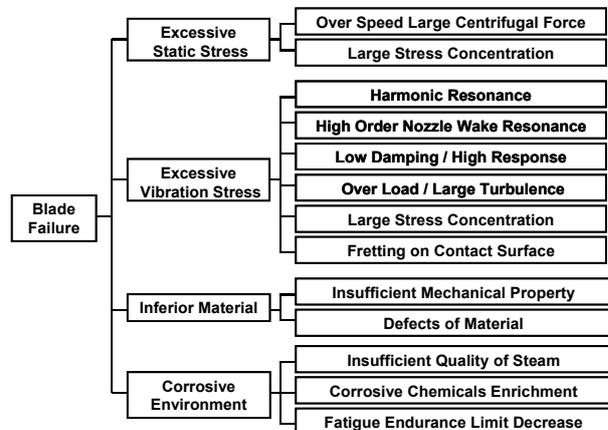
Figure 5 Root Cause Analysis for Blade Damage

Detailed fracture and stress analyses of the actual blade are carried out by root cause analysis, which is shown in Figure 5. Key factors involved in this failure could include excessive static and dynamic external forces, and a decrease in the fatigue endurance limit in a corrosive environment. It is also important to evaluate resonance stress in the variable speed range in such a corrosive environment.

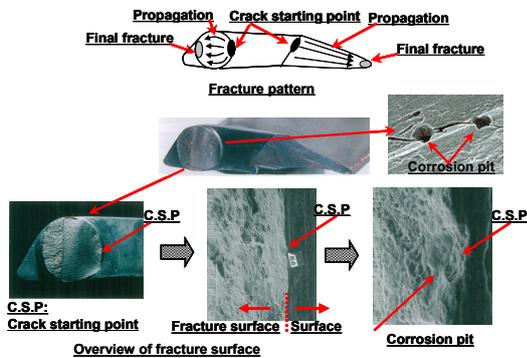
Figure 6 Corrosion Pits on Fracture Surface

As a result of the fracture surface analysis shown in Figure 6, the typical corrosion pits of diameter about 20 micrometers in diameter are observed around the fatigue crack starting point. Though corrosion fatigue includes environmental factors, it is difficult to quantitatively estimate the actual operating condition affecting the fatigue limit, and there are a lot of other unclear factors. A basic mechanism of corrosion fatigue is explained in Figure 7⁽⁹⁾⁽¹⁶⁾. This corrosion fatigue phenomenon is affected by certain types of chemical materials and their concentration levels, and it is thought that concentration cell effect and selective passive film formation cause material embrittlement.

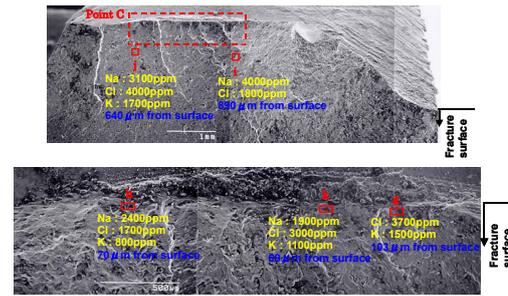
Figure 8 Corrosive Chemicals Concentration of Deposits on Fracture Surface

Considering the fact that several typical corrosion pits are observed, it is easy to expect a very severe corrosive environment under high concentration of corrosive chemicals. In order to define this severe corrosive environment, a concentration analysis of deposits on the fracture surface is carried out. As indicated in Figure 8, the concentration of Na and Cl are at a maximum of 4000 ppm and that of K is 1700ppm; these levels are relatively high.

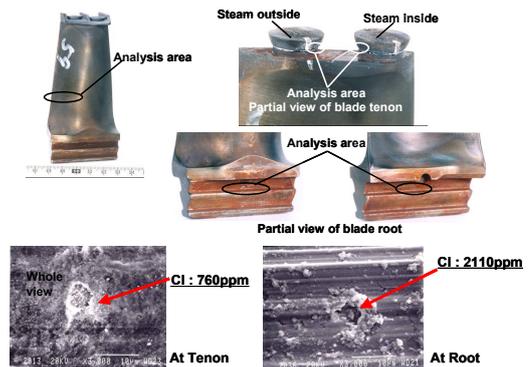
Figure 9 Corrosion Pits on Sound Blade and Corrosive Chemicals Concentration inside of Pits

In addition, the same corrosion pits are observed on the tenon, blade profile, and root of sound blades of the same stage and turbine as shown in Figure 9. Inside these pits, 2000 ppm Cl is detected. For further investigation, the numbers of corrosion pits are counted on the blades for each stage from the high-pressure section to the low-pressure section in the flow path to compare the corrosion environment level reiteratively. The profile of the measured pit count number in the flow path is shown in Figure 10.

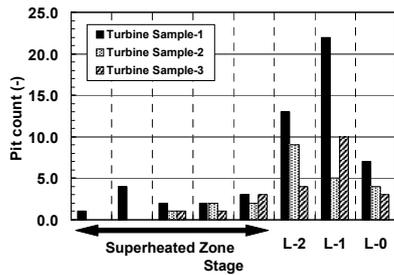
Figure 10 Corrosion Pit No. of Each Stage and Profile

According to this profile, the frequency of corrosion pits occurrence in the 3 stages (L-2, L-1, L-0: last stage) of the low-pressure section located in the wet zone is high. This is especially the case for the L-1 stage located in the wet/dry transient enrichment zone, which has the highest frequency of corrosion pit occurrence. The profile of the measured concentration of corrosive chemicals that is sampled from the blade surface for each stage is shown in Figure 11. According to this profile and the Cl concentration of the L-1 stage, which is extremely high at around 40000ppm⁽¹⁰⁾, it is considered that the corrosive chemical enrichment in the wet/dry transient zone and the corrosive environment have a strong relationship with blade corrosion fatigue damage. The threshold of the Cl deposit concentration level for determination which is a cause of general fatigue or corrosion fatigue is around 1000 ppm.

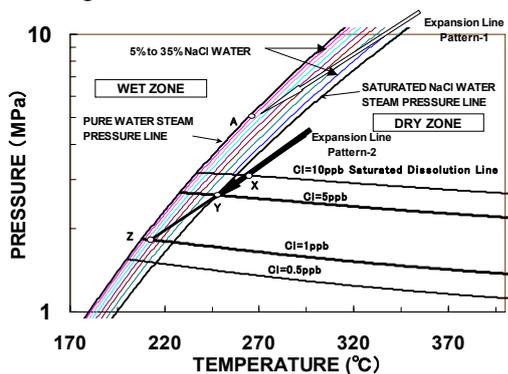
Figure 12 Cl Concentration in Steam Expansion and Deposit/Dissolved Condition

The separation and deposit, liquid, or solid phases and concentration level of corrosive chemicals on the nozzle and blade profile in each stage are determined by steam temperature and pressure on the turbine designed expansion line and concentration of impurities in steam, which is related to water/steam quality control. The analysis results of Cl concentration in steam expansion and deposit /dissolved condition are shown in Figure 12. This analysis is based on steady chemical equivalent conditions ⁽¹¹⁾ by varying pressure, temperature, and Cl saturated concentration, and focusing on the NaCl supersaturation line in the high concentration zone.

Where Cl concentration reaches 10 ppb for pattern-1, steam expands in the region of high pressure and temperature over the Cl saturation line. Even if the steam condition expands to point-A, the NaCl phase is still gas in

the dry zone and the blade surface is not exposed to high concentrations of corrosive elements in wet conditions.

On the contrary, in the case of 5 ppb, if steam expands in the temperature and pressure of the Cl saturation zone and goes to supersaturation point-Y, water with 30% NaCl, an extremely high concentration, occurs and the blade surface is exposed to a severely corrosive condition. According to these analysis results, even if the Cl concentration is extremely low, such as 1 ppb to 5ppb in steam, a severely corrosive environment can still appear around the blades ⁽¹²⁾.

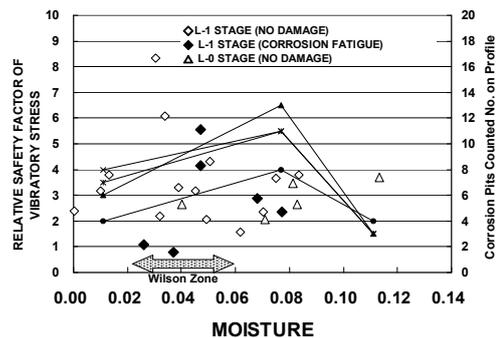
Figure 13 Relation of Wilson Enrichment Zone, Actual Moisture and Fatigue Strength Safety Factor

The L-1 stage blade damage is related to the enrichment and concentration level in the wet/dry transient zone, and the vibration stress level. To verify this relationship for damaged and undamaged blades, the relative safety factor of vibration stress based on the allowable limit in the transient zone and measured number of corrosion pit are plotted per each designed stage moisture level as shown in Figure 13. From this result, it is clear that, even if the relative safety factor is sufficient, corrosion fatigue damage occurred in the enrichment zone. Furthermore, it is confirmed that the number of corrosion pits is maximum in the enrichment zone, in the same fashion as the profile of the relative safety factor of vibration stress.

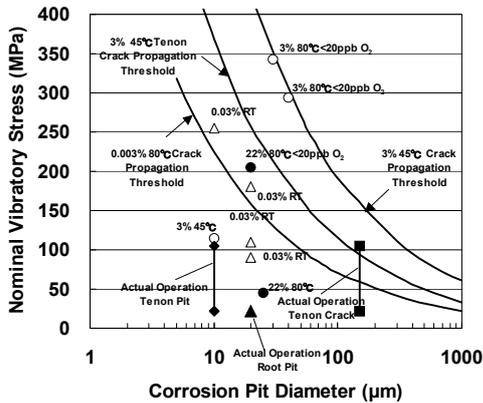
Figure 14 Relation of Corrosion Pit Size and Vibration Stress in Comparison with Crack Propagation Limit Line

environment by changing the concentration of NaCl to 0.03%, 3% and 22% respectively⁽¹³⁾. The relationship between vibration stress of fatigue test conditions and the observed corrosion pit diameter is plotted on Figure 14. In this figure, the vibration stress range is based on a calculation of the threshold of stress intensity factor⁽¹⁴⁾, and thus the limit of crack start propagation, as well as the vibration stress measured from detail fracture surface analysis for actual damaged blades, is plotted.

According to these results, if a corrosion pit of over 100 micrometers diameter has a vibration stress of less than 100MPa, there is a possibility of crack propagation. Under a severe corrosive condition of 22%NaCl concentration, together with a small amount of oxygen, even if a low vibration stress acts on the blade, small corrosion pits of 20 micrometers are observed and finally fatigue failure occurred. Based on the fact that the blade actually failed under low vibration stress and several corrosion pits were observed, it can be concluded that a corrosive environment easily contributes to initial crack generation, but crack propagation and corrosion pitting themselves don't seem to contribute to stress concentration.

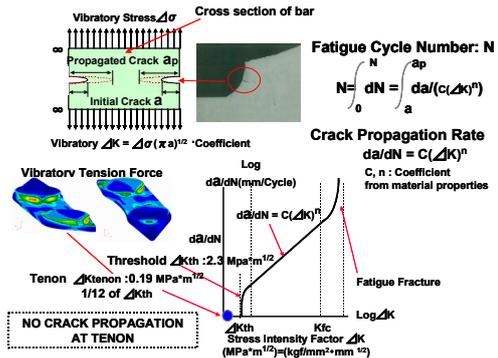
Figure 15 Tenon Caulking Stress Raiser and Crack Propagation Limit

Conventional blades have a tenon, and after tenon caulking from plastic forming, micro wrinkle occurs. It is suspected that this micro wrinkle contributes to crack propagation as a stress concentration or stress raiser in certain conditions. In Figure 15, the stress intensity factor calculated from the actual observed wrinkle depth and acting vibration stress is compared to the threshold of stress intensity factor. This figure tells us that if a large excitation force over 10 times that calculated acts on a blade, there is a possibility of crack propagation from micro wrinkles in tenon caulking.

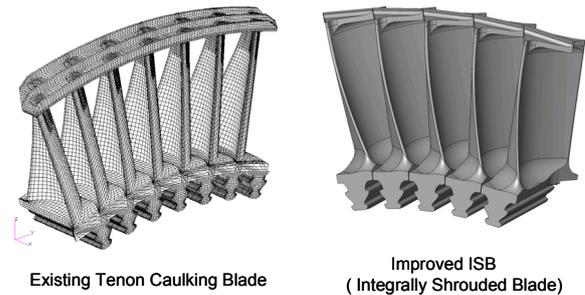
Figure 16 Improved ISB for Corrosion Fatigue Strength

Having reached this conclusion, as shown in Figure 16, ISB⁽¹⁵⁾ was developed by applying the blade profile and shroud in one piece without a tenon. These blades are thus infinitely grouped with a twist back torque mechanism as shown in Figure 17 in order to eliminate lowest frequency tangential load in phase mode and increase natural frequency. For this improved ISB, a stress analysis has been completed and sufficient improvement of safety factor confirmed⁽¹⁶⁾. Furthermore, this ISB has been applied on actual turbines and successfully operated.

From the above, it was concluded that the strength safety margin of conventional tenon caulking finite grouped blades has to be improved for an application of L-1 stage under the wet/dry transient zone for high speed and high loading turbine (such as synthesis gas compressor drivers), when considering the difficulty or limitation for water/steam quality control.

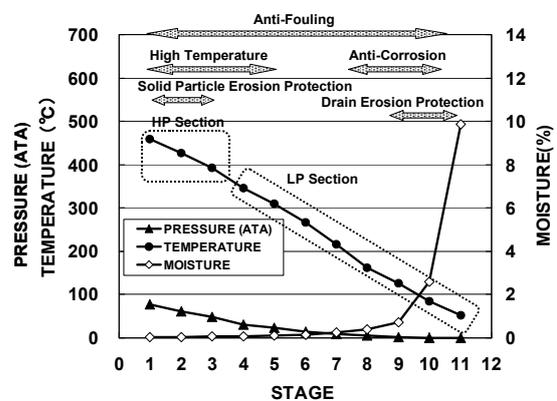
Figure 18 Turbine Internal Condition and Coating Required Function

In order to prevent both steam turbine performance deterioration and blade strength margin decrease during long-term operation, a new surface treatment is necessary to meet requirements of solid particle erosion prevention, anti-fouling, anti-corrosion, and drain erosion protection corresponding to steam temperature and pressure for each stage as shown in Figure 18. In this study, the requirements are defined as shown below for the low pressure section of steam temperature which is lower than 350 deg.C, as follows: 1) Prevention or relaxation of fouling on nozzle and blade profiles, 2) Improvement of washing efficiency during online washing, 3) Prevention of decrease in corrosion fatigue strength, 4) Anti-drain erosion performance in the same way as base materials

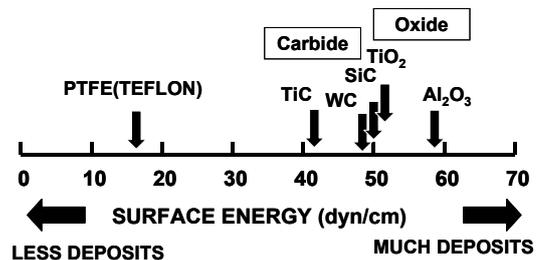
Figure 19 Several Types of Ceramics and Surface Energy Level

One of the main factors affecting fouling on the blade profile surface is the material surface energy. As shown in Figure 19, PTFE has a lower surface energy than other types of ceramics and this is therefore suitable for prevention of fouling. However, PTFE's own strength is low and it is necessary to improve coating performance with a hybrid for actual application.

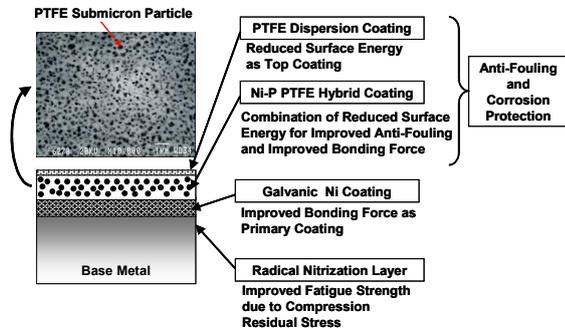
Figure 20 Basic Concept of Developed Coating

In order to realize a new suitable and multi-function coating considering the bonding strength between the anti-fouling coating layer and base metal, anti-erosion (prevention of layer separation) and anti-corrosion, a new coating has been developed. This coating concept is shown in Figure 20.

metal with a radial nitriding surface treatment. Furthermore, a Galvanic Ni Coating layer is formed to improve bonding condition and coherency. A Ni-P PTFE Hybrid coating is formed to realize the combination of reduced surface energy for improved anti-fouling and bonding force. Finally, a top PTFE dispersion coating is formed to further reduce surface energy more.

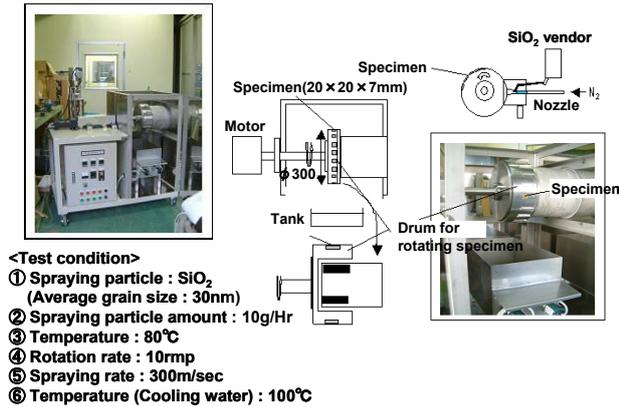
Figure 22 Anti-Fouling Test Set-Up

An anti-fouling test set up for simulating fouling conditions so that deposits will form on the material surface has been designed and manufactured according to the theory of cohesion and adhesion engineering of micro fine particles. For the basic fouling test procedure, fine particle material, diameter and particle collision velocity were adjusted the same as actual conditions and the amount of particle concentration was increased for acceleration of fouling conditions. Figure 22 shows the anti-fouling test set up and Table 5 shows the test conditions. The rotating drum is heated up to 500 deg.C and Silica fine particles are sprayed over the test pieces at a velocity of 300 m/sec. The ease of fouling is evaluated relatively by measuring the weight increase of deposit on the test piece surface during over a 200-hour test period. Figure 23 shows the surface deposit condition during this 200 hours of spraying each test piece. An anti-fouling index (difficulty to deposit) is defined as the ratio of deposit weight based on SUS 410J1 base metal. The relationship between this anti-fouling index and surface roughness for each test piece is shown in Figure 24.

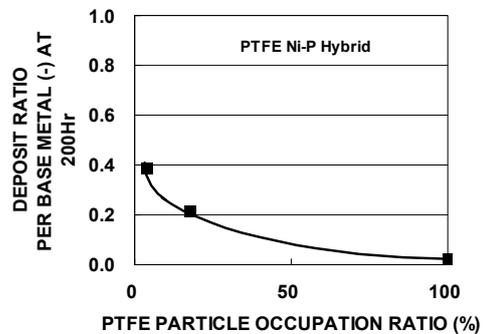
Figure 25 PTFE Occupation Ratio and Deposit Ratio

According to this result, PTFE Ni-P hybrid coating has almost the same anti-fouling characteristics as PTFE coating. The change in the anti-fouling index for PTFE Ni-P hybrid coating, when changing the occupation ratio for PTFE dispersion in the top coating is shown in Figure 25. With a 20% occupation ratio of PTFE dispersion and practical surface roughness, the anti-fouling index can be decreased to 1/5 of the base material. Furthermore, this coating performance is twice as effective as the conventional spray paint coating usually applied for a compressor.

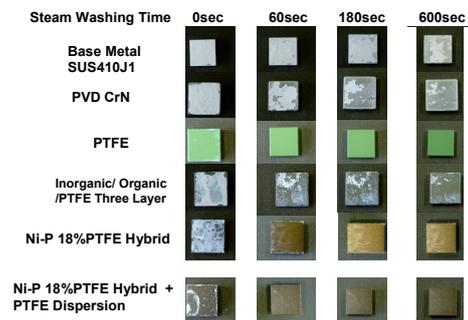
Figure 26 Surface Deposit Condition during Washing

An evaluation procedure for the simulation of actual washing has been developed by applying steam injection to test pieces with deposits after a 200-hour fouling simulation test period. The washing efficiency is evaluated quantitatively by the weight of removed silica deposit and qualitatively by an overview of the washed surface. Figure 26 shows an overview of surface deposit conditions during

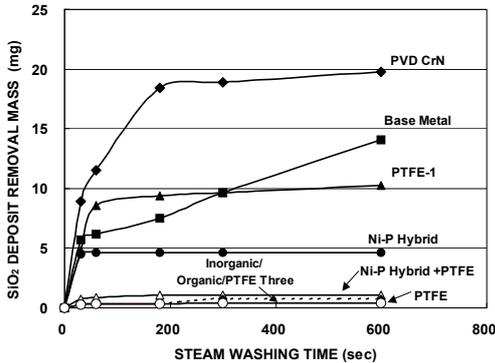
Figure 27 SiO₂ Deposit Removal Mass during Washing

washing and Figure 27 shows SiO₂ deposit removal mass during washing. The SiO₂ deposit removal time is listed in Table 6.

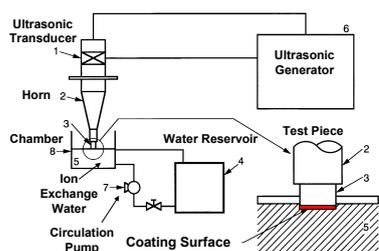
Figure 28 Cavitations Erosion Accelerated Test Set-Up

An anti-erosion evaluation test was conducted in accordance with ASTM G32-77⁽¹⁸⁾ using the cavitations erosion accelerated test set-up shown in Figure 28. The results of this test are shown in Figure 29. The wear mass reduction of the Ni-P PTFE hybrid coating is much smaller than that of the PTFE single coating and larger than that of the base metal at the beginning of the test. However this wear mass reduction is expected to saturate to a level smaller than that of the base metal at the end of the test.

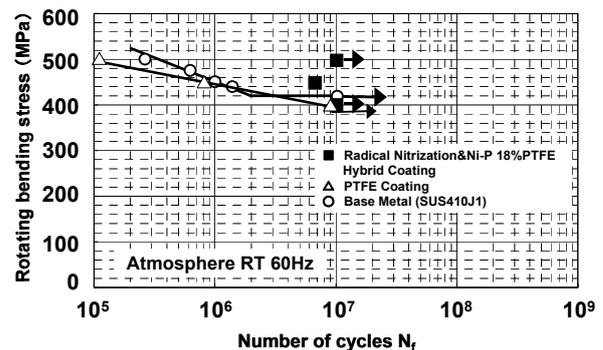
Figure 30 Fatigue Test Result at Atmosphere

A rotary bending fatigue test was conducted for the PTFE single coating and the radical nitriding Ni-P hybrid coating under normal atmospheric conditions and very severe corrosive conditions, with 3% NaCl distilled water. The test results are shown in Figure 30 and Figure 31 respectively. Under normal atmospheric conditions, the fatigue endurance limit for both of the PTFE single coating and the radical nitriding Ni-P hybrid coating is 400MPa at 1X10⁷ cycles, almost the same as base metal SUS410J1 applied for blades and nozzles.

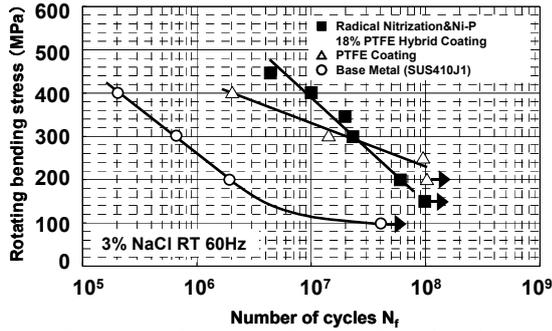
Figure 31 Corrosion Fatigue Test Result

However, with 3% NaCl distilled water, the fatigue failure rotating bending stress decreased to 200 MPa at 1X10⁸ cycles for the PTFE single coating, 100 MPa at 4X10⁷ cycles for the base metal, and 150 MPa at 1X10⁸ cycles for the radical nitriding Ni-P hybrid coating. This is twice the corrosion fatigue resistance than the base metal. It is thought that the reason why the corrosion fatigue resistance is improved with both coatings is because the coating layer is very fine with fewer defects (such as pin holes), and that they contribute to the effect of environment interception. In addition, in the LCF region of high stress, the corrosion fatigue resistance of these coating has improved, which means that the layer itself has a high level of toughness and high bonding strength with the base metal.

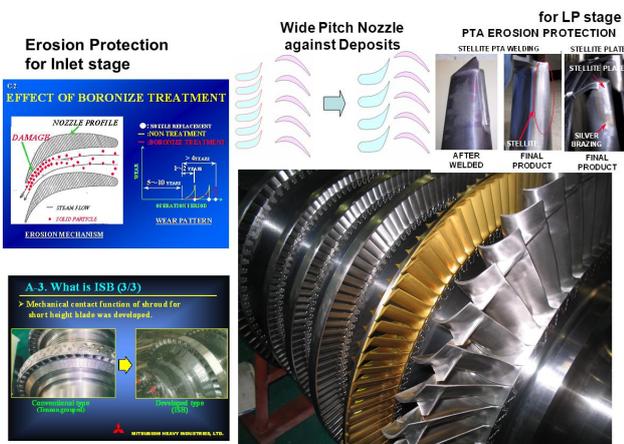
Figure 33 Improvement of Blade Integrity, Coating Application of Actual Blades and Additional Improvement for Anti-efficiency deterioration

Following the results of this study and the evaluation tests as explained above, the PTFE Ni-P hybrid coating was applied to the actual blade as shown in Figure 32. Additional improvement measures for prevention of steam turbine efficiency deterioration were applied to an actual steam turbine as shown in Figure 33 and listed below. ISB⁽¹⁹⁾ was applied for all stages (impulse and reaction types) to increase overall efficiency and prevention of corrosion fatigue in the dry/wet transient zone. For inlet 1st stage nozzles, boronizing coating was applied to prevent solid particle erosion and last-1 and last stage blade surfaces were treated with TiN ion plating and PTA (plasma transfer arc welding) respectively to prevent drain erosion. In addition, wide pitch nozzles were applied for all stages to increase stage efficiency and to minimize after stage pressure due to fouling.

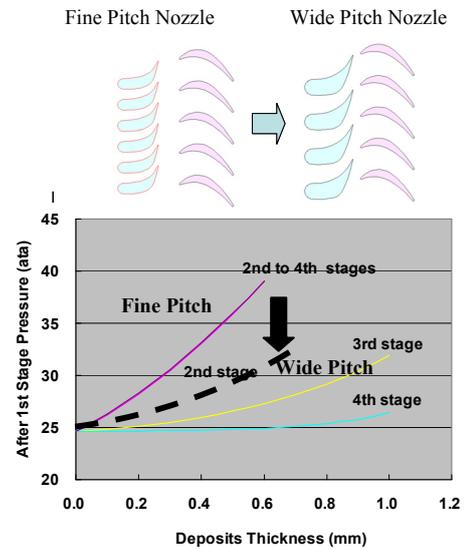
Figure-34 Wide Pitch Nozzle to Minimize Pressure Increase due to Fouling

In Figure 34, the difference in after stage pressure increase due to deposits on the nozzle profile is explained by comparing a fine pitch nozzle and wide pitch nozzle. If deposit thickness increase rate (mm/year) is the same, the nozzle area reduction rate of wide pitch nozzles can be decreased by half because of the smaller number of nozzles or smaller profile surface area than the fine pitch nozzle. After-stage pressure increase is proportional to steam flow and this turbine can have more margin for operating time reaching the pressure limitation under fouling conditions, whilst maintaining the required power and extending operation time.

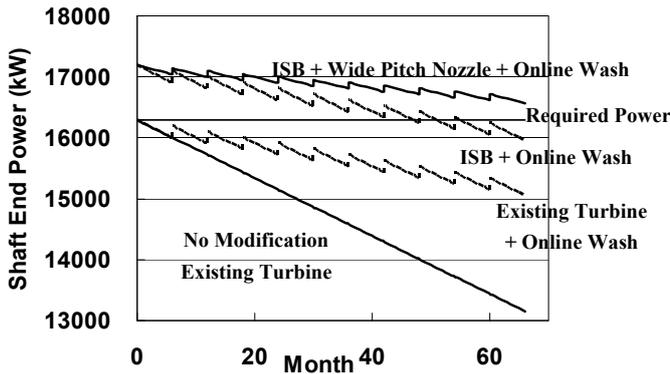
Figure 35 Advantage for combination of Wide Pitch, All ISB and On-line Washing

Figure 35 explains the advantage of each improvement and their combination. In this case study, the power recovery ratio after online washing is assumed to be 80% and the power decrease rate due to after-stage pressure increase caused by fouling is half of a fine pitch nozzle when using a wide pitch nozzle application.

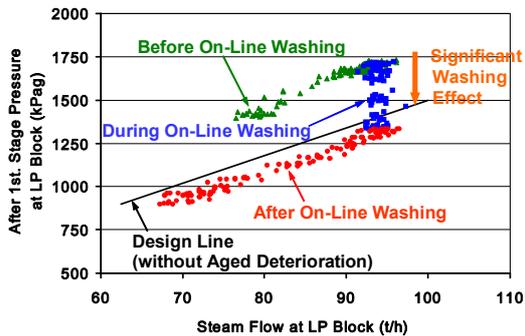
Figure 36 Successful On-line Washing at Site

This new online wash technology has been applied for over 20 turbines and typical successful results on site are shown in Figure 35^{(20) (21)}. In this case, an anti-fouling coating such as an Ni-P PTFE hybrid multi layer coating is not applied. However, it has been confirmed that the turbine performance recovers after online washing to the original clean condition. If this newly developed coating and other improvements, including online washing and wide pitch nozzles as explained above are applied systematically, the turbine integrity and performance can be maintained to the same as the original during long-term operation over 8 years^{(22) (23) (24) (25) (26)}.

The steam turbine online wash procedure had already been established and applied in more than 30 actual turbine applications. The water is directly injected inside of the turbine valve chest and typically it is not necessary to reduce the power and speed. During several-hour-short-duration online washing, the LP section condition becomes wet and washable chemicals are washed out as indicated by a high spike of conductivity. After several hours of washing, the extraction pressure decreases to a level much lower than the allowable pressure limit and the turbine performance increases as shown in Figure 36. Before and after washing, the operating conditions, including power based on measured torque are compared and typical results are shown. A large increase in the power recovery ratio is confirmed.

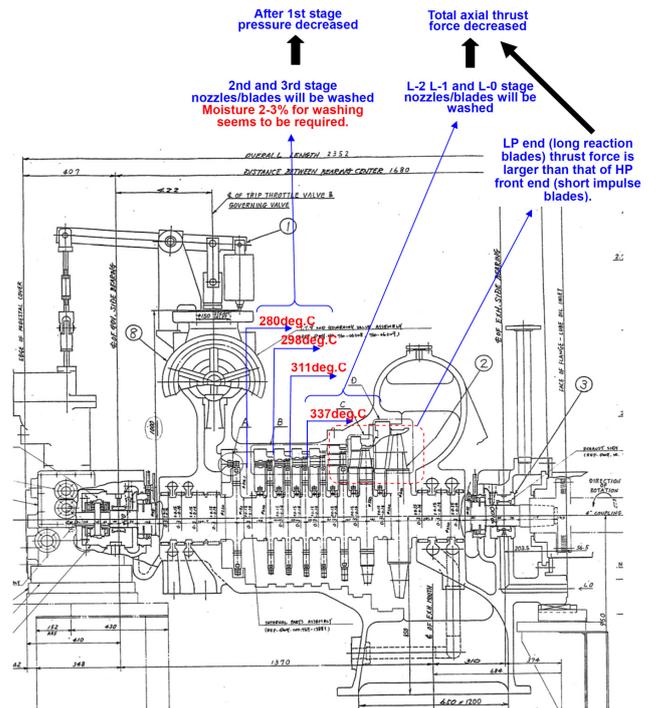
Figure 37 Typical Full Condensing Steam Turbine for On-line Washing

As a typical case of on line wash for investigation of thermodynamic condition in flow path, the full condensing steam turbine shown in Figure 37 is selected. The expansion curve during of this steam turbine during on line wash is shown in Figure 38 on i-s chart, according to this curve, the moisture for each stage can be estimated.

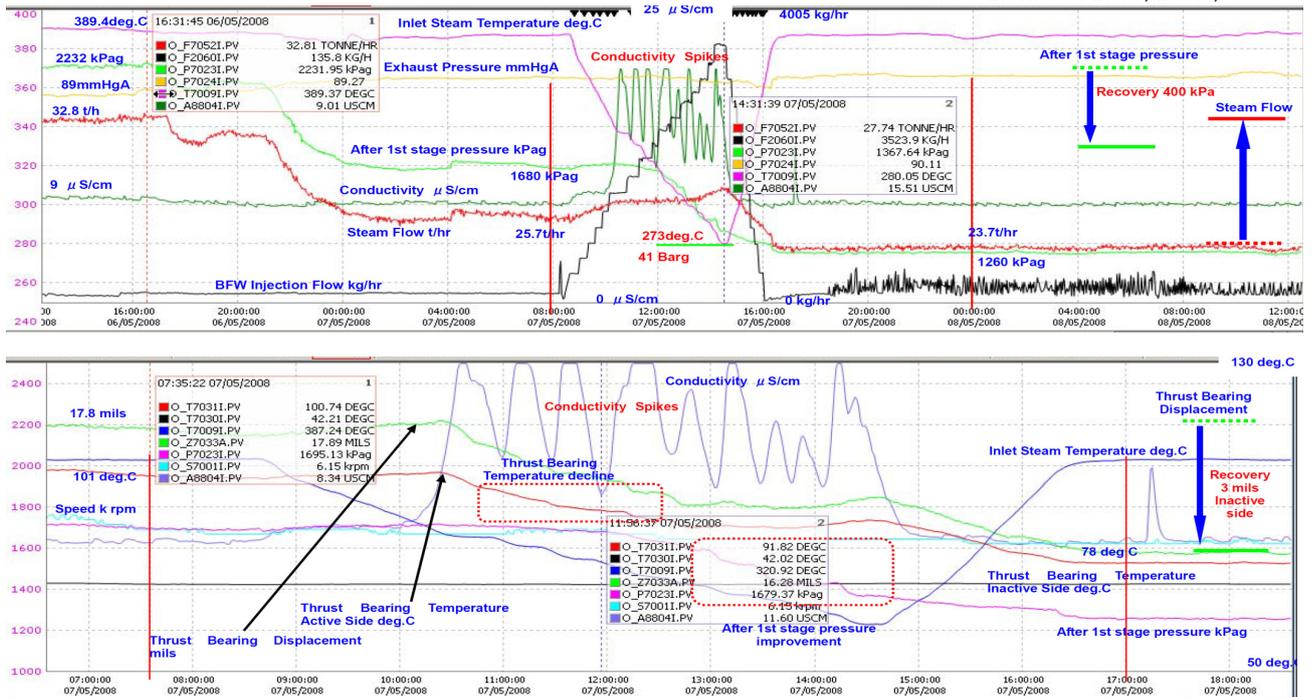
Figure 39 Operation Trend Data Summarized during Online Wash

Top graph of Figure 39 shows the change of operation conditions in decreasing inlet temperature by injecting boiler feed water. In this case, inlet steam flow is reduced from normal condition to have a safety margin and minimize any risk and normally 10% steam flow reduction is recommended. During decreasing inlet steam temperature from 389 deg.C to 273 deg.C, there are a number of distinct conductivity spikes and it is seemed that the position of the moisture point inside the turbine moves across more than one wheel and diaphragm or it concentrates more locally around one row position. Also is showing the regain that we have made in the wheel chamber pressure. After returning to full load condition, the after 1st stage pressure has recovered approximately 400KPA after completion of wash.

Bottom of this graph shows the effect of removing fouling has on thrust bearing temperature and axial position of rotor. It is observed that the majority of temperature decline in active thrust bearing is occurring earlier than when wheel chamber pressure is starting to improve. The axial position of the rotor has also moved 3mils back after cleaning of rotor and the thrust bearing pad metal temperature goes down from 101 deg.C to 78 deg.C.

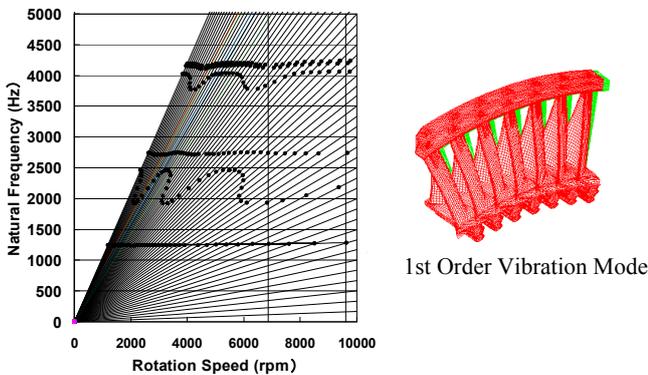
Figure 41 Campbell Diagram and Operation Range

The resonance points are identified in the operation speed range and analyzed to determine the vibration response of the excitation force at resonance point⁽⁷⁾. In case of finitely grouped blades, the vibration stress becomes largest at resonance with lowest frequency tangential in-phase mode. The excitation force is given on the blade profile calculated from pressure distribution of a steady CFD analysis and stimulus of fluctuation level per steady level and harmonic number. The vibration response is calculated in relation to system damping. The vibration stress profile (contour) is shown in Figure 42 and the maximum peak vibration stress is observed on the inside of the tenon and stress concentration point of corner radius, which is the same as the actual crack initiation point.

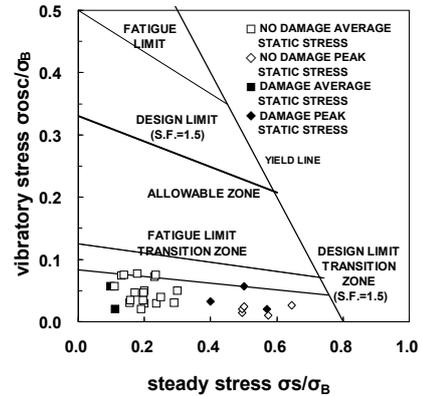
Figure 43 Design Experience on Goodman Diagram

The same standard blades have been applied to over 80 turbines, which have all been in long-term operation. Among them, three turbines have the same blade damage. The static stress and vibration stress for each turbine is plotted on the Goodman diagram shown in Figure 43, comparing the allowable fatigue limit corresponding to a wet and dry transient Wilson zone⁽⁸⁾. Considering the fact that vibration stress is very small and lower than this limit, and this blade damage happened after long-term operation, it is expected that the blade damage is caused by a corrosive environment related to unsuitable water and steam quality control.

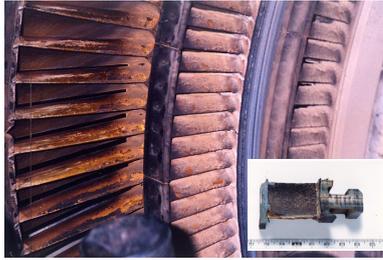
Figure 44 Deposit Condition of LP Section

During steam turbine continuous long-term operation, steam contaminants, such as silicate and sodium, deposit on the internals as solids. This occurs under certain operating conditions related to steam pressure and temperature for each of the stages. These contaminants foul the surfaces of nozzles and blades and gradually build up during steam turbine operation. Figure 44 shows the fouling condition after 7 years of continuous operation.

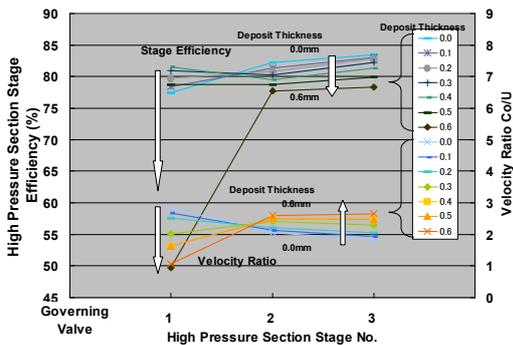
Figure 45 Blade Design, Efficiency affected by Fouling in Each Stage

The composition and characteristics of the fouling materials are different along the steam path from the high-pressure stages to the low-pressure side. Under these fouling conditions, the pressure profiles across the nozzles, blades, and throat areas increase. These profiles in turn result in the deterioration of turbine performance, and it will continue to do so over time if left unattended. The authors have calculated the relationship between after stage pressure increase and efficiency change (loss) due to the fouling thickness within the high and low pressure sections. When fouling happens and the nozzle profile has deposits, the nozzle area is reduced, and the nozzle exit speed and velocity ratio per stage change. This velocity ratio is directly related to stage efficiency and overall efficiency of the HP and LP section. The typical calculation result for the HP section is shown in Figure 45. According to this thermodynamic calculation and analysis, the HP section efficiency is more sensitive than that of the LP section where each stage profile has the same fouling thickness. Overall efficiency change and after stage pressure change depend on what stage has deposits and its fouling thickness.

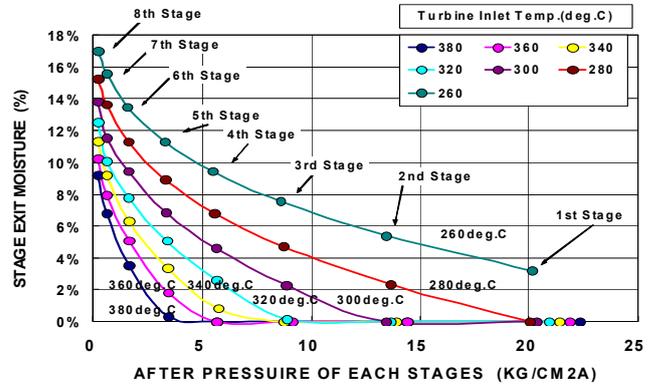
Figure 46 Moisture Profile during Reduction of Inlet Temperature

Figure 46 shows the calculated moisture change of internals when inlet temperature decreases from normal to the lowest during washing. At the normal inlet steam temperature, only 6th to 8th stage locate on wet zone and maximum moisture is about 9%. In case of the lowest inlet temperature 260deg.C, all stages are located lower than saturated line and the maximum moisture of last stage becomes 17%. The on line wash condition have to be

optimized in considering what stage has the fouling and what is the allowable limit of high moisture in terms of erosion damage and countermeasures for protection such as ceramics coating, PTA power welding and stainless steel diaphragms .

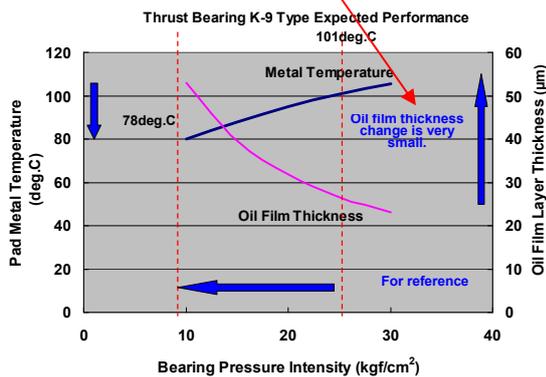
Figure 48 Thrust Force Reduction and Axial Displacement after Online Wash

We expect thrust force decreases from 20-25 kgf/cm² of bearing pressure (intensity) to 10 kgf/cm² of normal as designed. Almost change of axial displacement (about 100 micron meter) is elastic deflection of leveling plates and oil film thickness increases by 30 micron meter as your pointing out.

Levering plates for Equalizing have elastic deflection 0.12mm, Levering plate elastic deflection is larger than oil film thickness change

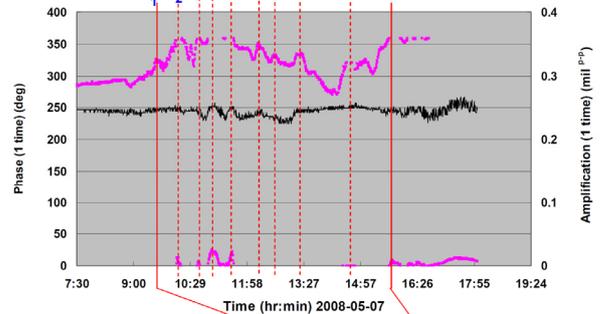
Figure 49 Vibration phase change and correspondence to conductivity spikes during online washing

On the contrary, in case of 2 time vibration, amplitude changes and phase does not change. It is expected that excitation force in rotating in drain or mist and unbalance caused by partial washing during washing start affect rotor response. The detail investigation is necessary.
