The 1st Middle East Turbomachinery Symposium (METS)

RCFA Case Study: Infant Mortality: Lean Solvent Centrifugal Pump Motor

Qadeer Ahmed

Qatargas Operating Company Limited, Qatar

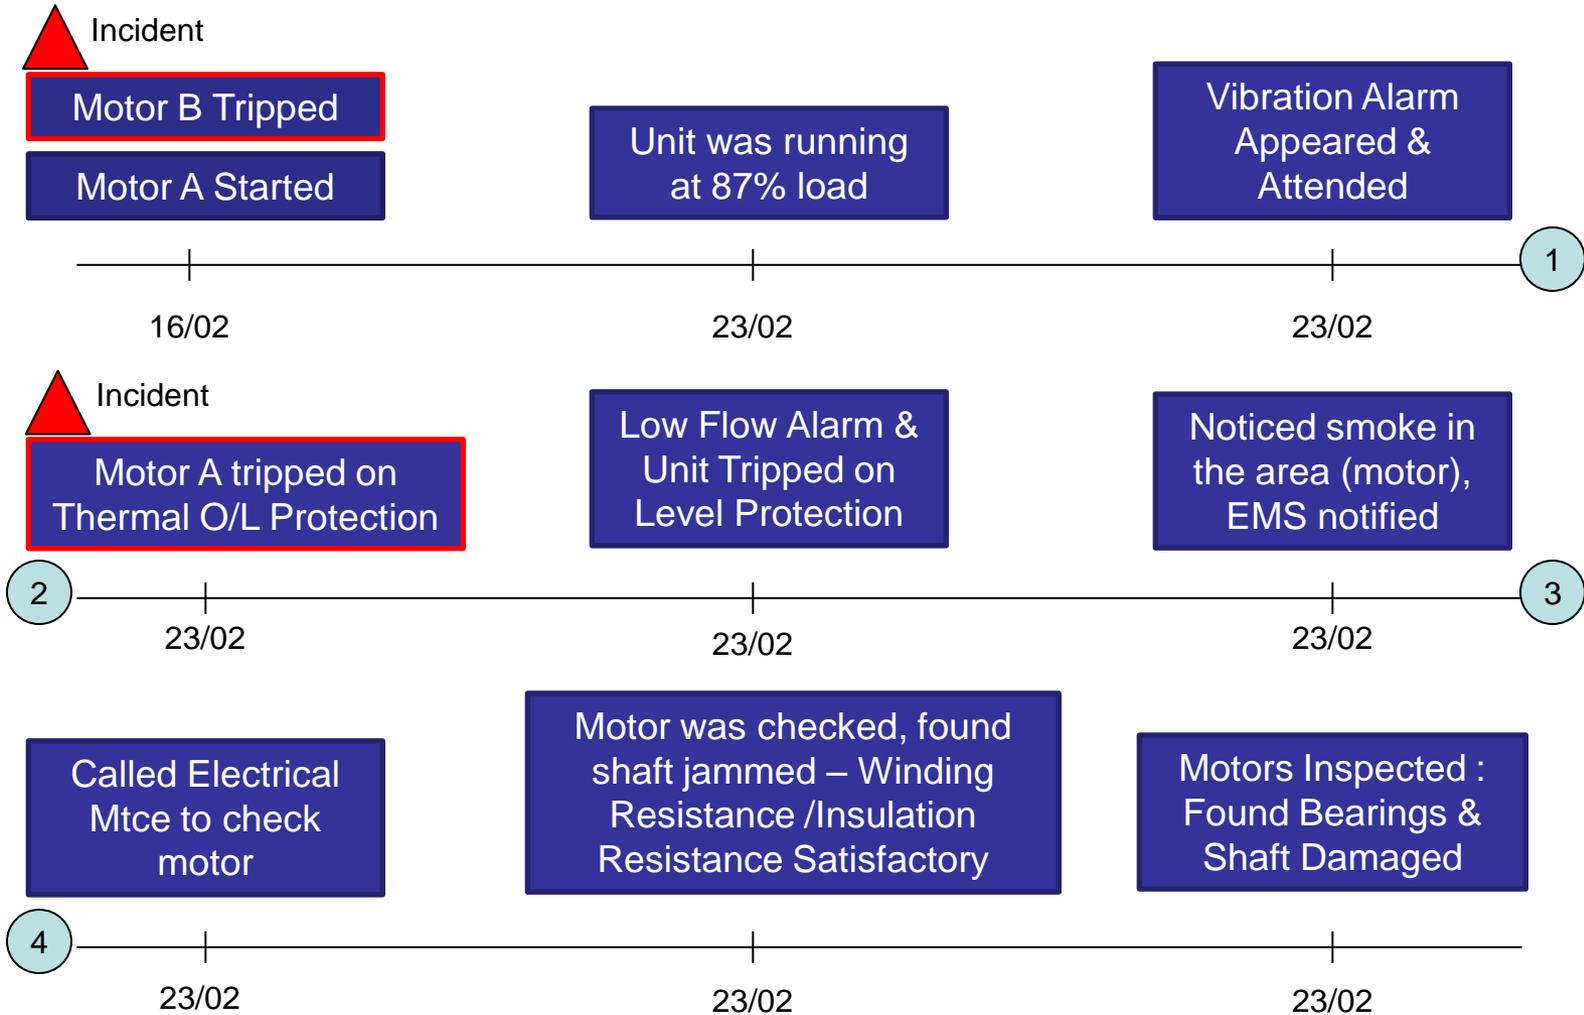
Event Diagram (Timeline):

- During the early stage of plant service, Two out of two motors failed within a short duration and caused disruption in normal operations and other consequential damages (pump, production etc..)

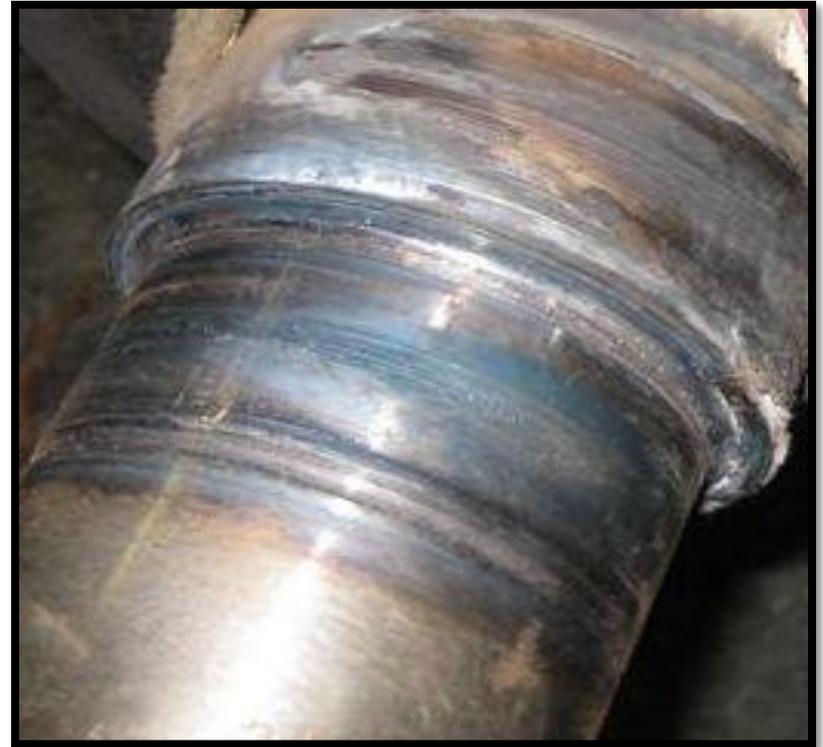
- Lack of lubrication is the leading root cause of this failure. No grease was found during inspection and bearing showed the clear signs of overheating. Vibration data supports and confirms the failure initiating point was bearing (BPFO -Ball Pass Frequency Outer Race).

1. Activate the all PM plans in CMMS. Ensure to set the initial PM startup date manually. Revisit the equipment strategies to include vendor recommendations.
2. Create area based lubrication work orders and release for maintenance execution.
3. Develop greasing procedure for Motors (based on type of bearing).
4. Inspect the pump and accessories prior to installation of new motor.

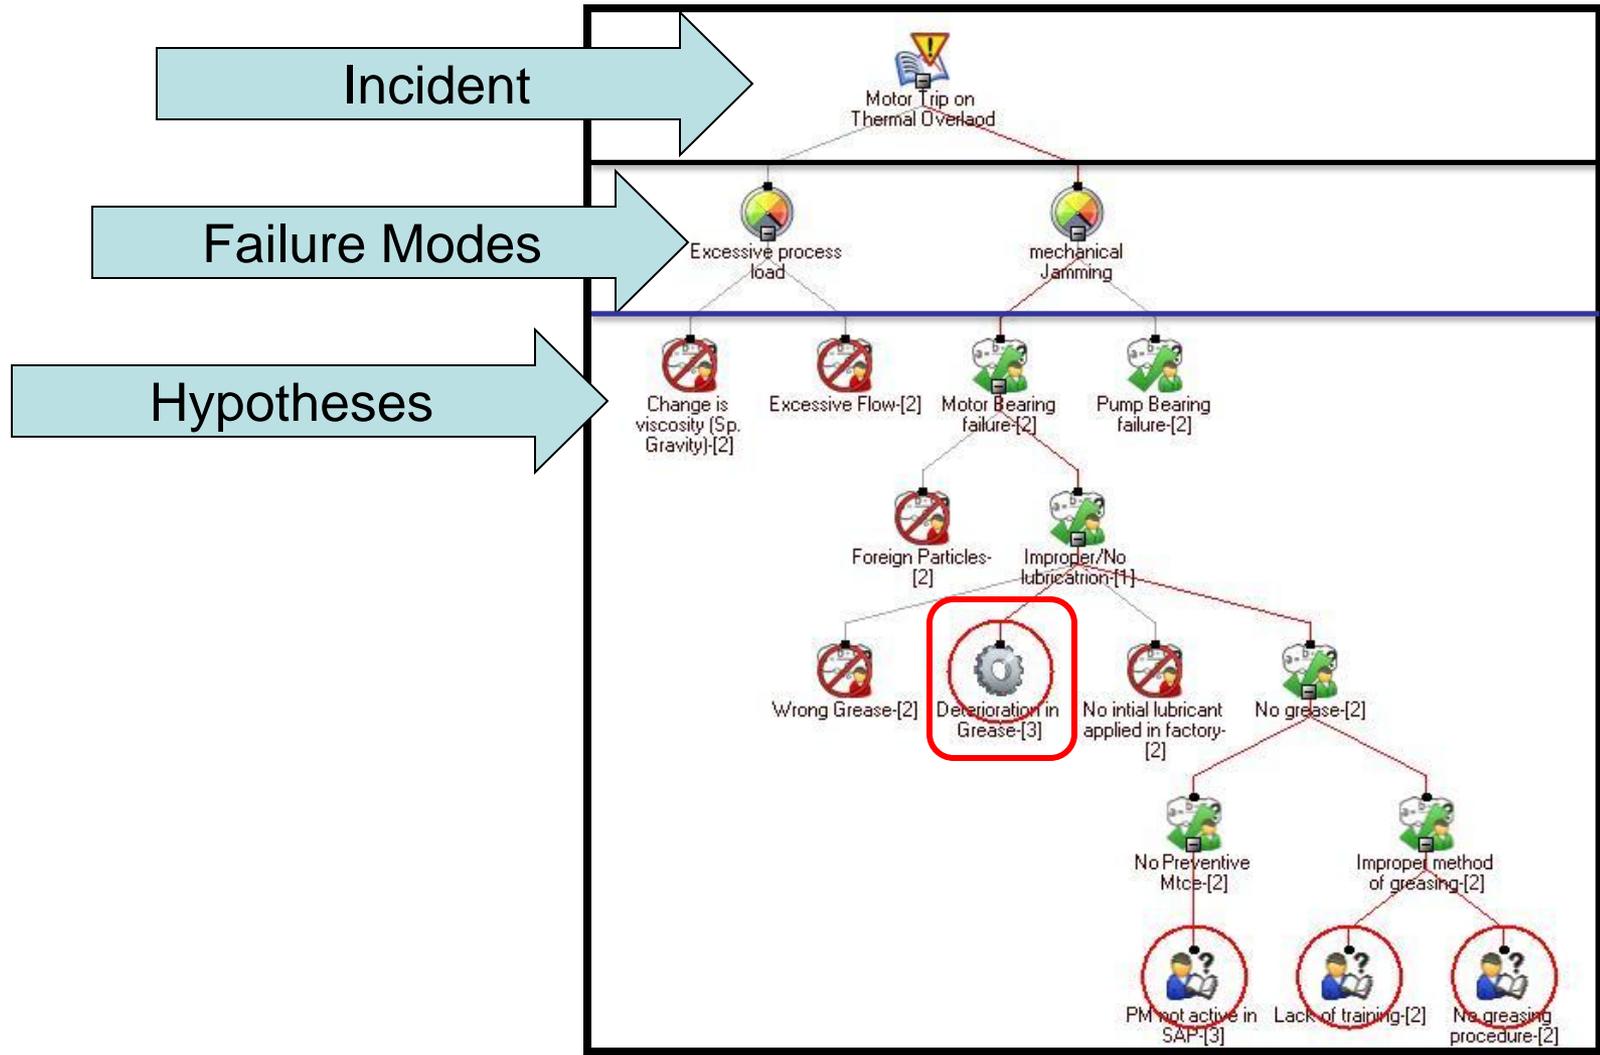
PROACT Logic Tree:

- PMs to lubricate the bearings were not active in CMMS.
- Grease was not checked/replaced during commissioning (built in 2006).
- Greasing procedure was not available for such motors
- Vendor Recommendation were not followed about greasing.
