FLOATING SEAL RING ACTING AS A THIRD BEARING

Case History

Presented by:
Sherif Mekawey, Principal Engineer
Machinery Management Services
GE – Bently Nevada
Abu Dhabi

February 2011

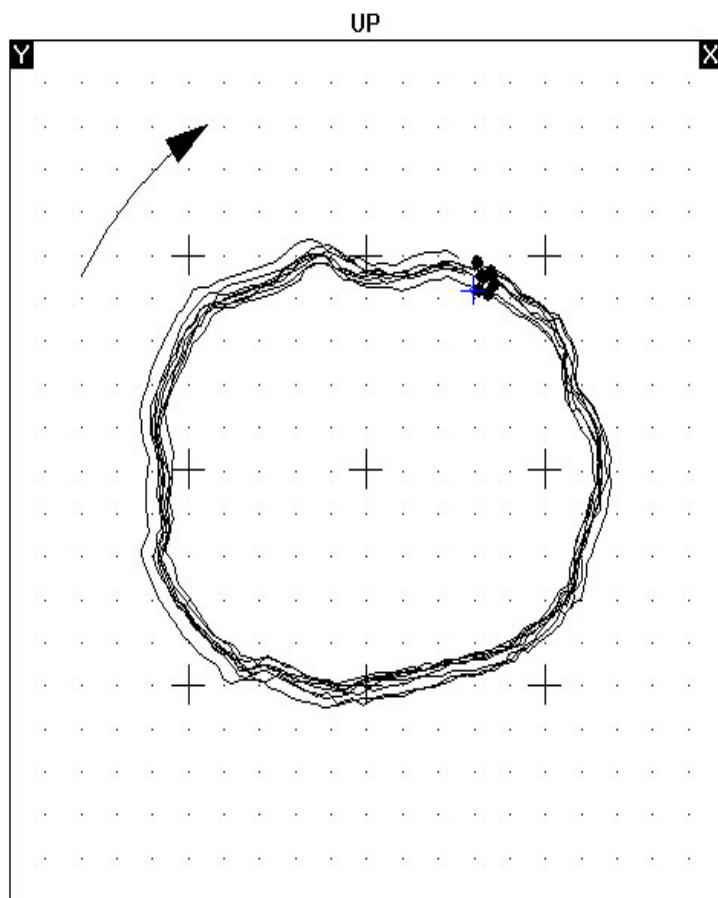
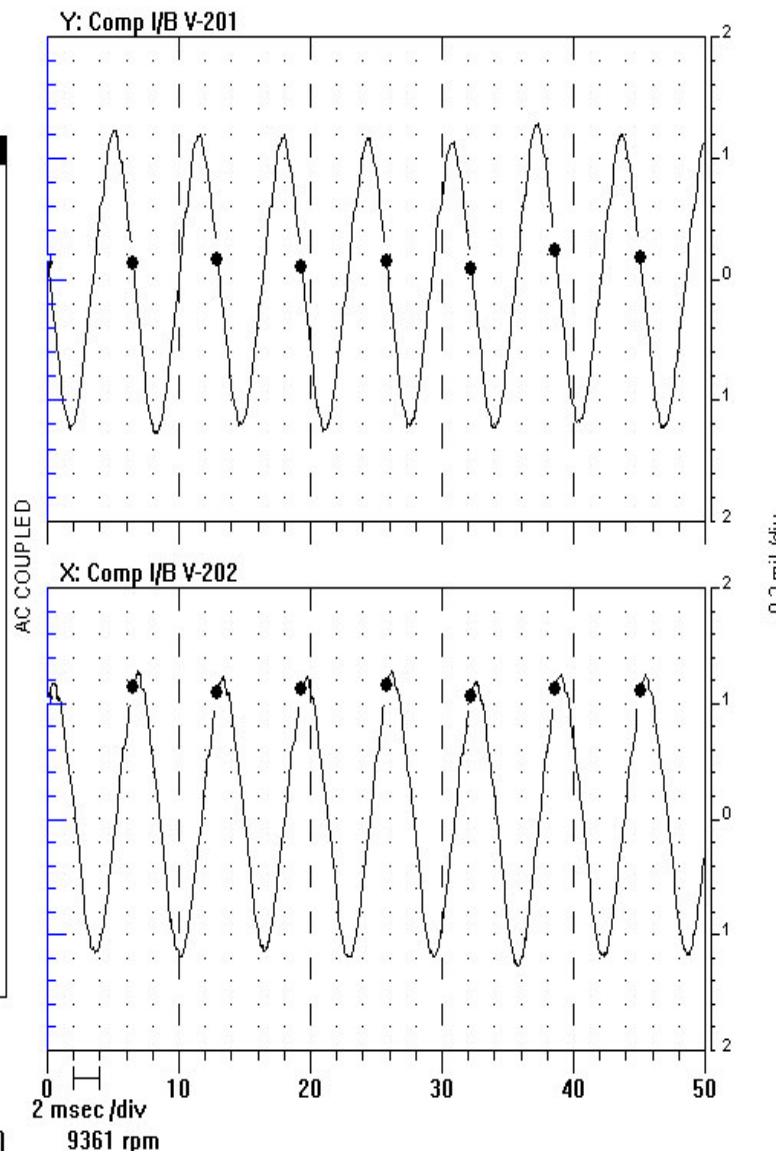
Direct Orbit/Timebase Plot

- The synthesis Gas Compressor was recently overhauled.
- Replaced the IP Compressor rotor, interstage seals and floating seal rings.
- Replaced the Inboard radial & thrust bearings of IP Compressor.
- When the machine started, high vibration was experienced on the Inboard bearing while Outboard bearing indicated low vibration levels.

Y: Comp I/B V-201 45° Left DIR AMPL: 2.55 mil pp
X: Comp I/B V-202 45° Right DIR AMPL: 2.50 mil pp
MACHINE: IP Compressor
01AUG2001 06:30:47.5 Steady State DIRECT

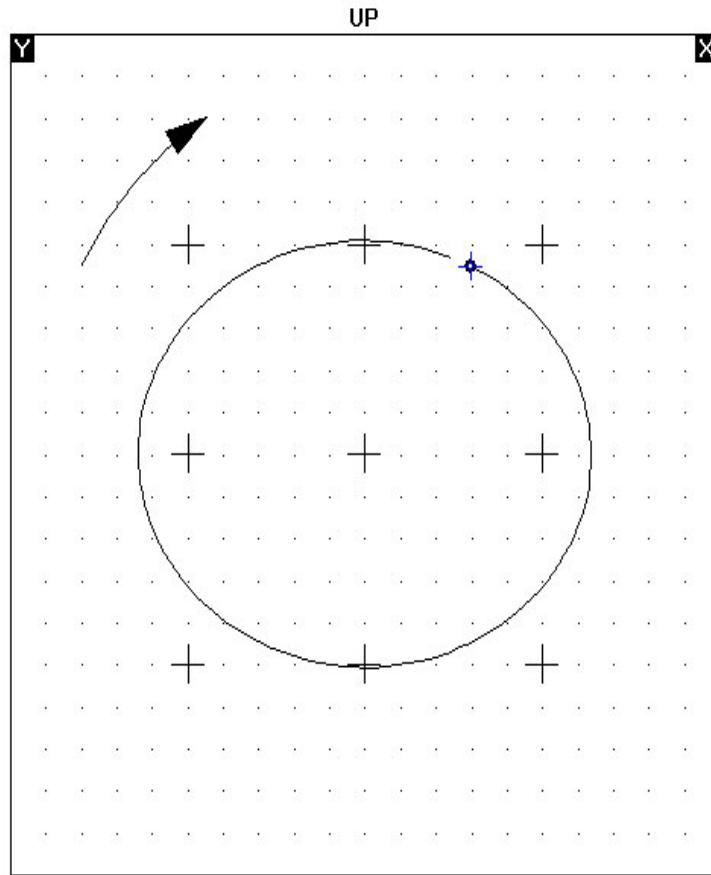
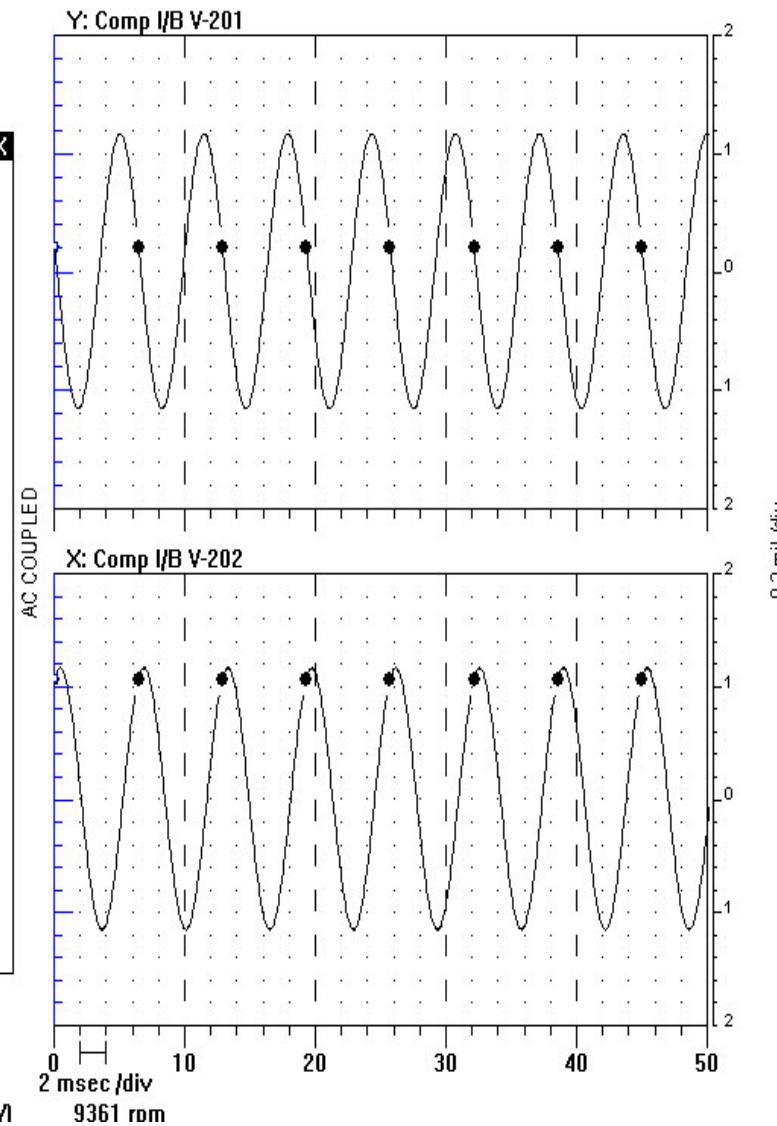
Filtered Orbit/Timebase Plot

: Comp IB V-201 45° Left VECTOR: 2.32 mil pp 283°
: Comp IB V-202 45° Right VECTOR: 2.31 mil pp 26°
MACHINE: IP Compressor
MAUG2001 06:30:47.5 Steady State 1X UNCOMP

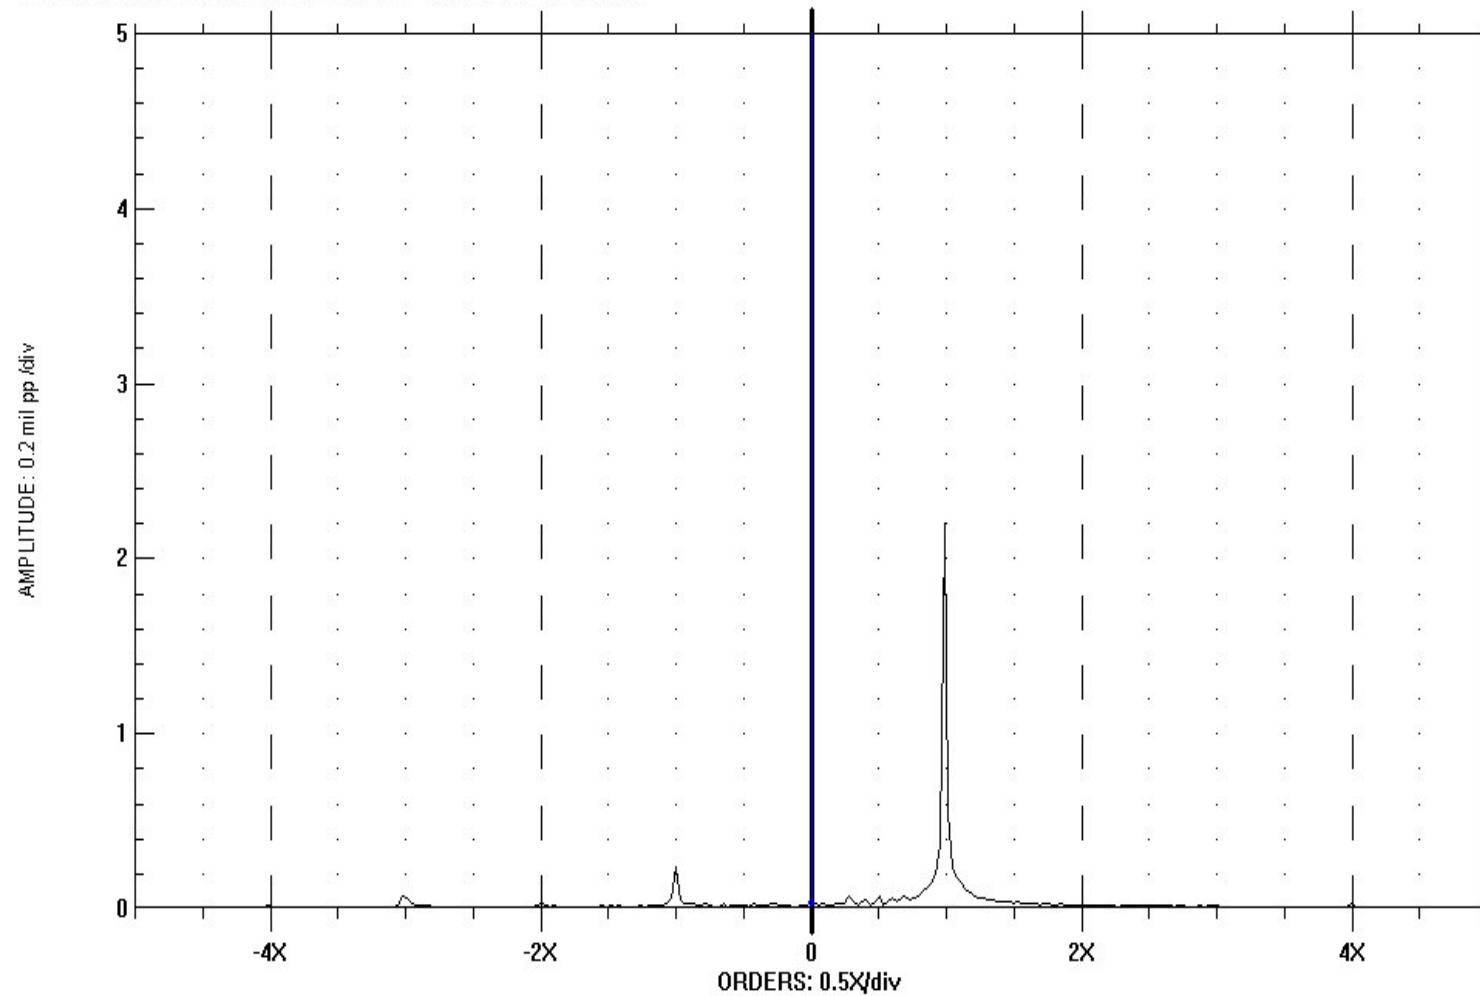
Full Spectrum Plot

POINT: Comp IVB V-201 $\angle 45^\circ$ Left DIR AMPL: 2.55 mil pp
POINT: Comp IVB V-202 $\angle 45^\circ$ Right DIR AMPL: 2.50 mil pp
MACHINE: IP Compressor MACHINE SPEED: 9361 rpm
01 AUG 2001 06:30:47.5 Steady State
WINDOW: None SPECTRAL LINES: 400 RESOLUTION: 0.032X

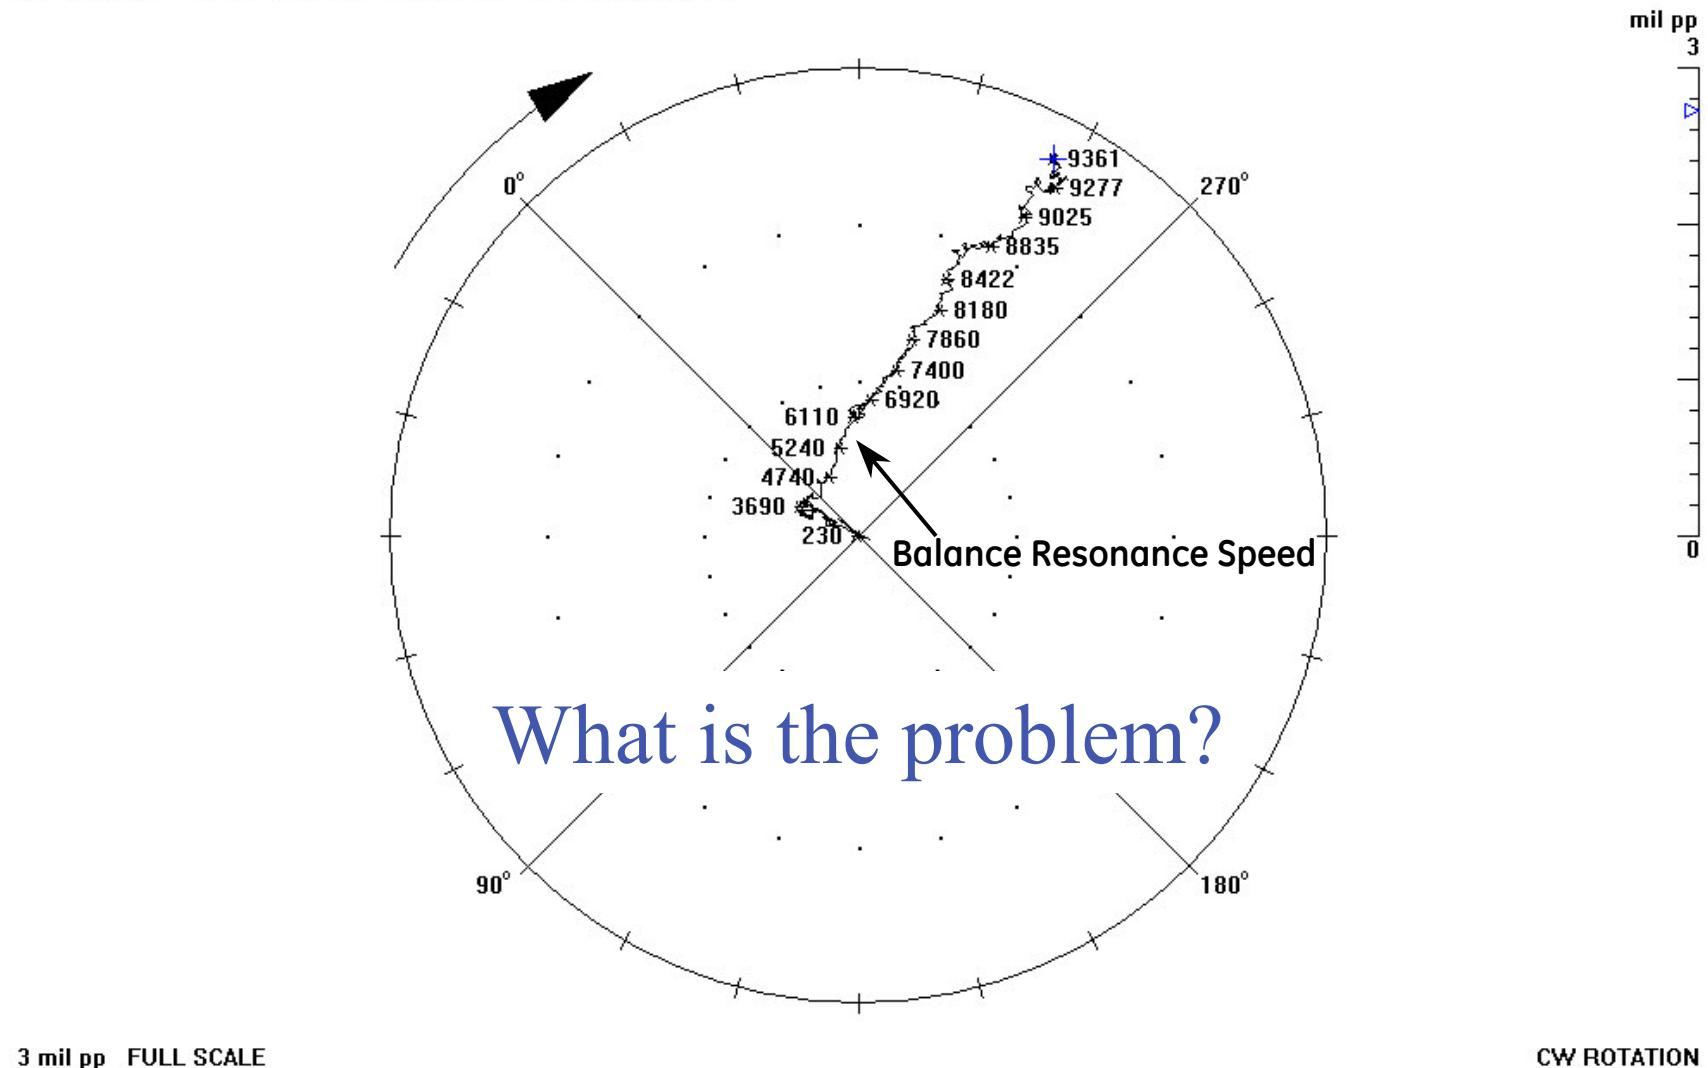
Shutdown Polar Plot

POINT: Comp I/B V-201 $\angle 45^\circ$ Left 1X COMP SR: 0.437 $\angle 131^\circ$ 2.72 $\angle 288^\circ$ @9361 rpm
MACHINE: IP Compressor
From 01AUG2001 06:30:47.5 To 01AUG2001 08:00:03.6 Shutdown

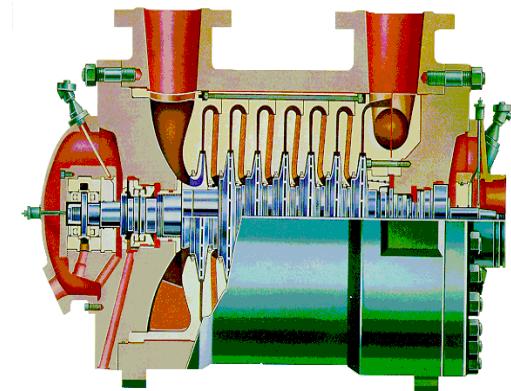
Symptoms:

- Vibration amplitude did not peak at the designed balance resonance speed of 5700 rpm
- The amplitude kept changing as the square of the speed changed from 5000 rpm to 9200 rpm.

All these symptoms prove that the balance resonance speed has increased to beyond operating speed.

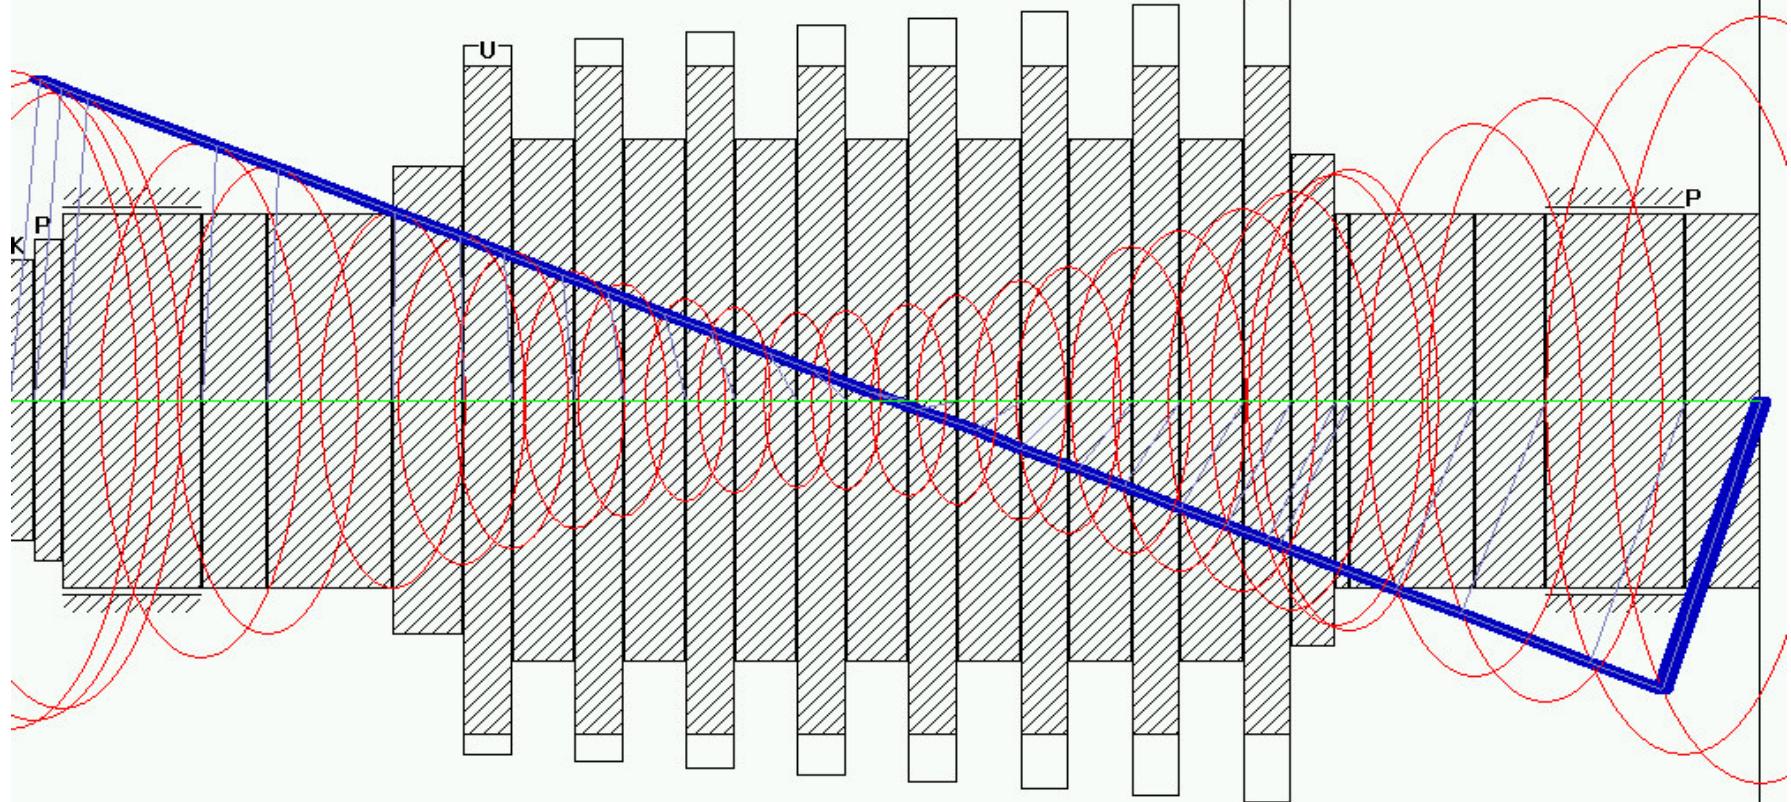
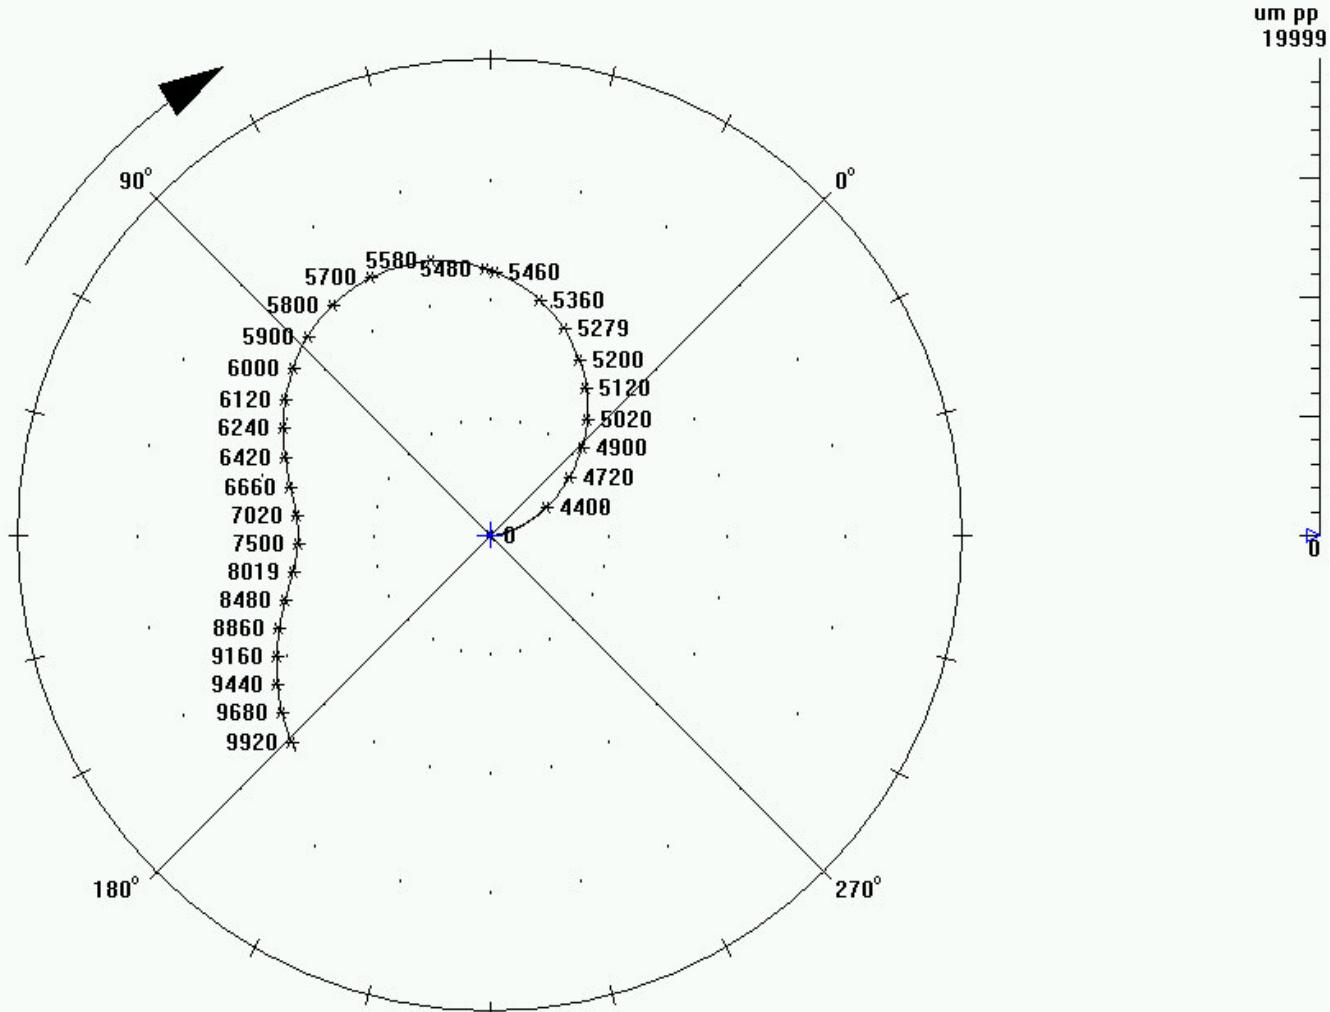
Modal Analysis

POINT: 2YD $\angle 45^\circ$ Right 1X UNCOMP

0 $^\circ$

@ 0 RPM

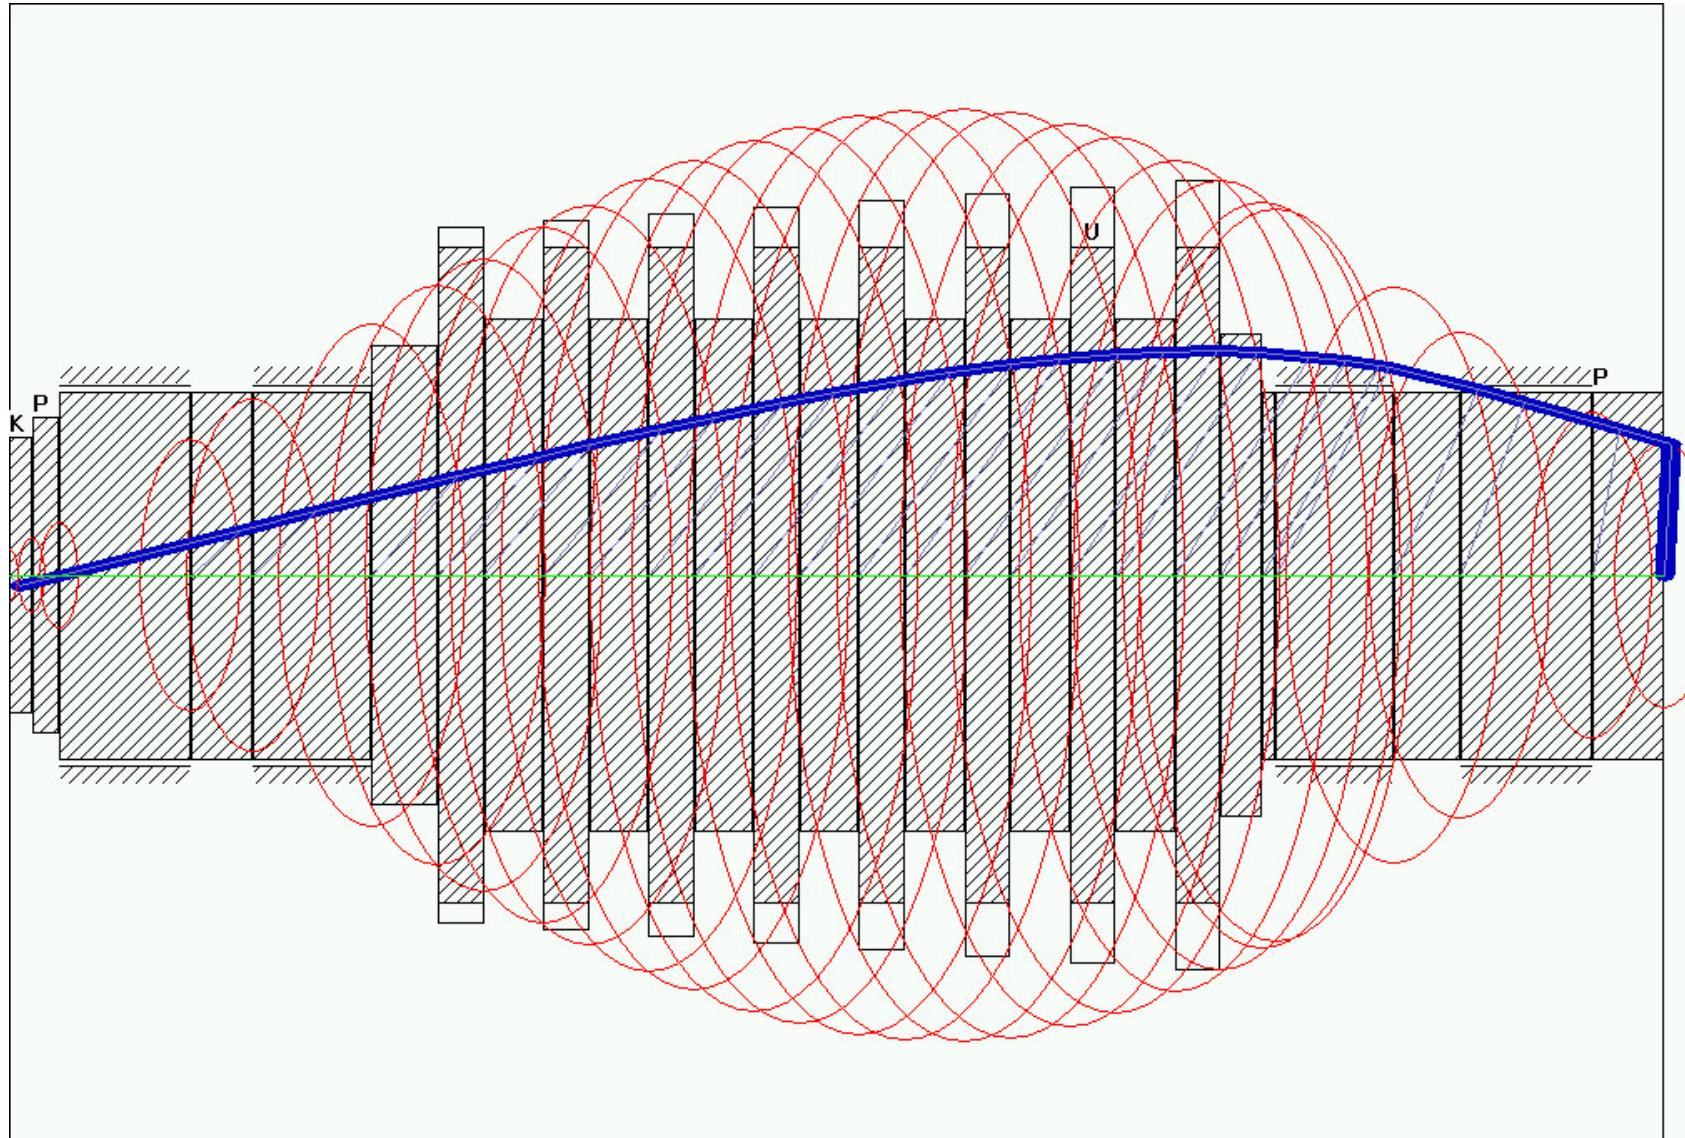
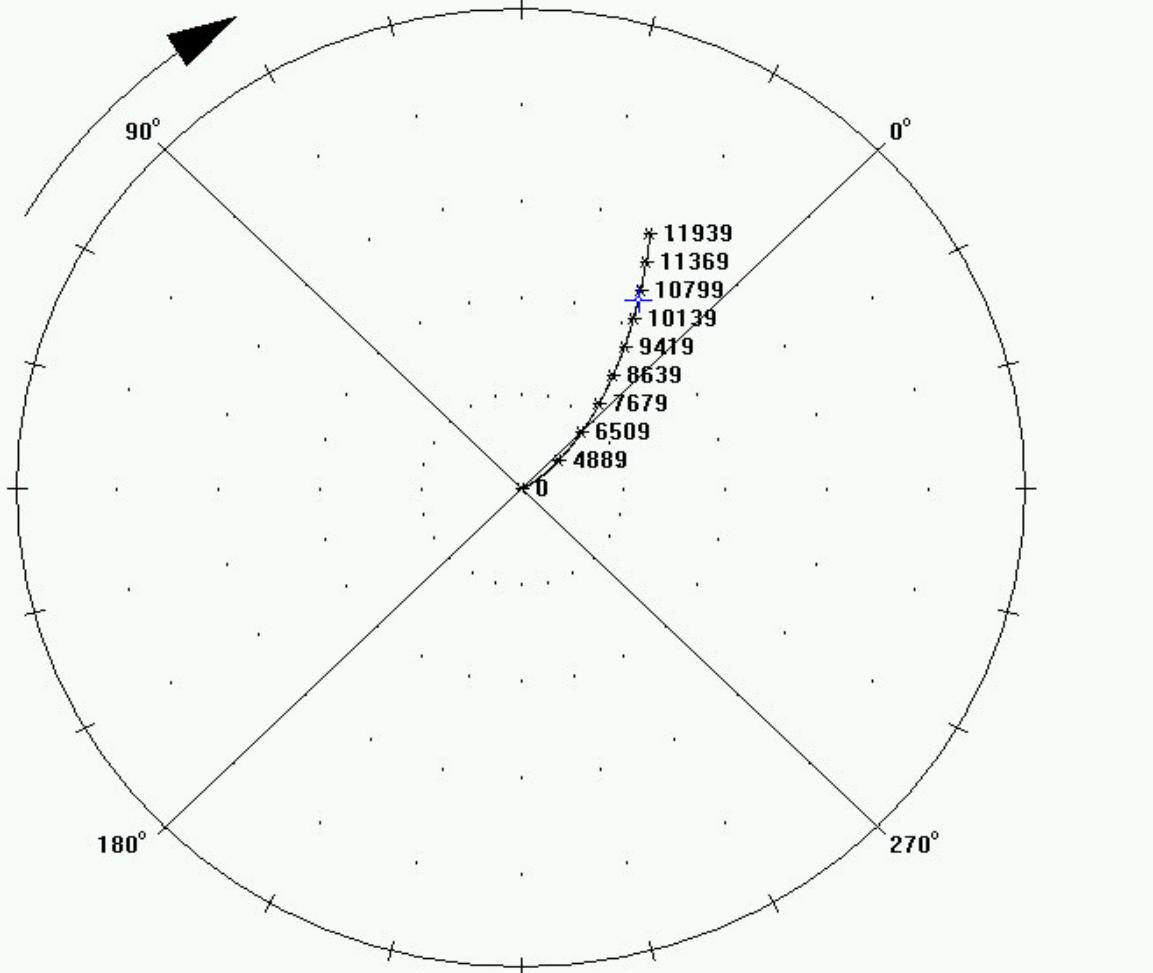
*Locked-up seal ring acting as
an additional bearing*

POINT: 2YD $\angle 45^\circ$ Right 1X UNCOMP

22.8 $\angle 15^\circ$ @ 10589 RPM

- Increased the seal rings clearance, typically from 0.001 to 0.003 inch (OEM Recommendation)
- Adjusted the anti-rotation pins to allow maximum floating

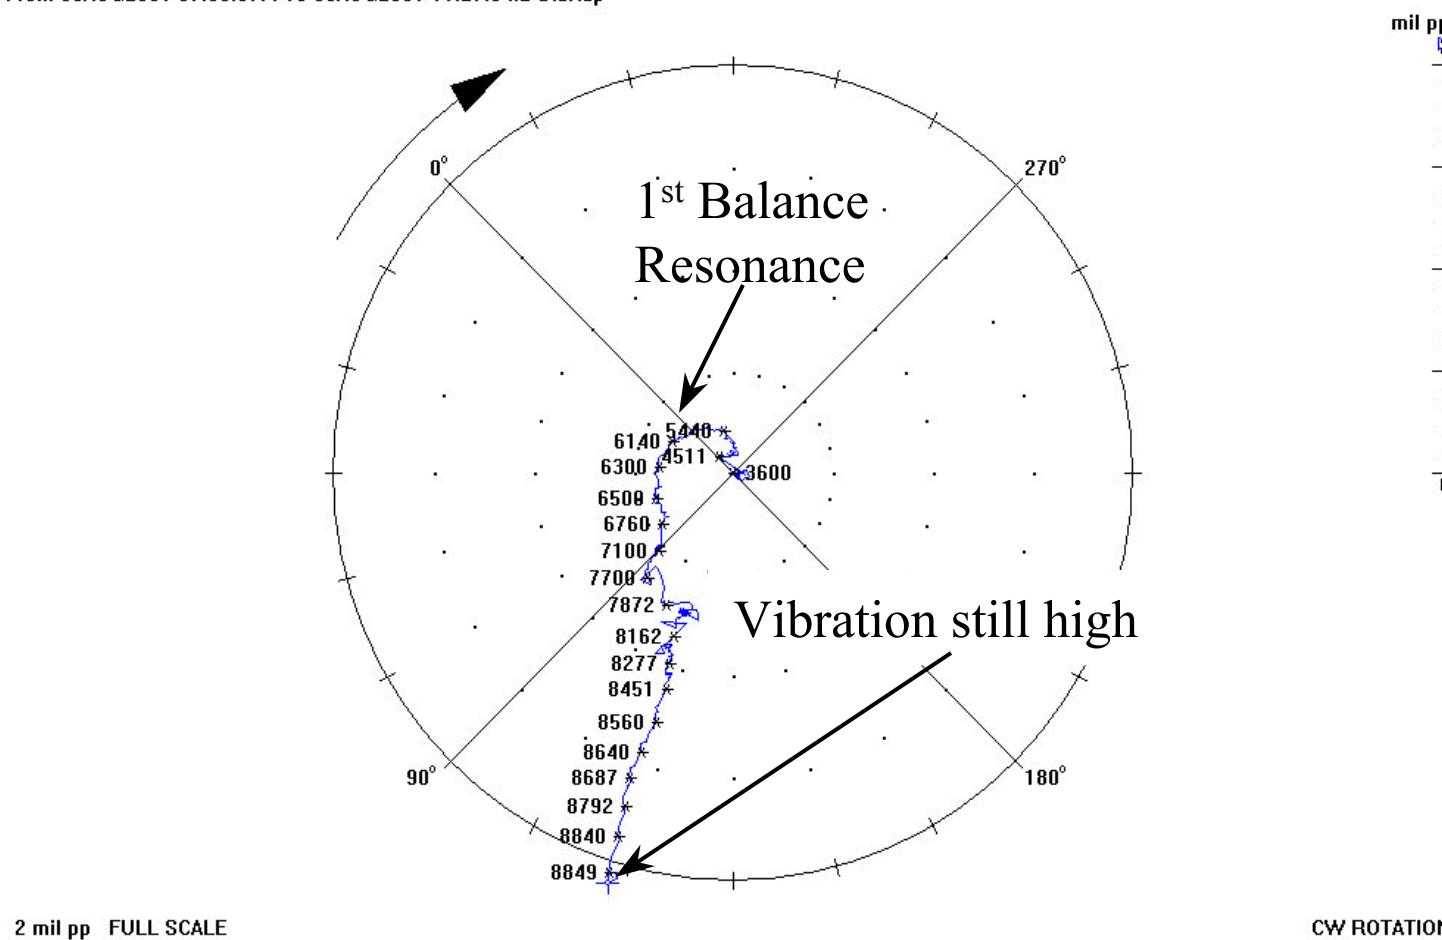
Startup Polar Plot

POINT: IP Comp I/B V-201 $\angle 45^\circ$ Left 1X COMP SR: 1.13 $\angle 169^\circ$ 2.10 $\angle 118^\circ$ @8849 rpm
MACHINE: IP Compressor
From 06AUG2001 07:06:07.4 To 06AUG2001 11:27:04.2 Startup

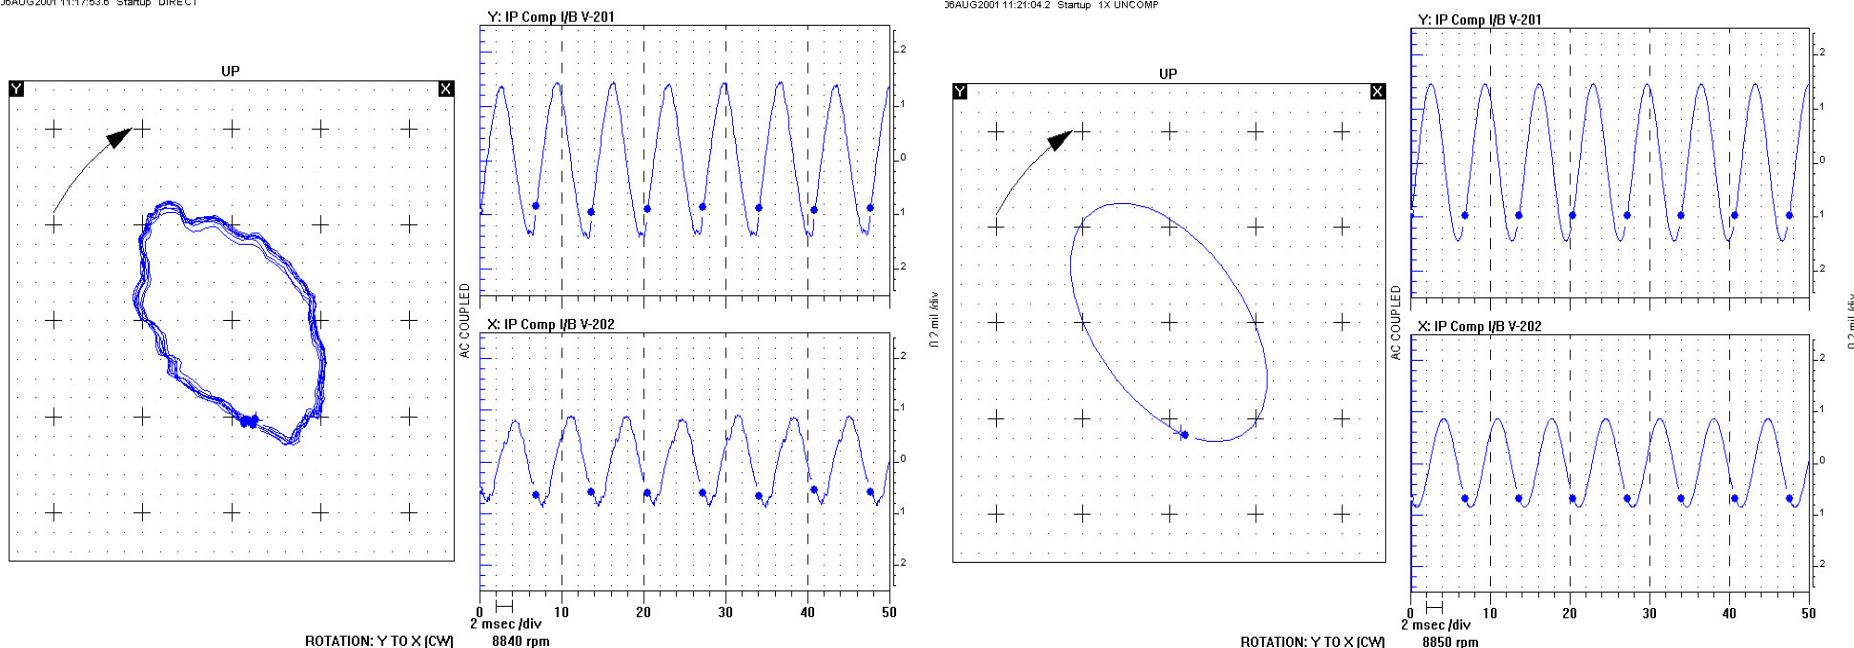
Y: IP Comp I/B V-201 $\angle 45^\circ$ Left DIR AMPL: 2.85 mil pp
 X: IP Comp I/B V-202 $\angle 45^\circ$ Right DIR AMPL: 1.82 mil pp
 MACHINE: IP Compressor
 06AUG2001 11:17:53.6 Startup DIRECT

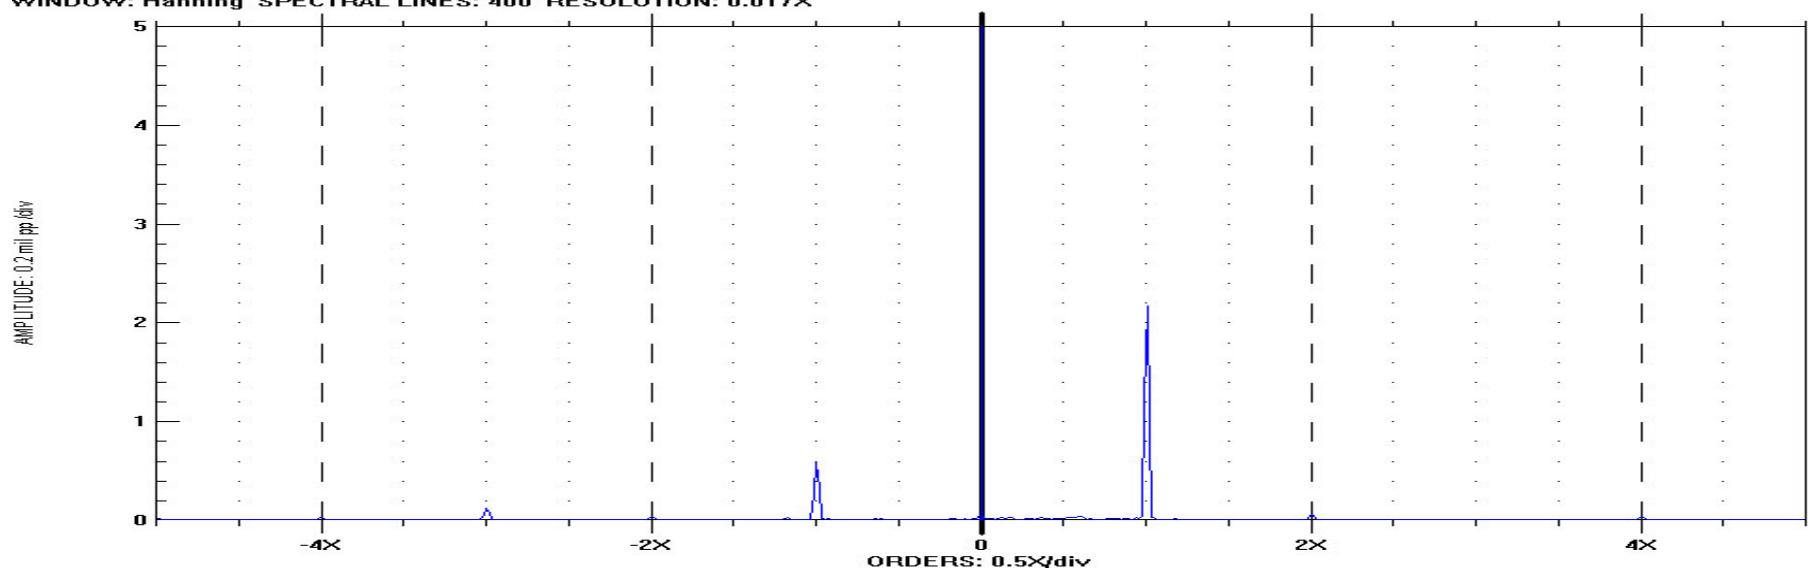
POINT: IP Comp I/B V-201 $\angle 45^\circ$ Left DIR AMPL: 2.85 mil pp
 POINT: IP Comp I/B V-202 $\angle 45^\circ$ Right DIR AMPL: 1.82 mil pp
 MACHINE: IP Compressor MACHINE SPEED: 8840 rpm
 06 AUG 2001 11:17:53.6 Startup
 WINDOW: Hanning SPECTRAL LINES: 400 RESOLUTION: 0.017X

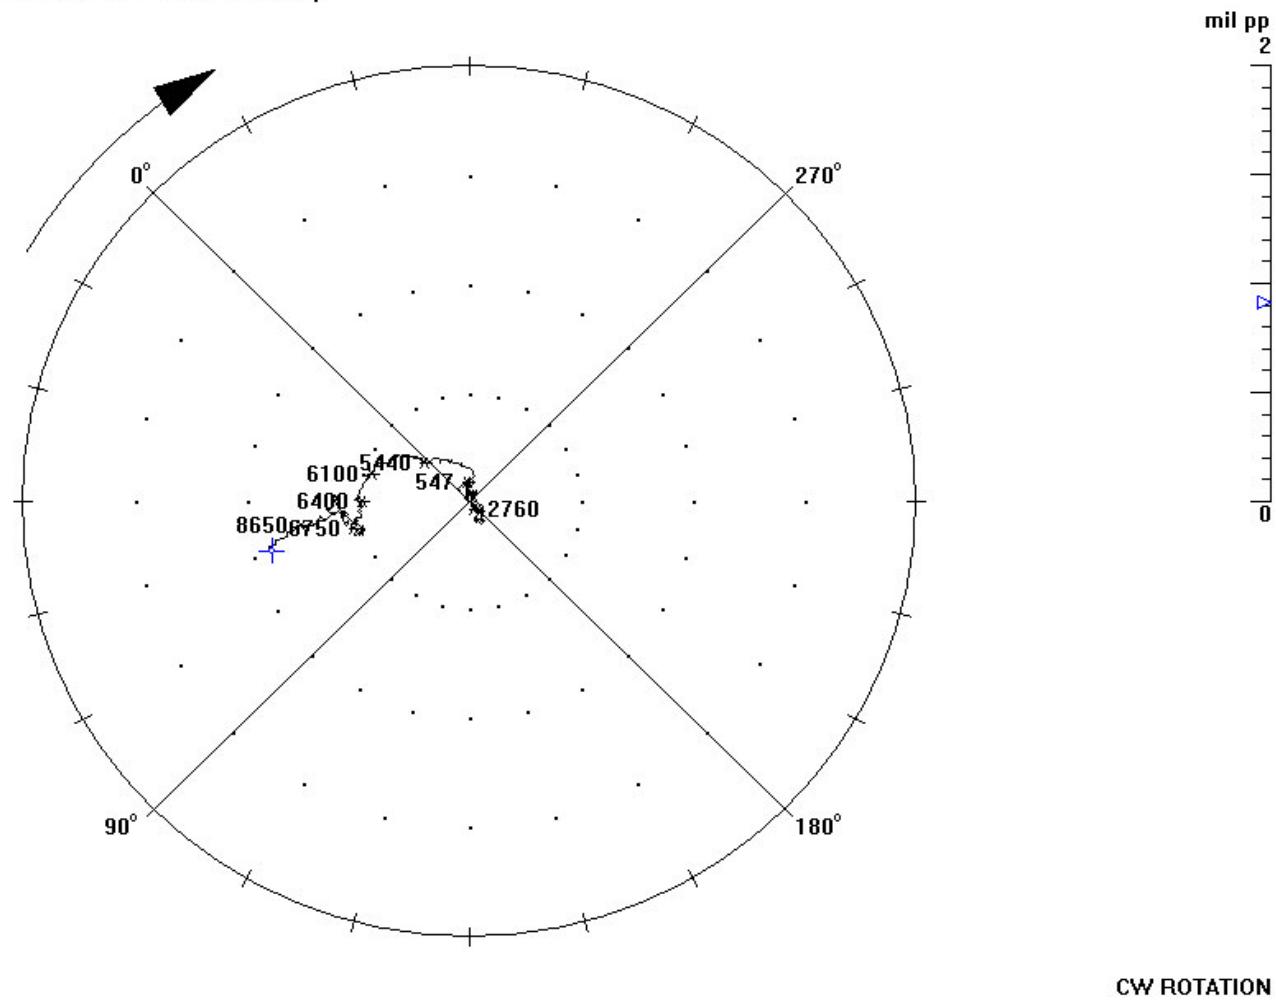
Startup Polar Plot

POINT: IP Comp I/B V-201 $\angle 45^\circ$ Left 1X COMP SR: 0.704/ 174° 0.910/ 59° @8820 rpm
MACHINE: IP Compressor
From 07AUG2001 04:40:46.3 To 07AUG2001 08:29:25.8 Startup
