Incinerator Air Blower Repetitive Failures

Authors : **RasGas Company Limited**

Incinerator Air Blower (Sulfur Recovery)

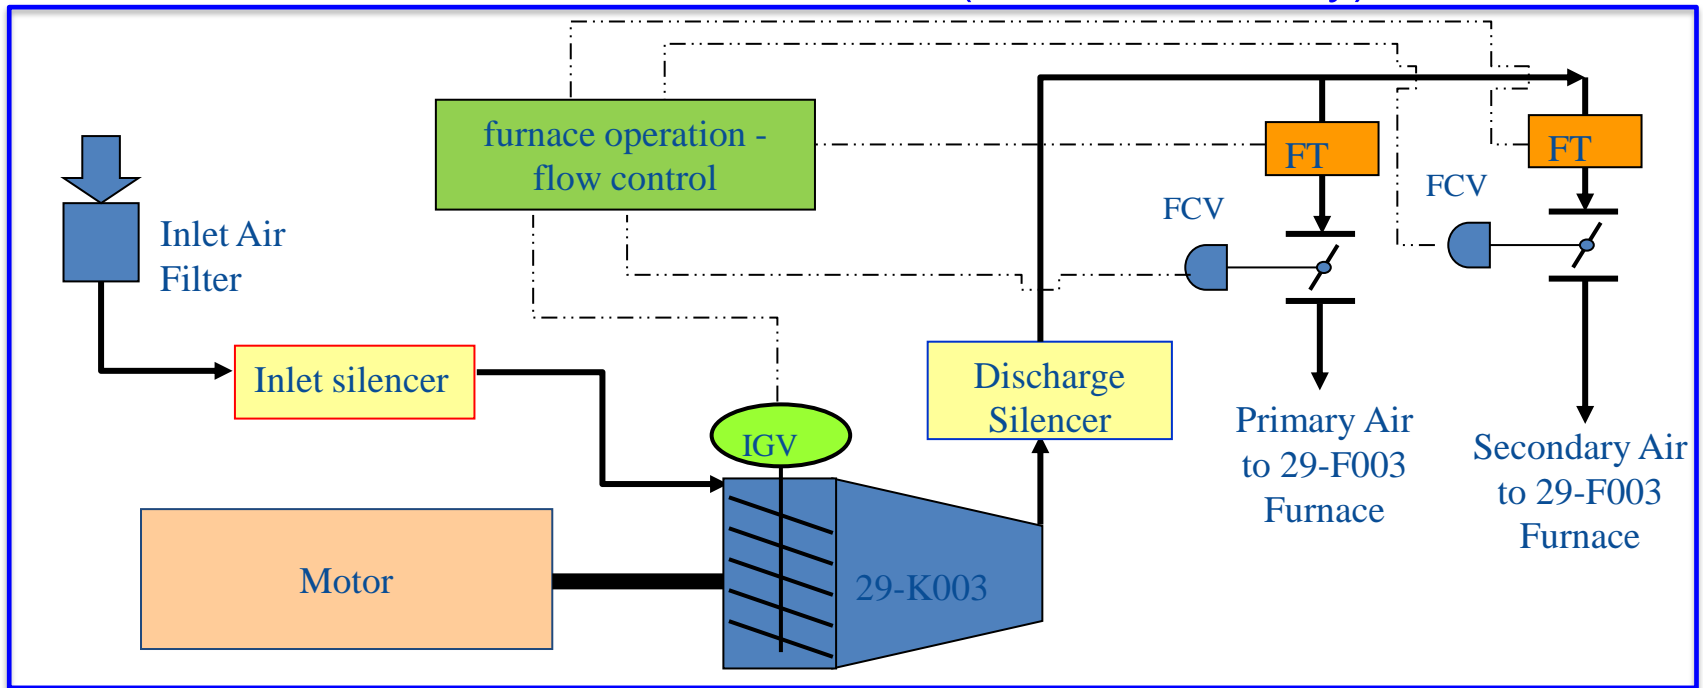
Equipment Details

Type	:	Centrifugal Fan, double side suction
Driver	:	Motor
Rated Power	:	930 KW
RPM	:	1500
Rated Flow	:	4830 M3/Min.
Suc. Pressure	:	Atm
Disch. Pressure	:	630 mm H2O G
Rotor Length & Wheel Dia.	:	4215 & 1680 mm

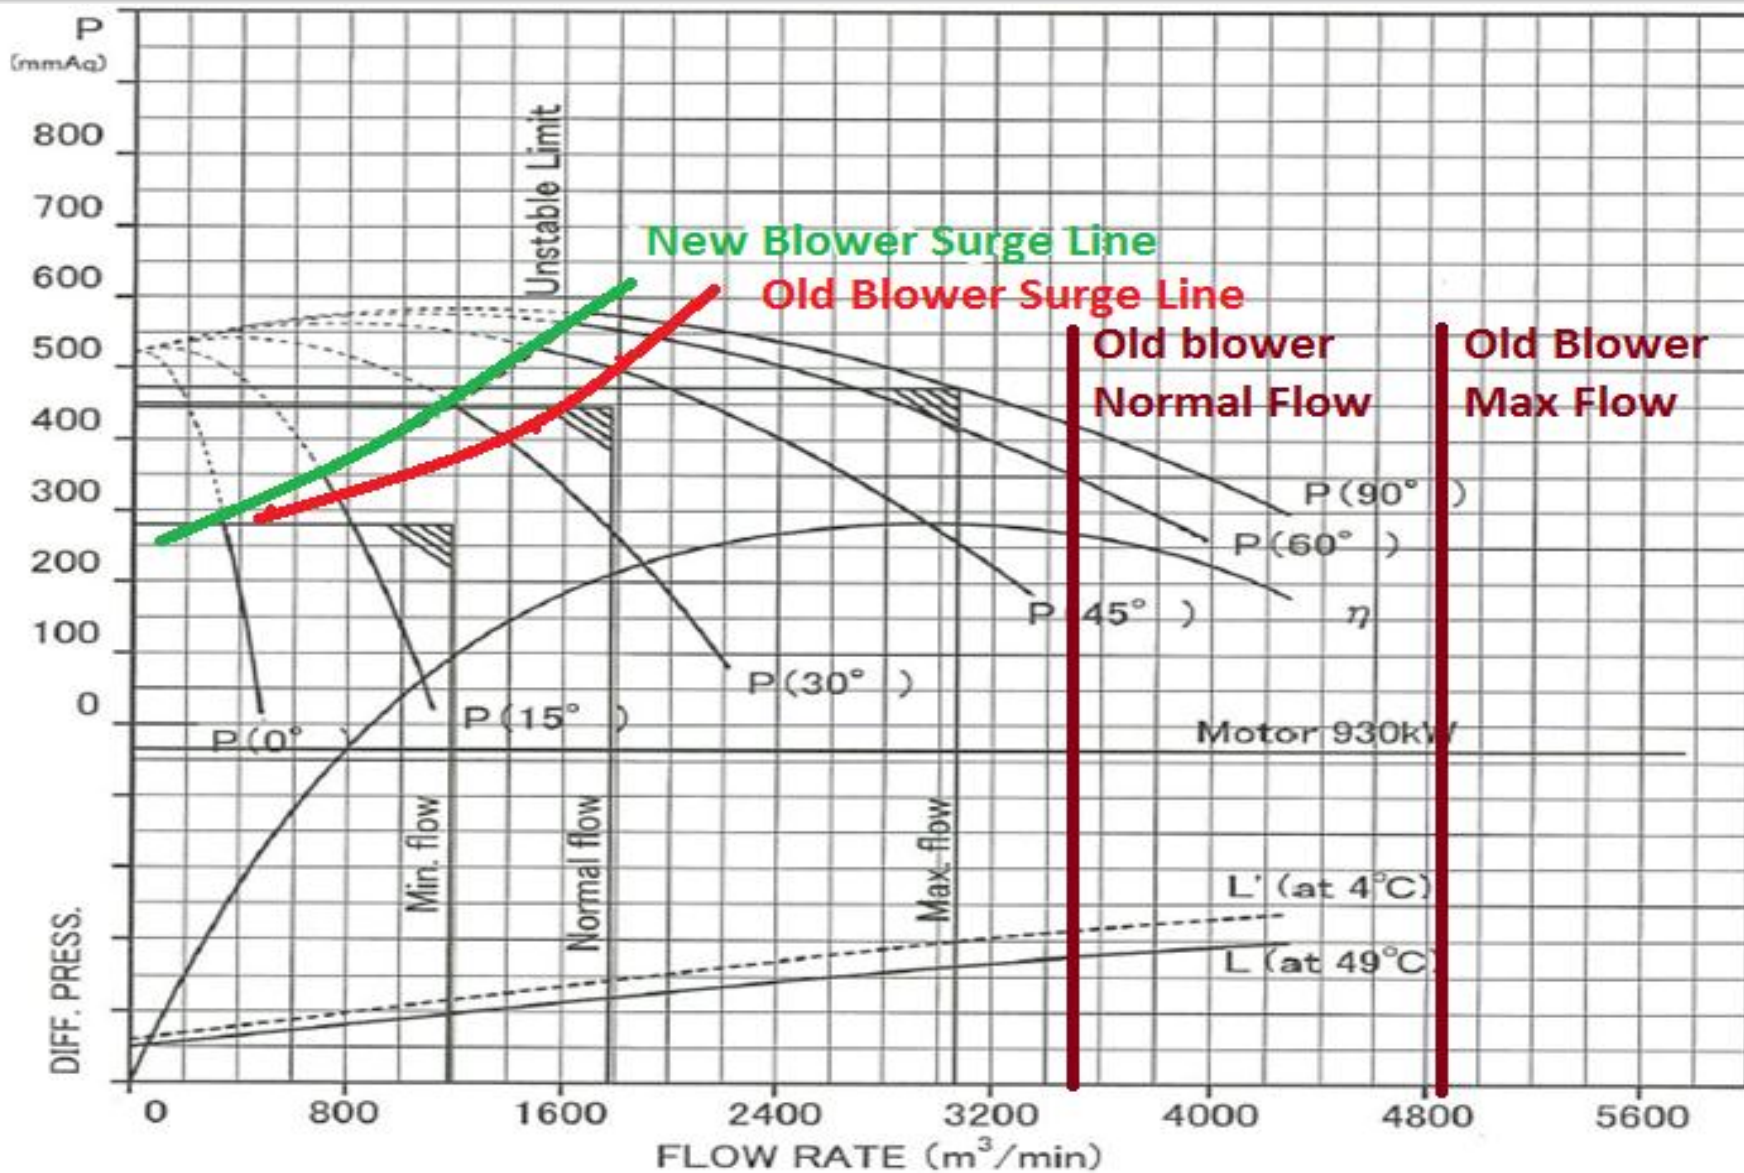
New Blower Performance Curve

- New blower max capacity is 3066 m³/min (old was 4830 m³/min).
- No major site modification:
 1. Same foot print, coupling and suction and discharge duct with transition pieces.
 2. Existing motor.
 3. No change in air inlet filtration unit.
