Compressor rotor failure due to fouling at Qatargas condensate refinery

Muhammad Zahid (Sr. Engineer – Rotating)
Devrajan Venkatesh (Rotating Equipt. Analyst)
N. K. Raju (Lead Process Engineer)
Christopher G Holt (Proj & Facilities Engg Div Manager)

A Case Study

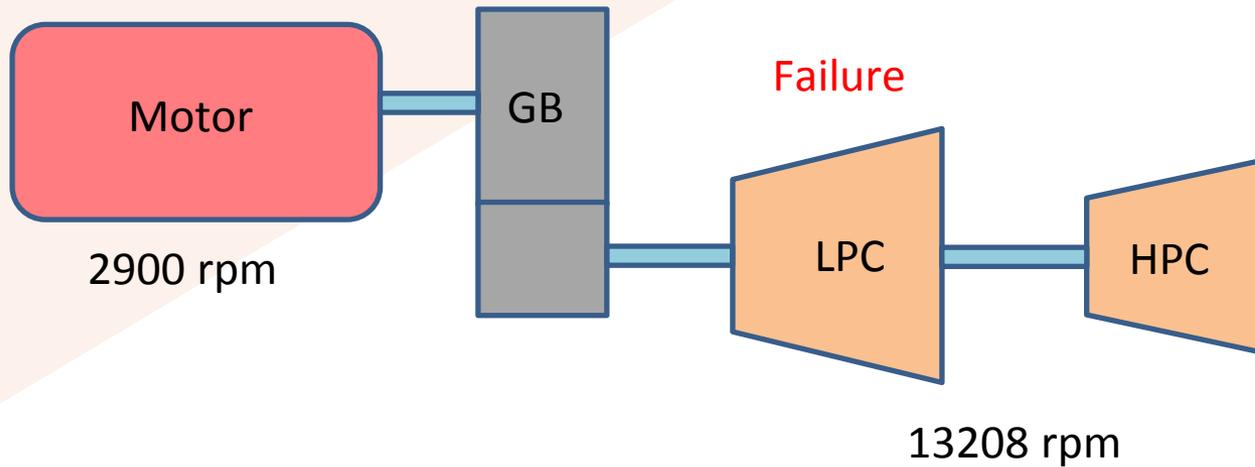
Hydrogen Recycle Compressor

- The compressor train is equipped with BN 3500 system
 - The compressors are of barrel type construction
-
