Oil-flooded Screw Compressor Failures, Causes, Rectifications

Quraisy Shatri (RE Specialist - RasGas)

Qatar is second world largest producer of Helium after the US, and biggest exporter of this lightest gas. In Helium Plants operated by RasGas several flooded-type screw compressors are running. There have been some issues with the units which can be categorized in to three groups: installation, maintenance and operations.

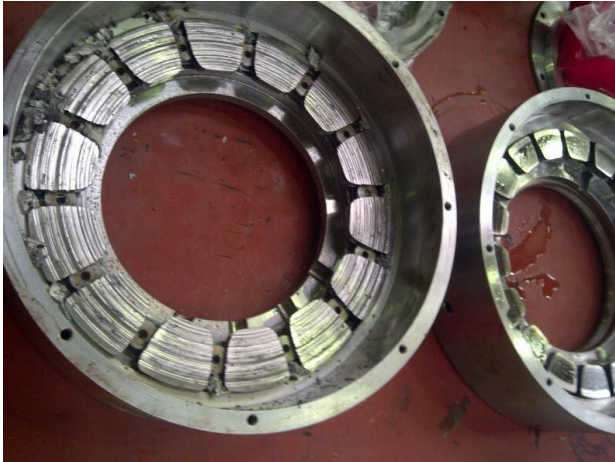
Main bearing Drive and driven side found with scratch marks.

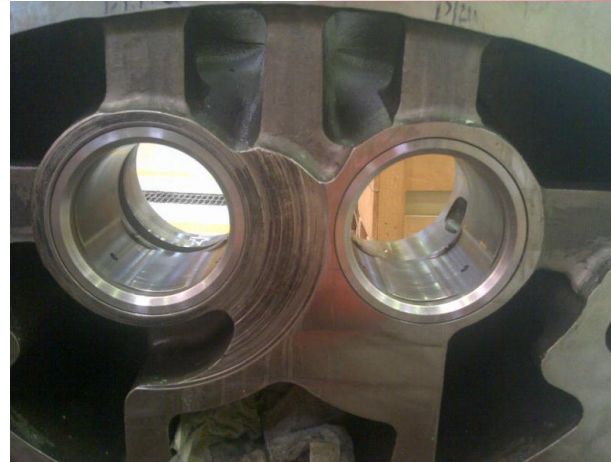
- Male rotor's active & inactive thrust pads severely wiped-out; thrust runner 'grinded-off.'
- Male-rotor shaft @ seal area worn-out
- Stuffing box – worn-out

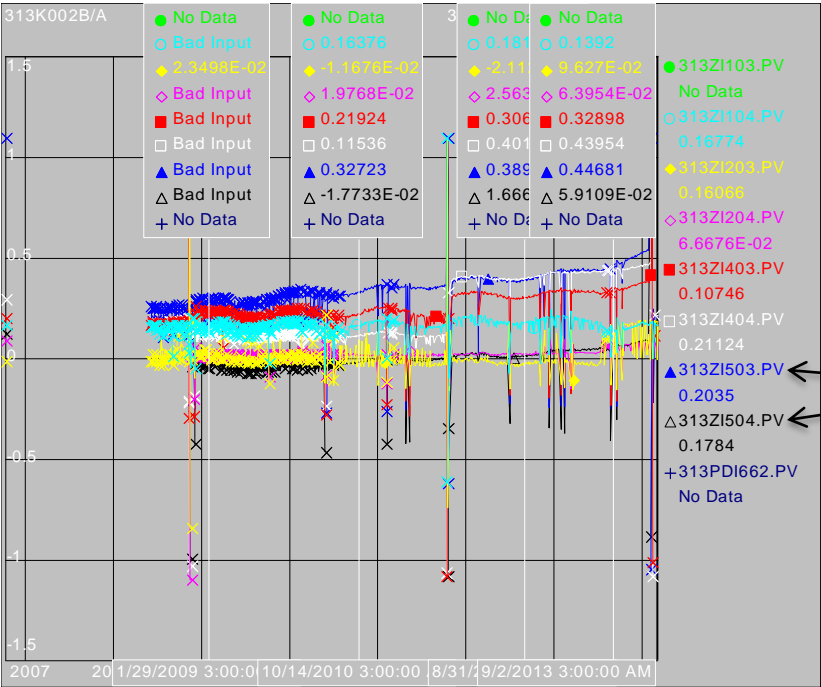
Increasing trends of both male and female rotors' axial position after ~ 6 years in service (2008 ~ 2014)

- If thrust bearings have not been replaced with new ones for a period of 5 or more years, plan for a change.
- 0 ~ 5 years of operations...review operation records to determine time to replace
- OEM recommendation ($L = L_{max} * CF$); Correction Factors are dependent on thrust-load (inlet pressure), service gas, oil properties, and change-out experience; with $L_{max} = 30,000$ hours.
- **This** HP Screw Compressor experience indicated that approx. life-span of the thrust bearings was 25k hours.
