RCFA for Recurring Impeller Failures in a 4.7 Mtpa LNG Train Propane Compressor

ABSTRACT

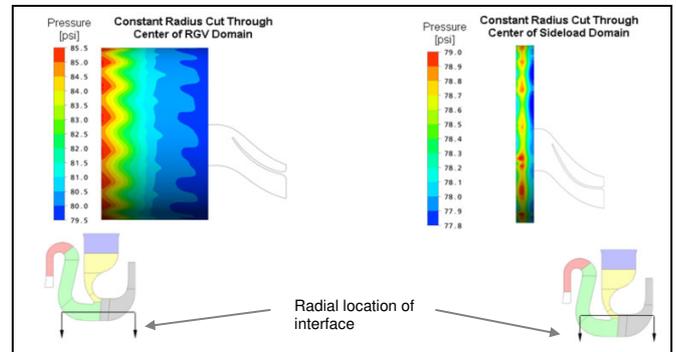
Figure 13. Fourth Impeller CFD results for vane wake impeller interface

surface but allowed to vary at the upstream and downstream locations. Figure 13 shows the predicted pressure wake distributions for the 16X return channel vane and 14X side load vane wake frequencies. The applied operating boundary conditions were close to the compressor rated point although other cases close to surge and choke were also run. The results indicate that no large wakes in either domain are present and the maximum pressure gradient is less than 2 psi (0.14 bar), which is about 2 percent of the fourth impeller inlet pressure

A particular area of concern was how both 16X return channel and 14X side load wakes would interact at the impeller inlet. In order to assess this, the predicted static pressure distribution at the interface between the return channel and side load domains was analyzed using the Fast Fourier Transform (FFT) method. Results are shown in Figure 14 where no higher harmonics causing resonance were discovered. The mixing signal on the graph is the pressure at the interface between the return channel and side load flows. It is approximately equal to the sum of the pressure variations from the two individual streams.

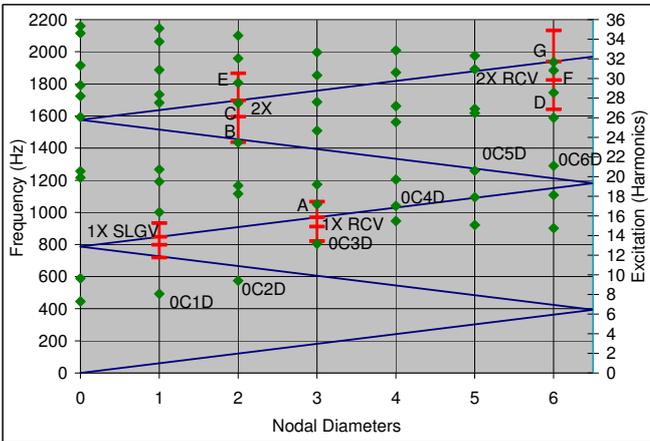
Figure 12. Fourth Impeller Interference Diagram

Figure 12 shows the interference diagram based on FEA predictions for the fourth impeller. The left vertical axis represents the frequency in Hertz (Hz). The horizontal axis represents the nodal diameter mode shape of the impeller. The right vertical axis shows excitation harmonics of running speed. The blue diagonal lines represent maximum continuous speed times multiples or harmonics of running speed shown on the right vertical axis. The red vertical lines show potential excitation from the 14 side load guide vanes and the 16 return channel vanes upstream of the impeller. Lines are shown for both 1X and 2X excitation. Because the compressor can be operated over a variable speed range, the red lines are shown with an upper and lower limit represented by the bar at the top and bottom of the line. The upper limit is for 10 percent above maximum continuous speed and the lower limit is based on 10 percent below minimum continuous speed. The plus and minus 10 percent values are used to account for potential differences between predicted and actual natural frequencies. The inner bars represent actual continuous operating speed range from 3420 to 3636 rpm. The green diamonds represent calculated natural frequencies versus nodal diameter mode shape. The points labeled "OCxD" represent the fundamental impeller nodal diameter frequencies. Based on this data seven potential resonant points were identified and are labeled A through G.

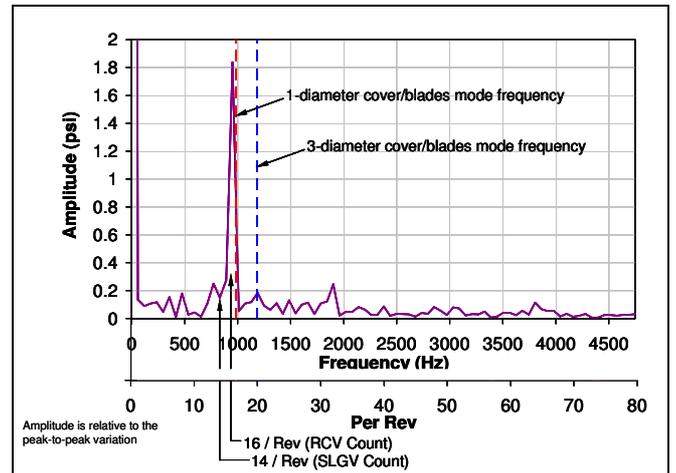
Figure 14. Fourth Impeller FFT for 16X and 14X combined signals

The measured 1-diameter cover/blades mode (984 Hz) is plotted as the red dashed line. This frequency is only slightly above the 16X return vane wake frequency and without phase cancellation would be considered resonant. A peak static

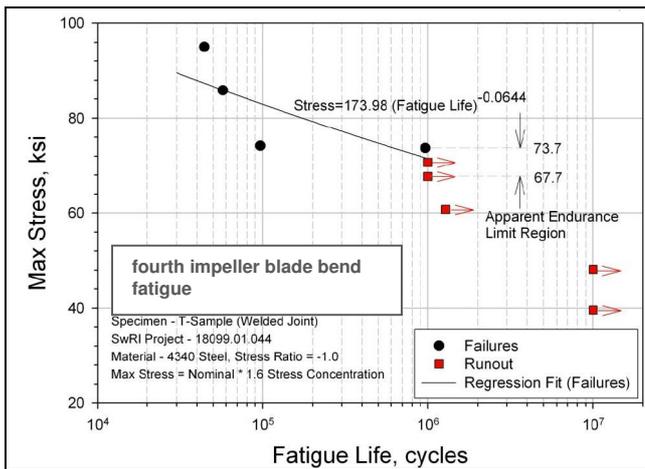
Figure 16. Fourth Impeller T-sample bend fatigue test results

As previously discussed, the alternating stress limit is defined under the condition of zero mean equivalent stress. Due to the fact that the failures occurred at the toe of a weld and the properties in welds can be variable, it was difficult to determine what and if published fatigue data would be applicable. It was suggested that testing of the actual weldment would provide the most satisfying results. The testing consisted of T-sample fatigue testing of twelve samples taken from four individual blades of the 2007 failed fourth impeller. Each sample was taken across the weld region near the leading edge of the blade. The applied alternating stresses ranged from 95.06 ksi (655.4 MPa) to 39.62 ksi (273.2 MPa) and resulted in lives of 44 thousand cycles and 10 million cycles respectively. Failure was achieved at 73.7 ksi (508.1 MPa) stress and 965 thousand cycles for one sample but two other samples achieved run-out at 10 million cycles at slightly less stress, see Figure 16. The failure stress that was applied within Goodman diagram was taken in between these three points at 70 ksi (482.6 MPa). Despite the fact that the samples were taken from the actual failed impeller, which, in theory, would remove effects due to geometry and surface variations, the analysis included the assumption that the T-sample test did not represent the worst case. For example, it was observed that the surface at the leading edge had slightly more extensive damage due to erosion than the location the samples were taken from. Therefore, a reduction of the endurance stress was included to account for the effects of material surface flaws and deviation from averaged endurance results (reliability). These “K factors”

were 0.7 and 0.81 respectively. The source for the values was taken from (ANSI/ASME B106.1M, 1985). The product of the K factors reduced the effective endurance limit for the alternating stress to 39.7 ksi (273.7 MPa). It is noted that the use of these values is conservative. In particular, the K factor related to the surface is the value used if the sample tested had a mirror finish rather than the actual eroded surface. The reliability K factor is essentially a statistical factor to account for the inherent variation in fatigue data. The value of 0.81 assumes that 99 percent of all samples tested at 70 ksi (482.6 MPa) do not fail after 10^6 cycles. This is a reasonable reduction given the number of samples available for testing.

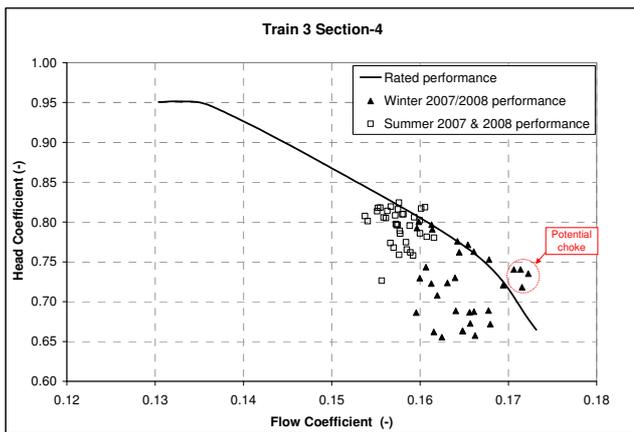
Figure 27. Fourth Section head versus flow coefficient – Train 3

65 data points were chosen from the performance monitoring database for Train 3. One point per week was chosen for the duration between the first and second failure shutdowns in June 2007 and May 2009. The criterion used to select each point was the highest measured mass flow rate at the discharge venturi meter. The performance of each compressor section was predicted using four different software packages, three of which were proprietary. The commercially available software package (Flexware) uses measured inlet pressure and temperature, gas properties, mass flows and shaft speed for each inlet. Thermodynamic calculations between two state points are done by applying the Redlich-Kwong equation of state. The main challenge associated with this approach is that the discharge temperature of each compressor section is not measured and can only be estimated by assuming a polytropic efficiency. The first section discharge flow combines internally with the known pressure, temperature, and mass flow of the first side load to form the inlet conditions for the second section. This is repeated for each section so that any inaccuracies can compound up to the fourth and final section. If the calculated fourth section discharge temperature does not match what is measured, the program logic will adjust work in all sections by an equal amount until the final temperatures match. Work is defined as polytropic head divided by polytropic efficiency. This has the effect of altering section polytropic efficiency and calculated discharge temperature. Although measured properties were typically well matched, some uncertainty still remained about the inlet conditions of the second, third and fourth sections. Another source of potential error came from the mass flow into the fourth section. Flow from the third side load is not a measured value, rather it is calculated from the final discharge flow minus the main inlet, first side load and second side load flows. Therefore, if any of these flows are in error, this error will also affect the mass flow calculated into the fourth section.

The results are plotted in Figure 27 in the form of head coefficient versus flow coefficient for the fourth section. The

The second recommendation was intended as the long term solution. A re-wheel study has recently begun with the OEM for all five impellers and their static flow path components. This would relocate the current operating points further to the left in Figure 27. Not only would this provide more margin from choke but it would also lead to a greater overall efficiency.
