Reliability Improvement for Turboexpander-Compressor System

Marc S. LeDuc Atlas-Copco Mafi-Trench Co. Hassan A. Mazi Saudi Arabian Oil Company

Hawiyah NGL Plant

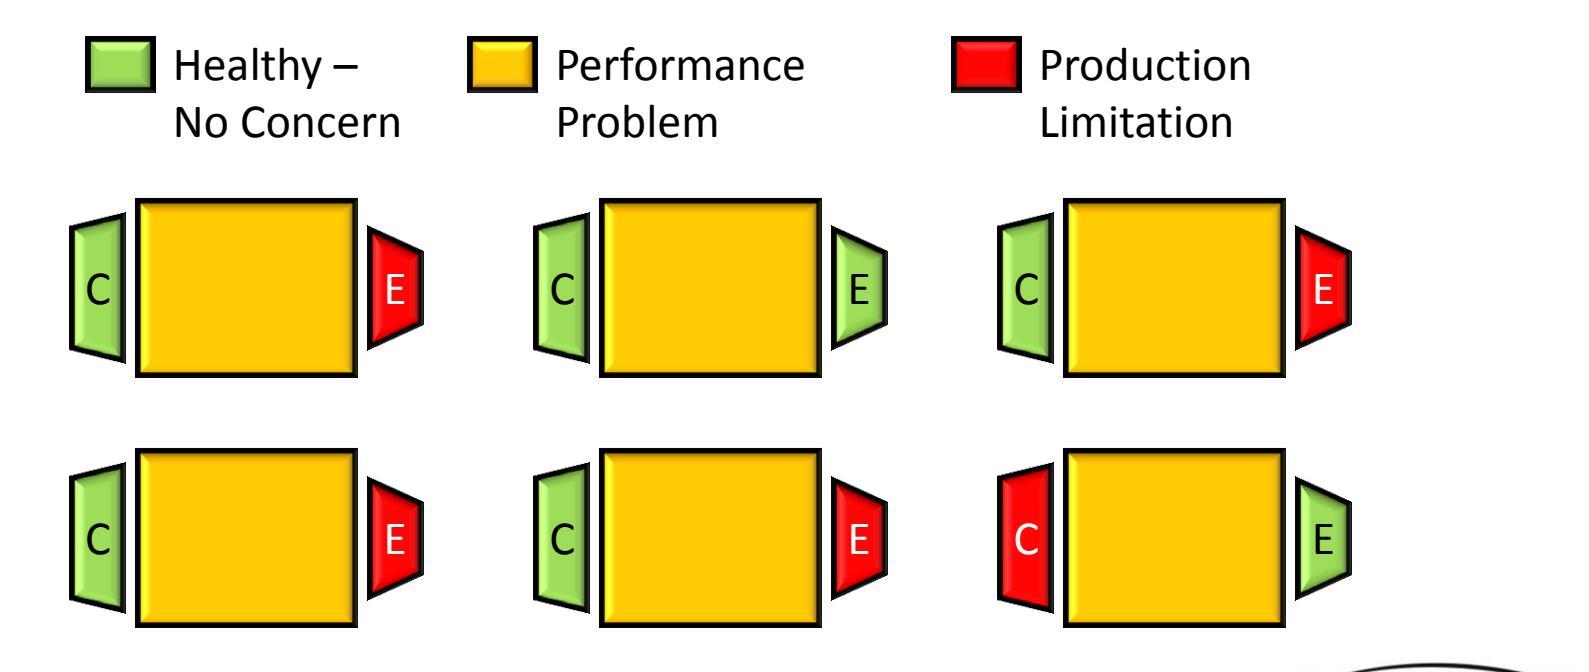
Performance Assessment Survey

The turboexpander exhibited three problems:

- 1. Buffer gas excessive flow
- 2. Wheel imbalance
- 3. High magnetic bearing current

(Bearing Housing) (Compressor) (Expander)

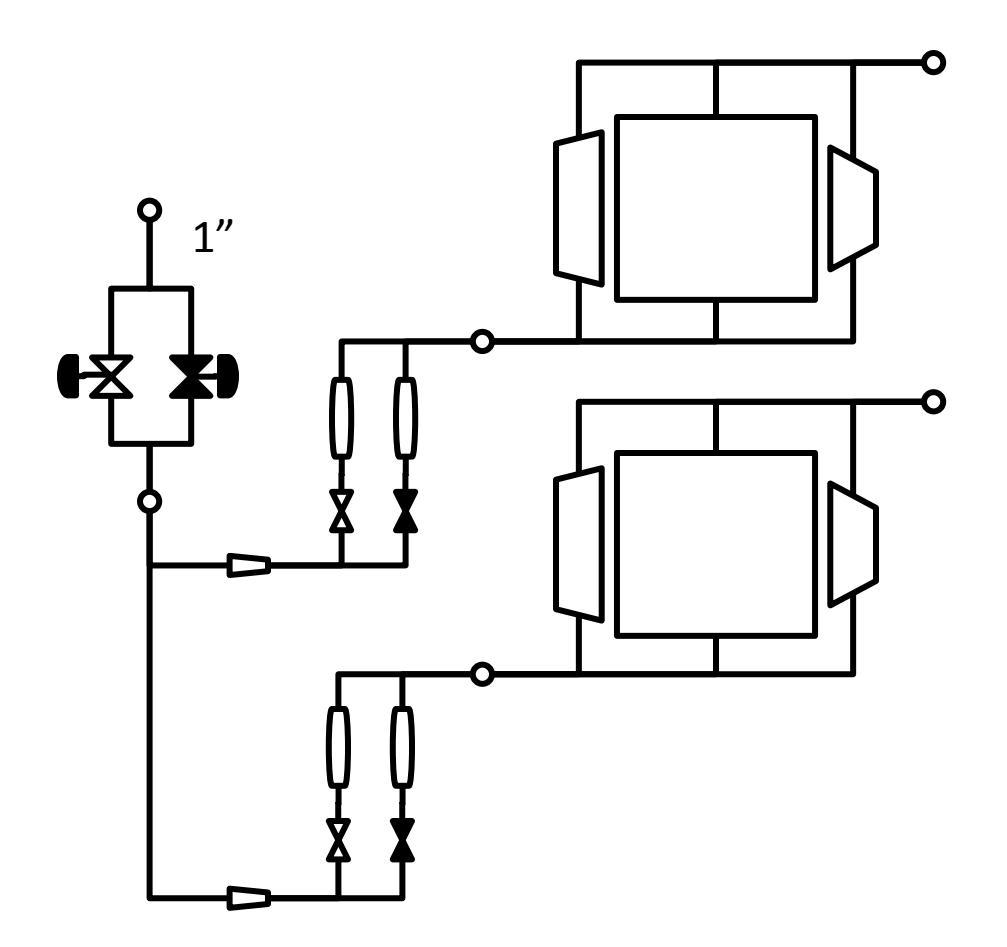
Challenge 1: Buffer Gas Performance

Buffer Gas Functions:

- Rejects heat generated by magnetic bearings and shaft windage.
- Protects auxiliary bearings from process gas.

Buffer Gas = Sealing Gas + Cooling Gas

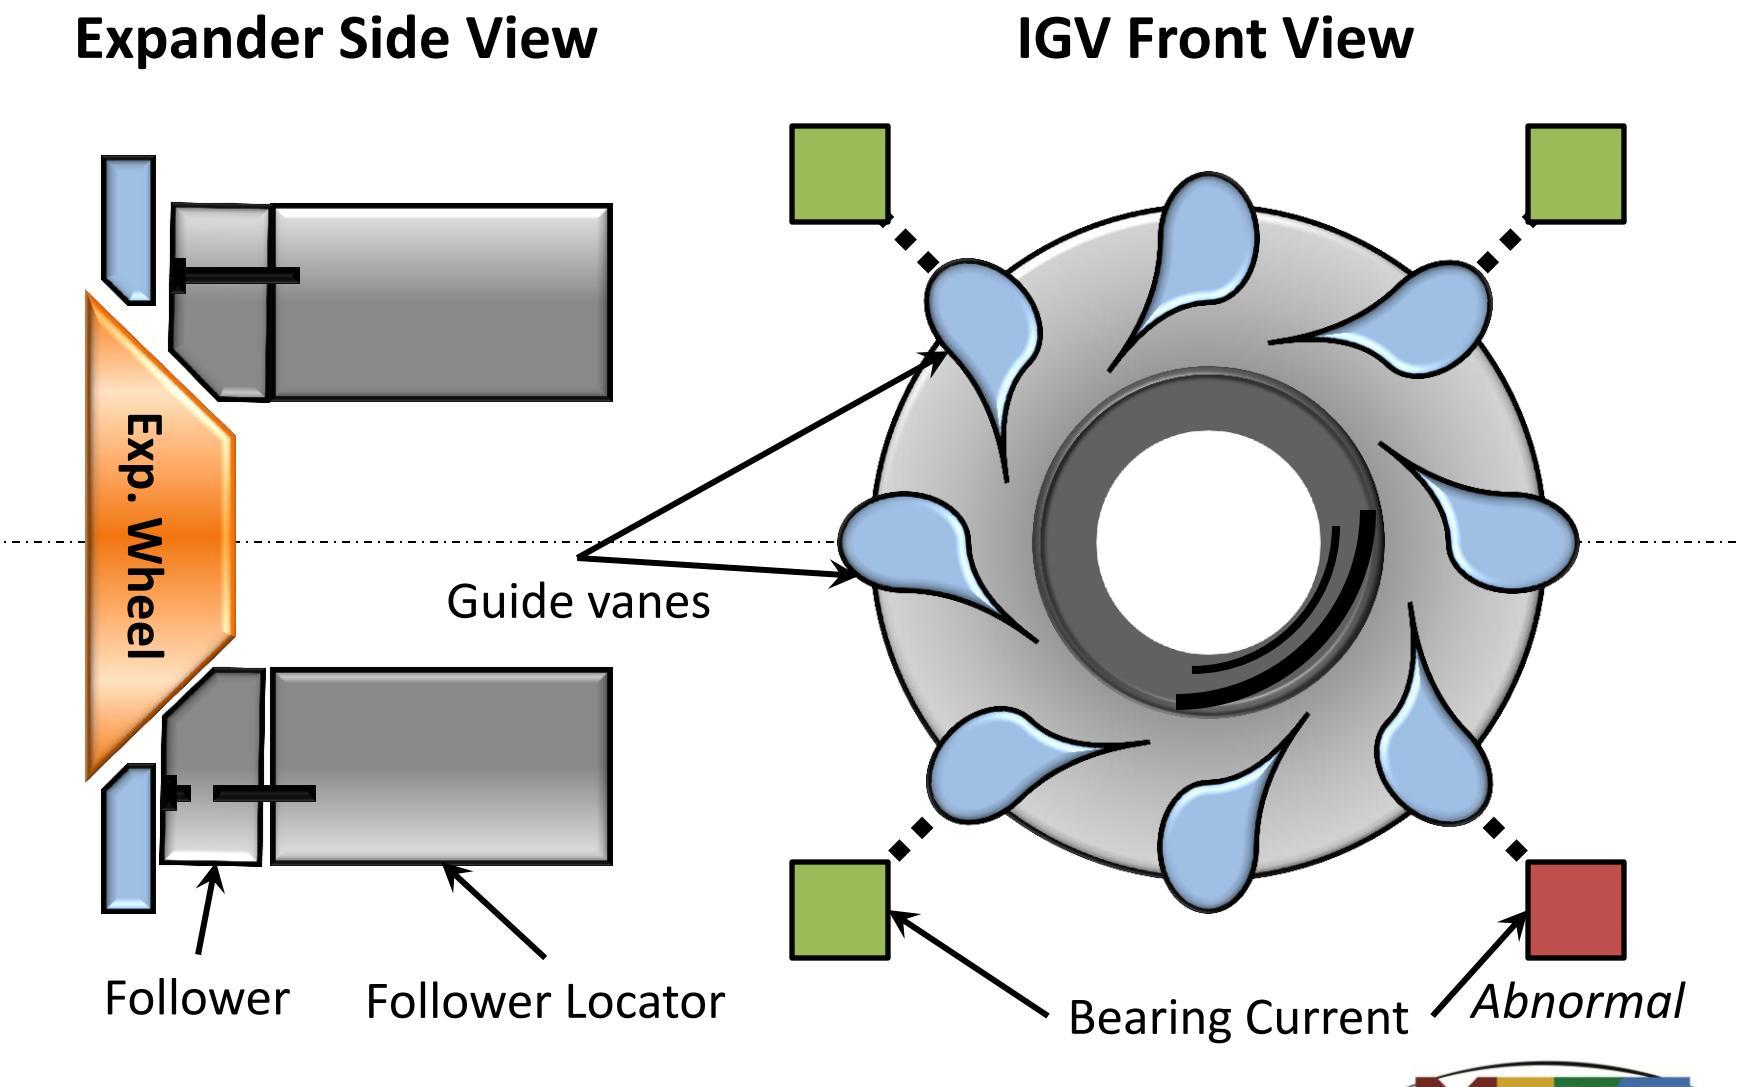
Challenge 2: Analysis

Challenge 2: Expander High Current

- Some machines could not be placed back online after planned shut down.
- Once started up, machines exhibited high magnetic bearing current on expander side.
- When the machine was shut down, high current still persisted.
- Lateral shaft translation by AMB control system was necessary to restore magnetic bearing parameters to acceptable levels.
