# Hydraulic Upgrade of Hot Water Circulation Pumps in a District Heating System

Erik Roosch & Frank Visser\*

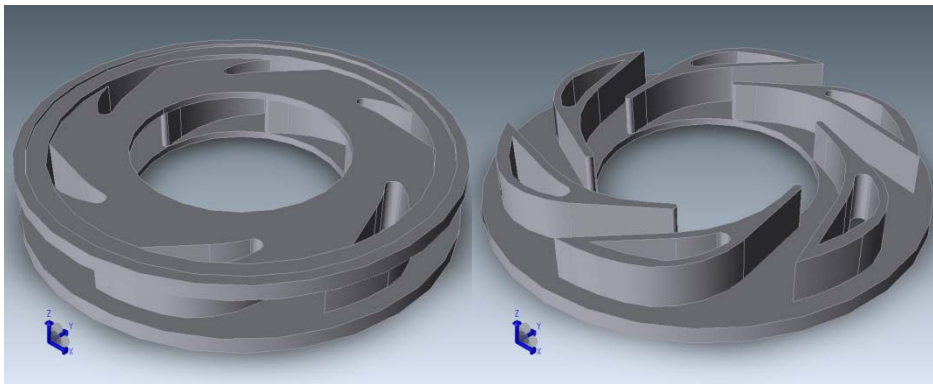
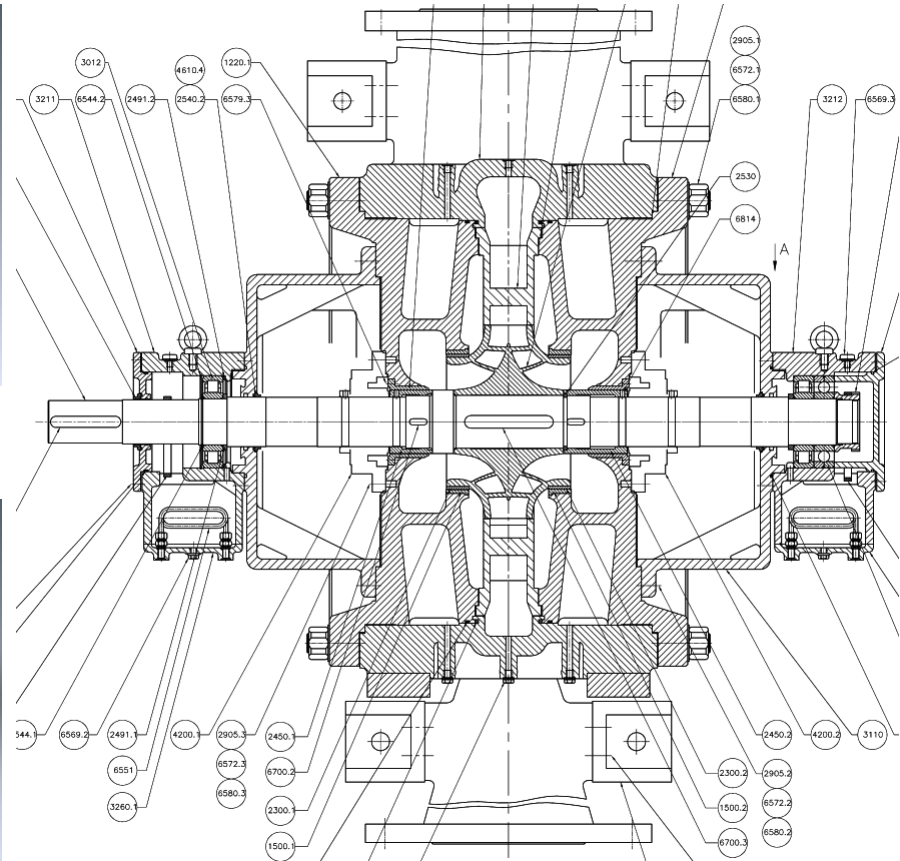
- New diffuser (6 vanes)

- ❖ Failed to make the head
- ❖ Efficiency too low
- ❖ Power too high
- ❖ BEP at too low capacity

- Keep new high capacity impeller
- Replace diffuser with (dual) volute insert
- Increase impeller tip clearance
