Centrifugal Compressor Over Speed Trip Case Study

Authors: Thota Praveen Kumar

Qatar Shell GTL Limited-Doha Qatar.

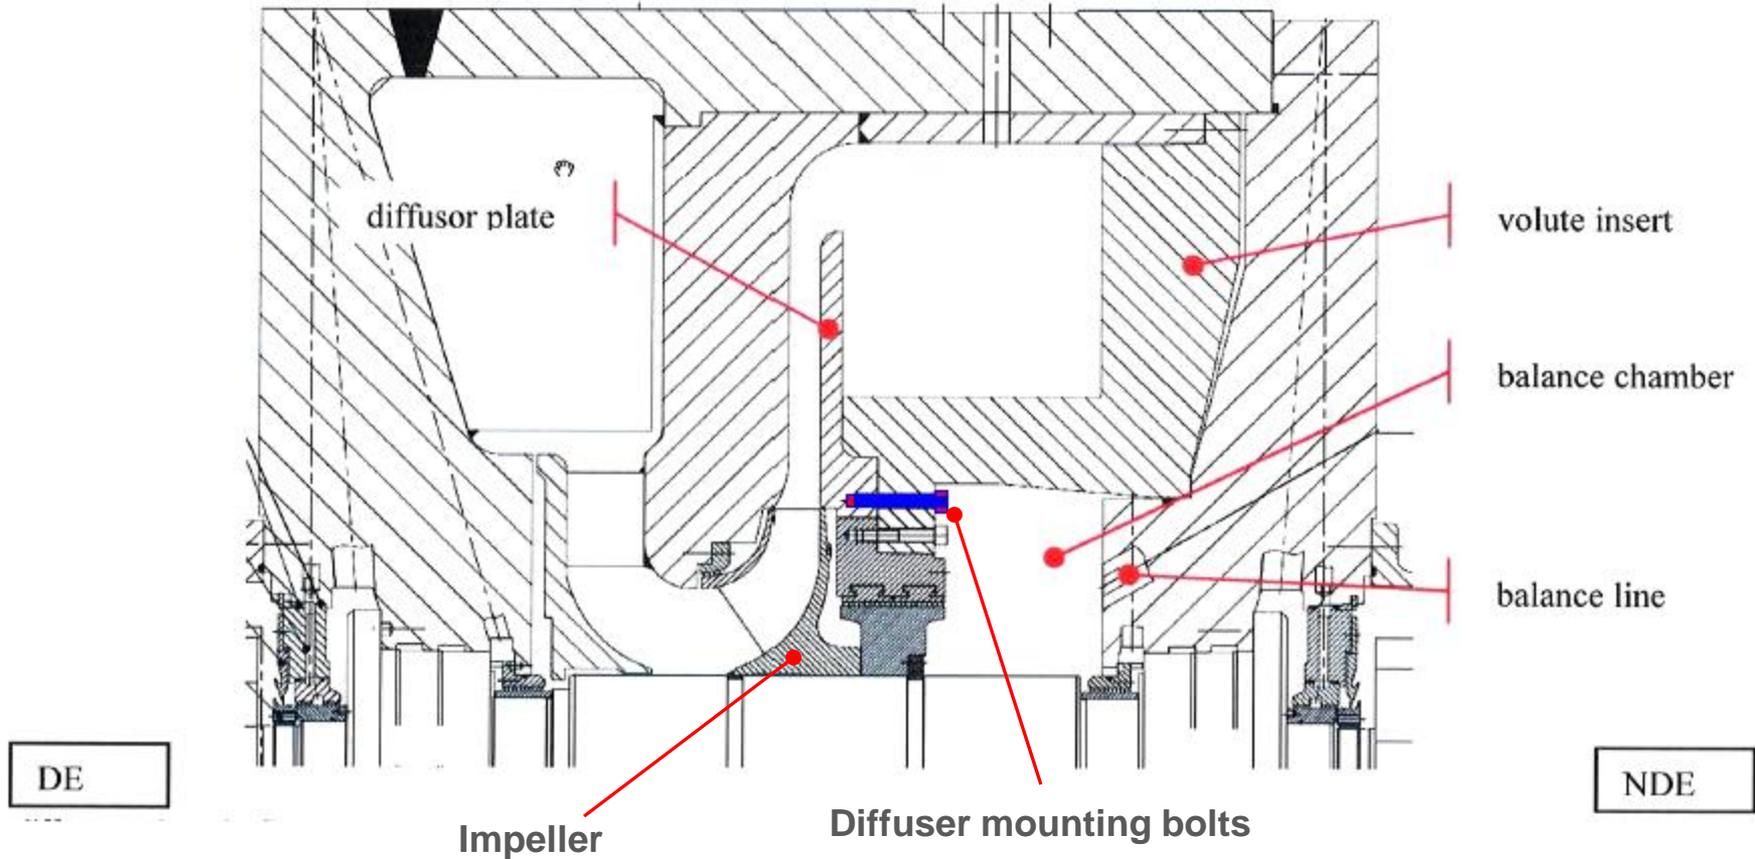
Compressor construction

Removed the compressor end cover found:

- ❖ Seven of the eight Allen head bolts holding diffuser plate in position were broken. One bolt was completely missing.
- ❖ Seven of the bolt heads were found sitting in the bottom of the balance chamber.
- ❖ One bolt broken had backed out and was found in balance chamber.
- ❖ 5 of bolts had been elongated.

- ❖ Rotor sent back to vendor for repair. Used the spare Rotor for assembly.
- ❖ The threads of the diffuser plate increased from M12 to M16 as they were found loose, and holes in the volute also increased to match.
- ❖ Diffuser plate Dye penetrant test carried out and found that there were no crack caused by the contact.
- ❖ All bolts were tightened with 130NM torque as per vendor recommendation and found no gap between diffuser plate and volute insert.
- ❖ Thrust and Radial bearings were reused.
