# Large Seawater Intake Pump Upgrades

Author: Ahmed Al Dossary

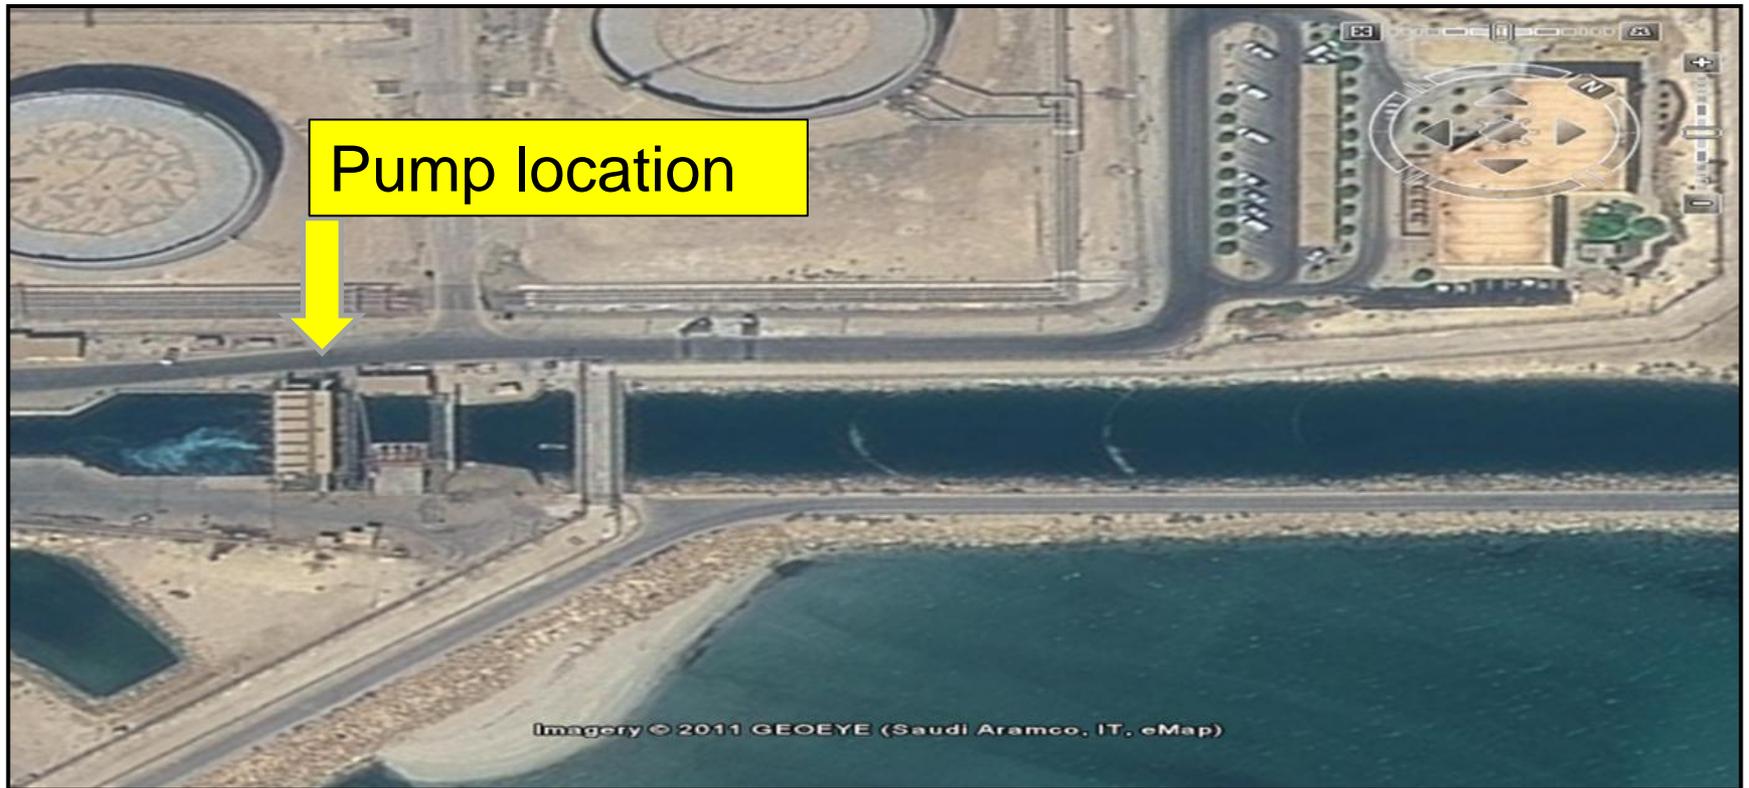
- Vertical pump with enclosed shaft tube.
- Flow rate 35,000 GPM.
- Over than 50 years old.
- Obsolete and no spare parts available.
