Resolving Intermittent Vibration Spikes on Steam Turbines

Rajakumar Thiagarajan

Rotating Equipment Engineer

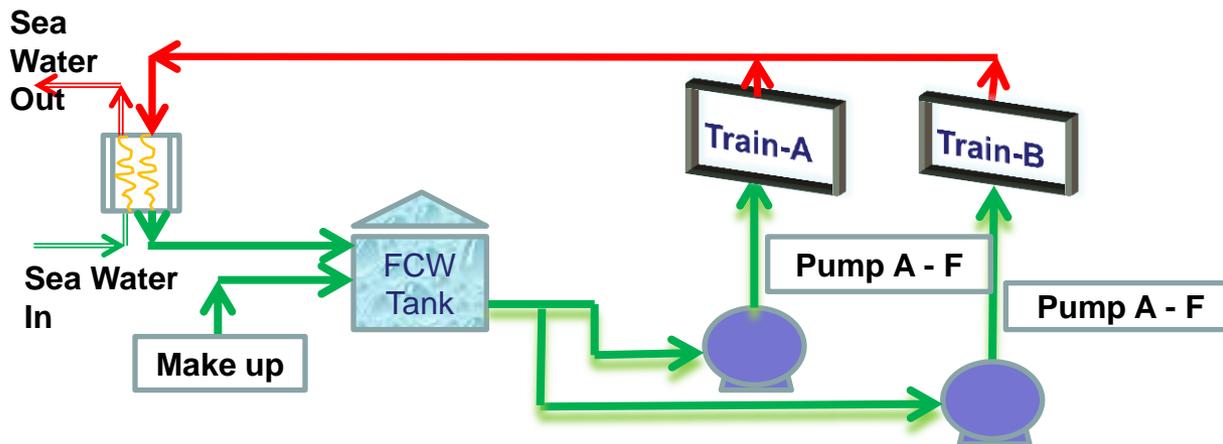
Schematic Diagram of Fresh Cooling Water System

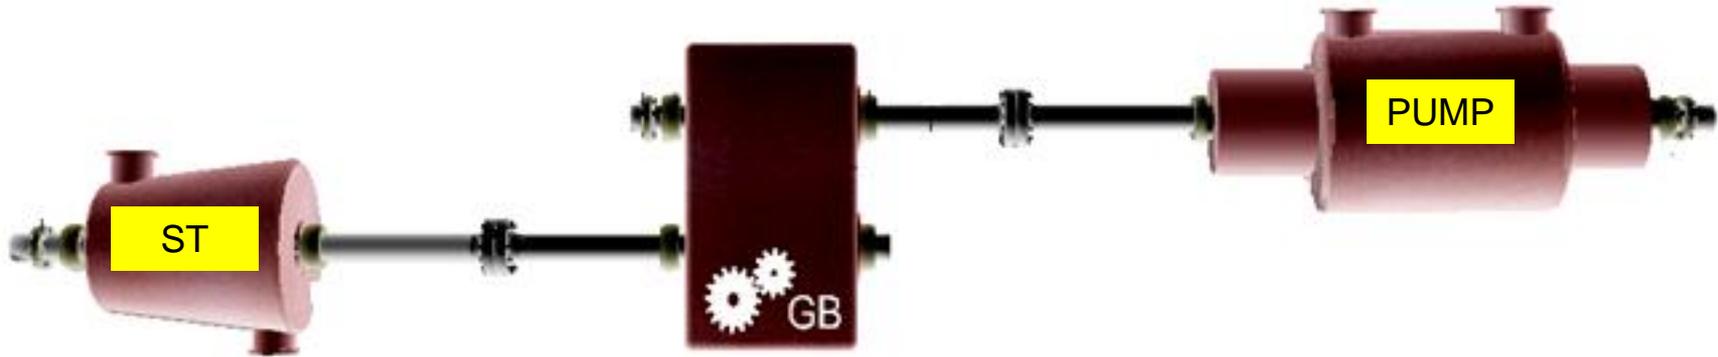
Machine Description

Turbine Type:	Back pressure (5 stage)
Bearings:	Tilting pad
Seals:	Mechanical Labyrinth
Coupling:	Diaphragm
Power:	3840KW
Speed:	3602 RPM
