Separation Seal Upgrade to overcome Repetitive Failures

Author : [RasGas](#)

[Pradip B Sonavane](#)

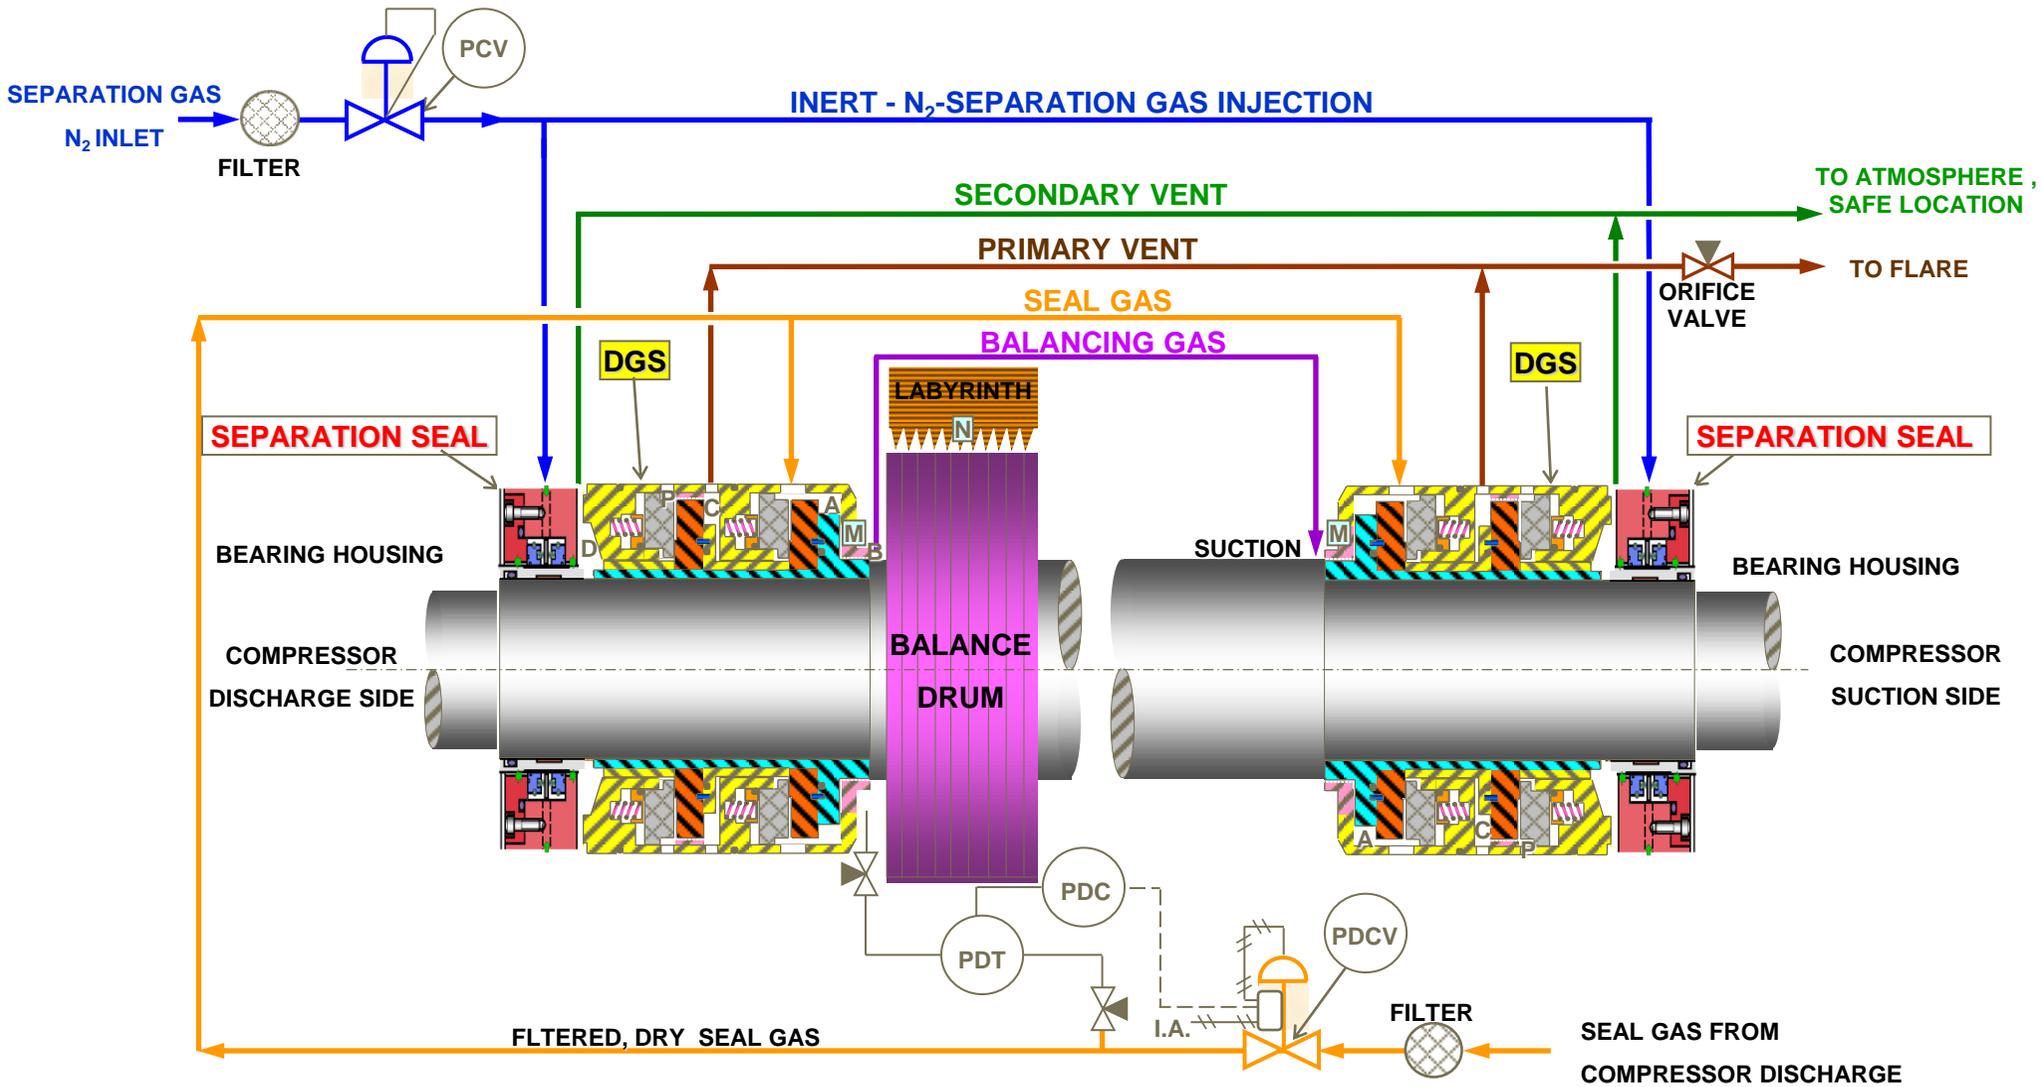
DGS Schematic

Dry Gas Seal

- Gas seal : Tandem 28AT Model
- Separation seal : Contacting type, (T82)
- Size : 7.625" (for LP) , 6.625" (for HP)

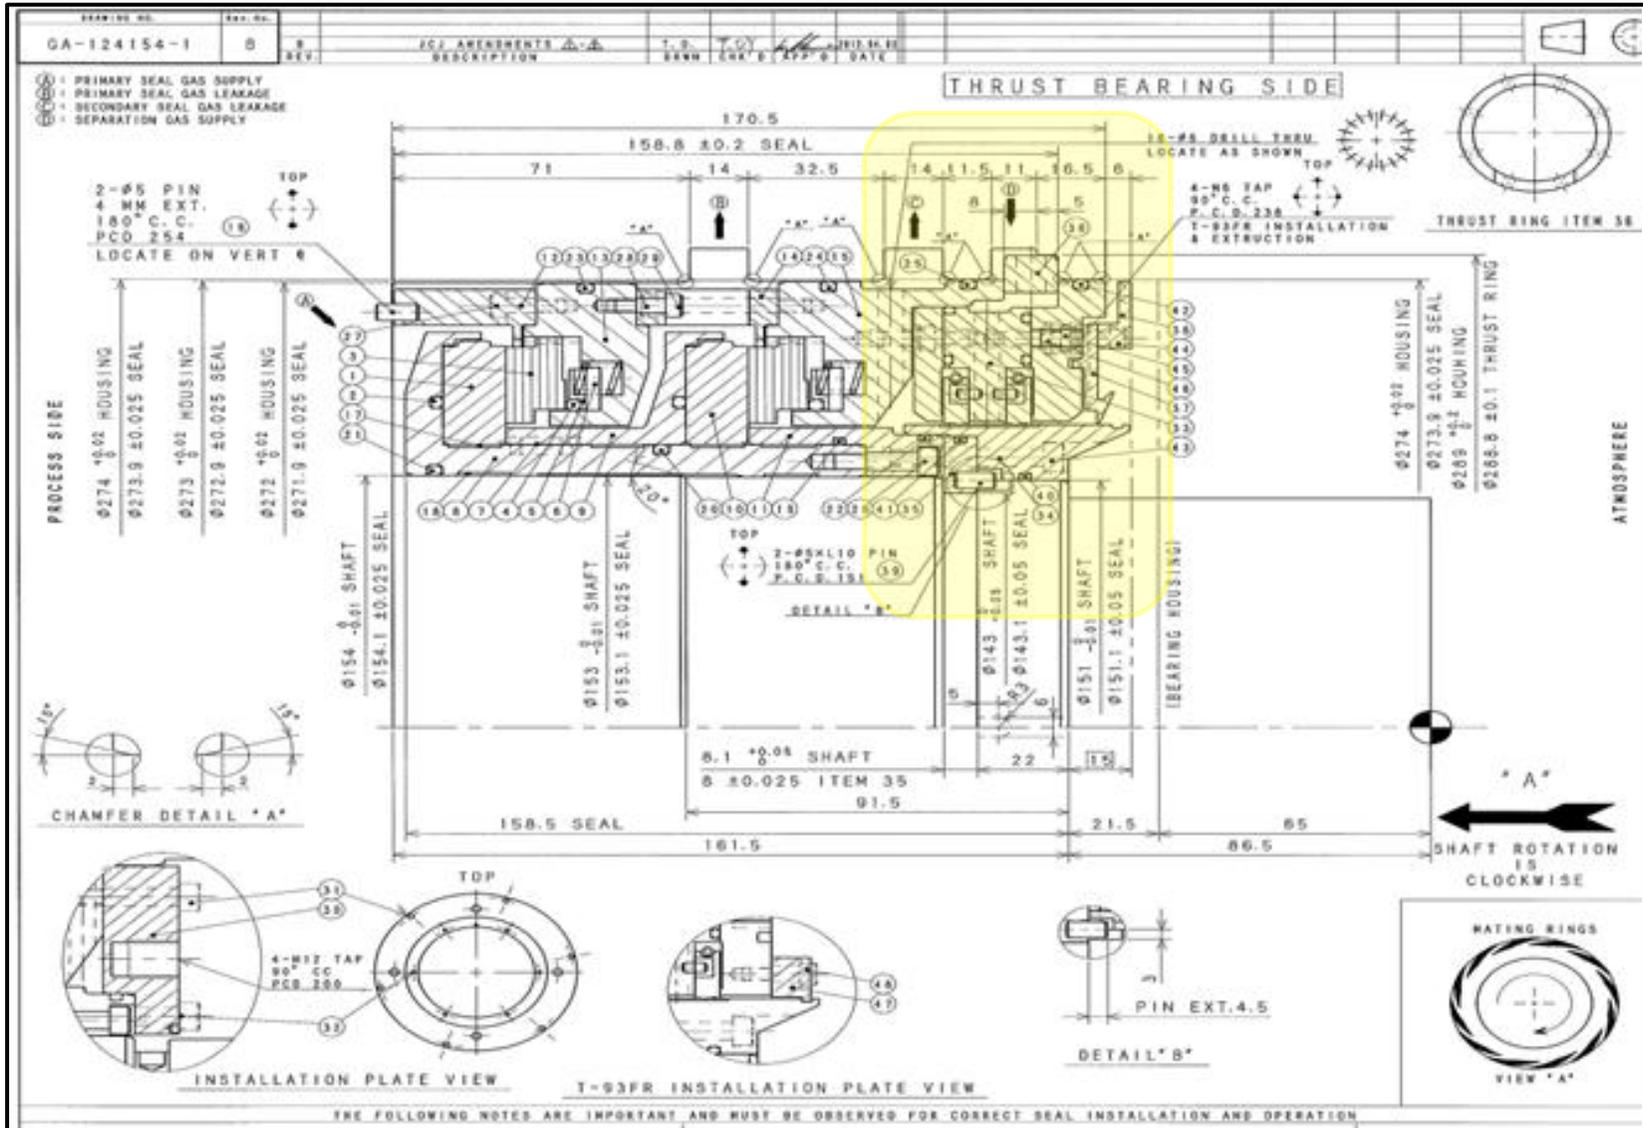
New seal T-93FR drawing

Design Features of selected T-93FR

- Non-contacting for longer life and improved reliability.
- Bi-directional.
- Suitable for running with N₂ separation gas irrespective of dew point.
- Self-centering design minimizes wear even during upset conditions.
- Robust cartridge design.
- Eliminate 'Fallback', 'Hang-on' phenomenon.
- Low heat generation, hence reduce coking.

“Upgrade existing DGSs to available technology of Non contacting type Separation Seal (T-93FR) with Oil Slinger / Deflector provision followed by related modifications in Main Gas Seal”

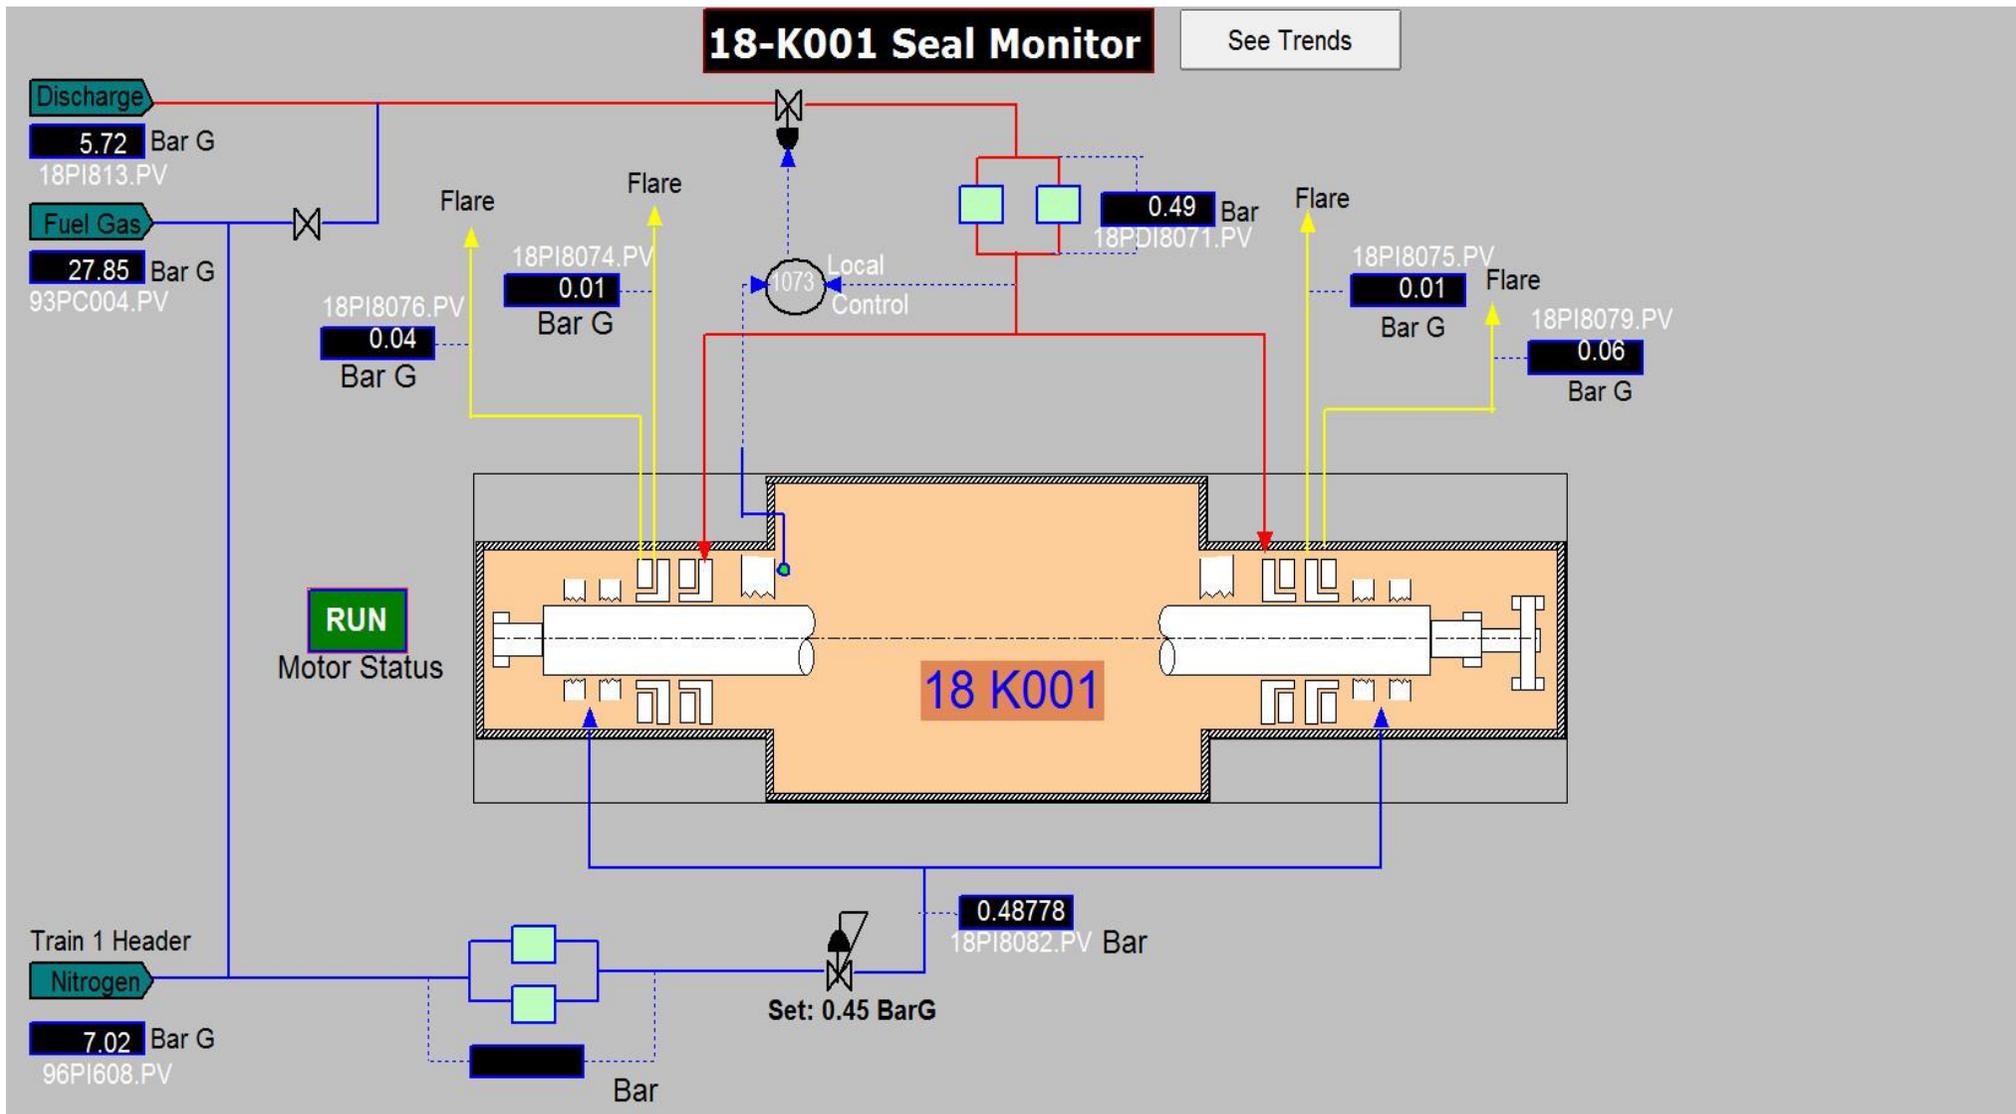
DGS Performance Monitoring

- DGS Upgrade with Floating Ring / Non Contacting Type T-93FR Separation Seal has so far successfully solved the Lube Oil Migration / Ingress issue.
- Oil Slinger provision along with Dual Segmented Floating Carbon Ring T-93FR Cartridge Assembly has proven as effective barrier between Main Gas Seal and Bearing Housing.
- This upgrade was carried out without any modification works on Compressor side.
- T-93FR Non contacting Type Separation Seal performance observed to be significantly better in comparison with T-82 and T-83 contacting type Separation Seals.
- Successful prototype implementation based on full OEM and End User contribution
